Taking delivery of a newbuilding vessel

Process of Taking delivery of a newbuilding vessel from the owner's representative perspective

Degree Thesis, Bachelor of Maritime Management

Turku 2022

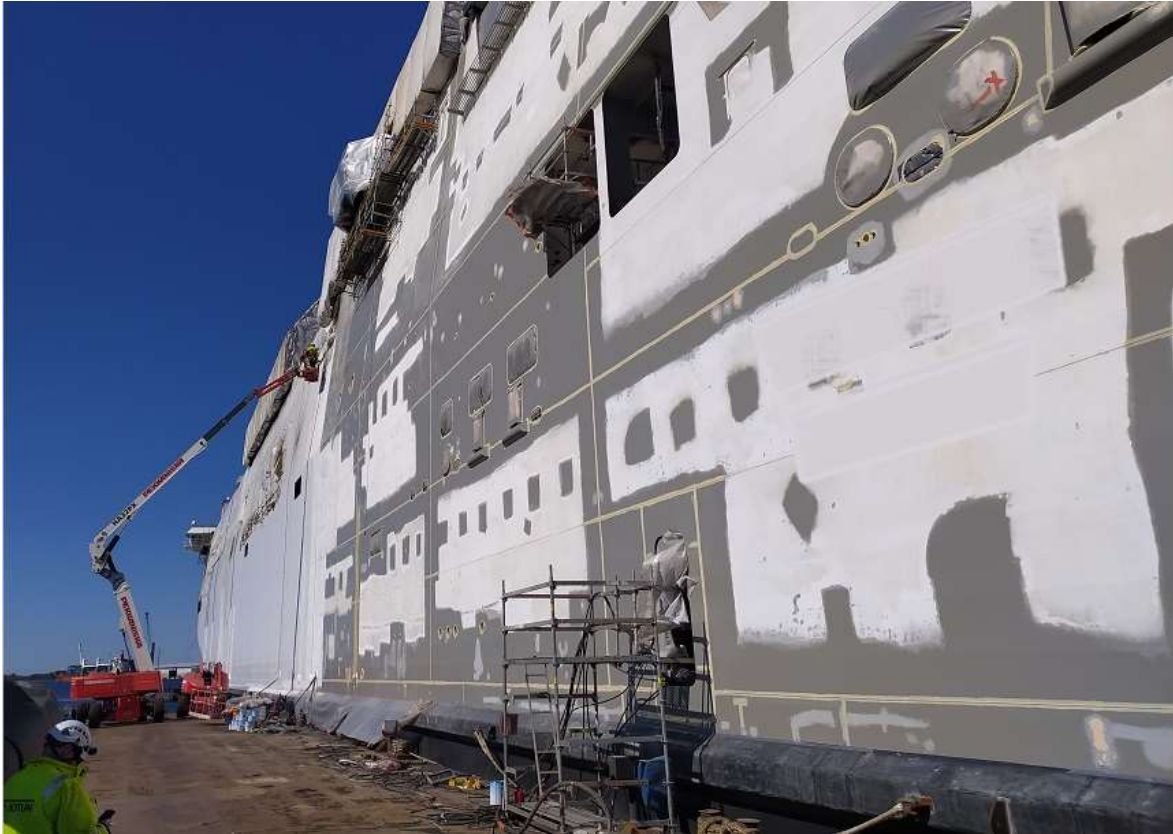
Figure 3: Side shell painting. Painting done in sectors. Area in background covered with top-layer while the aft area is stripe-coated. final inspection prior topcoat carried out. Note that filler has been used and left uncovered by primer on various spots on aft sector and the sector was not approved for top-layer painting.

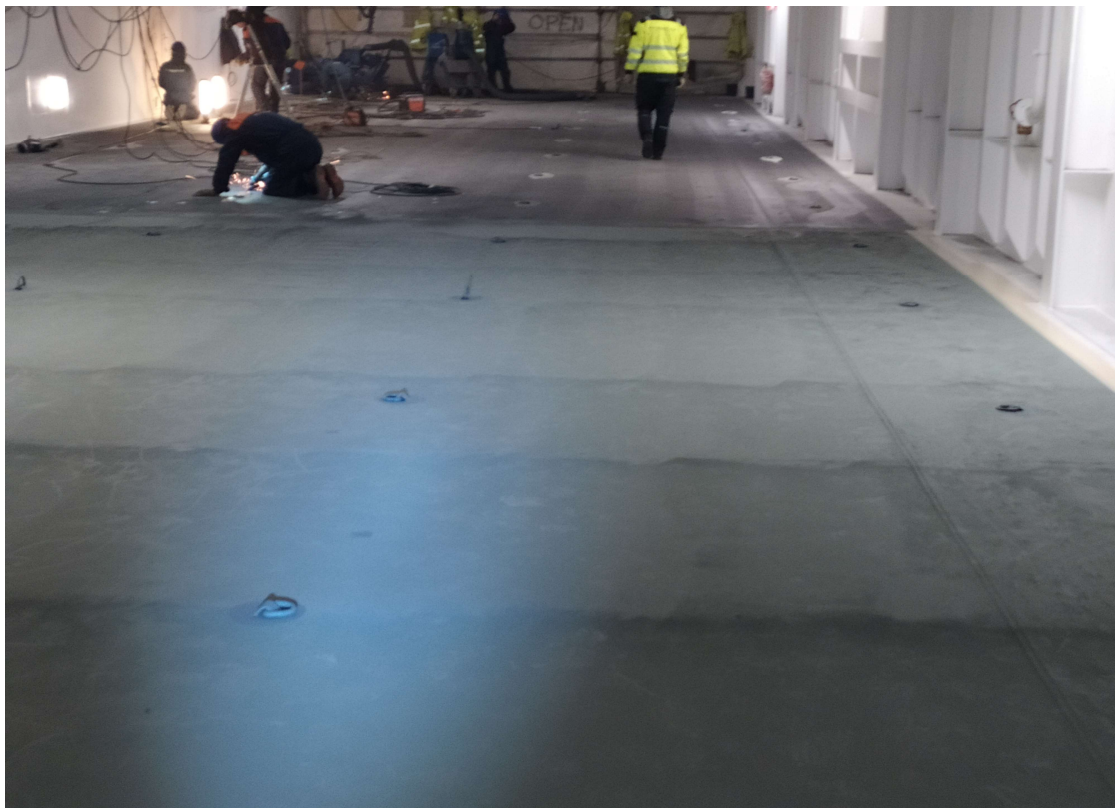
Figure 4: Zinc based stand-alone coat on car deck. Metalworks on-going on background. Note that the zinc coat has been sprayed poorly resulting excess or low DFT on overlapping areas. Based on 80-20 principle the area was accepted.

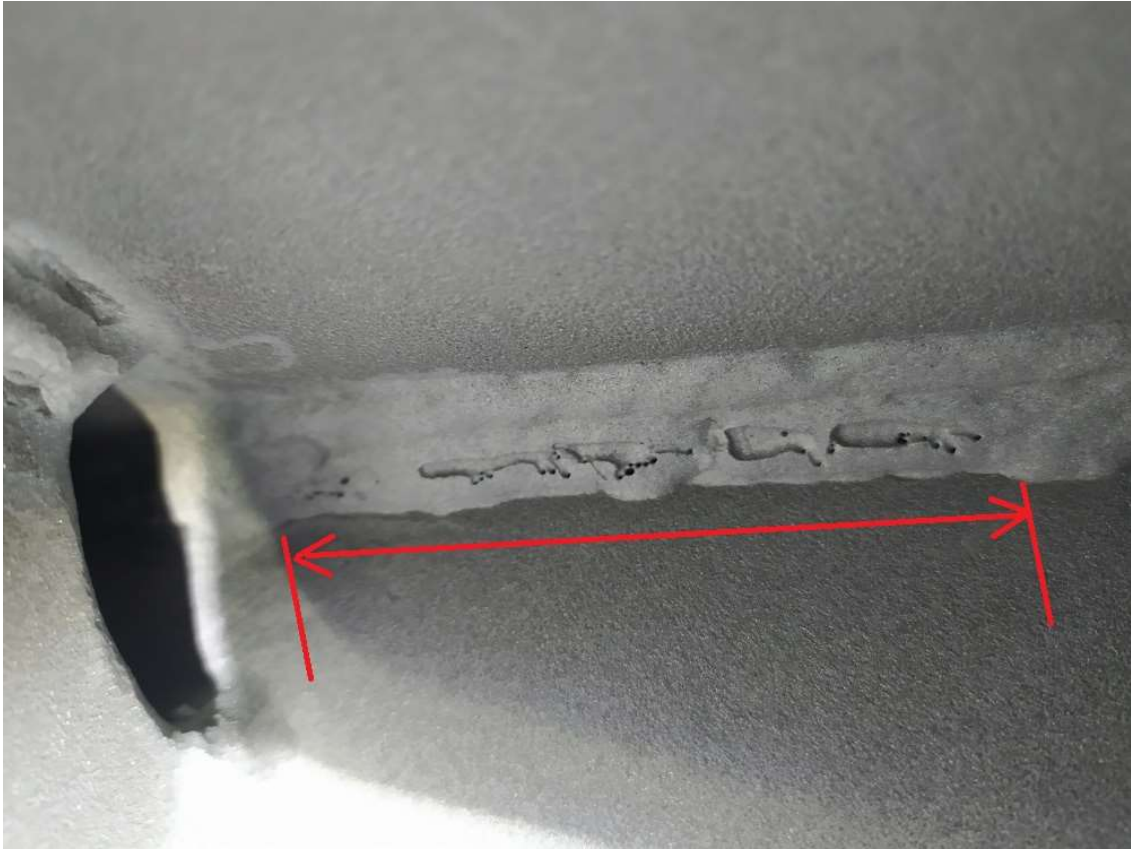
Figure 6: Example of poor welding quality. Pinholes revealed on freshly blasted area.

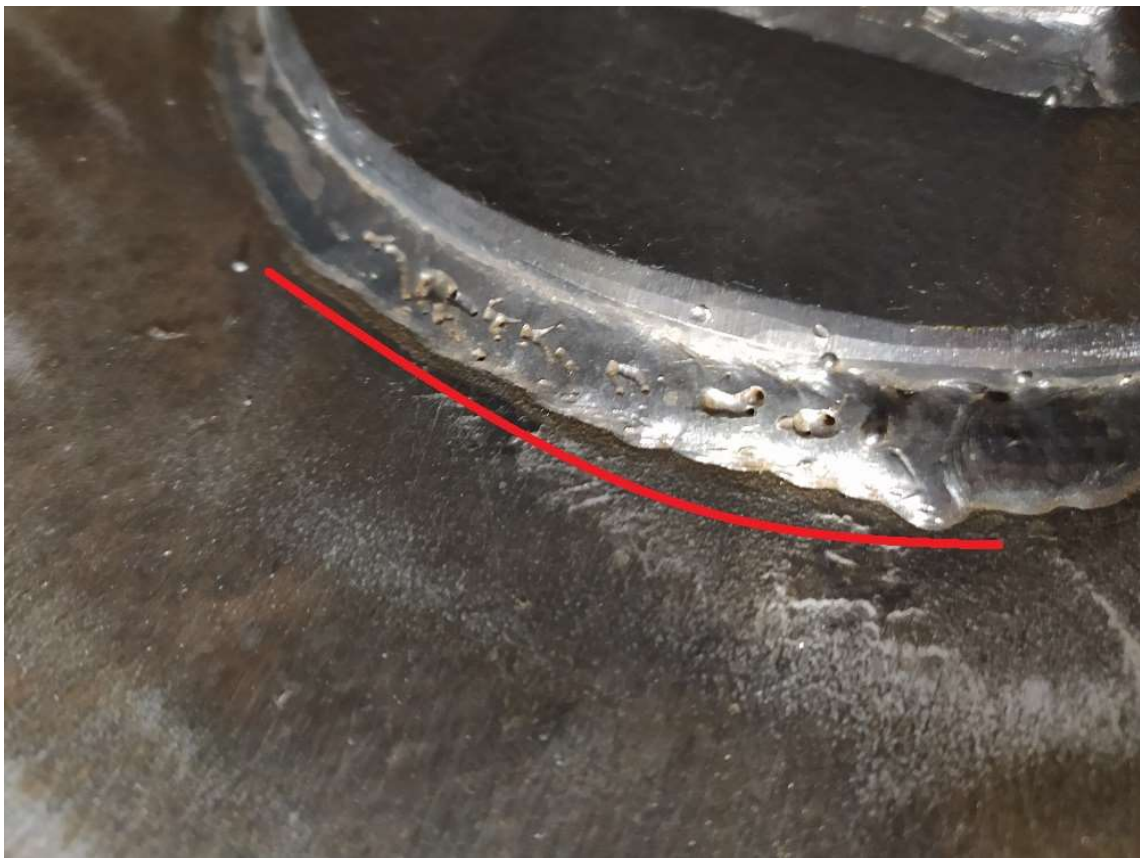
Figure 7: Example of poor welding quality. Pinholes and weld-spatter revealed on wire-brushed area.

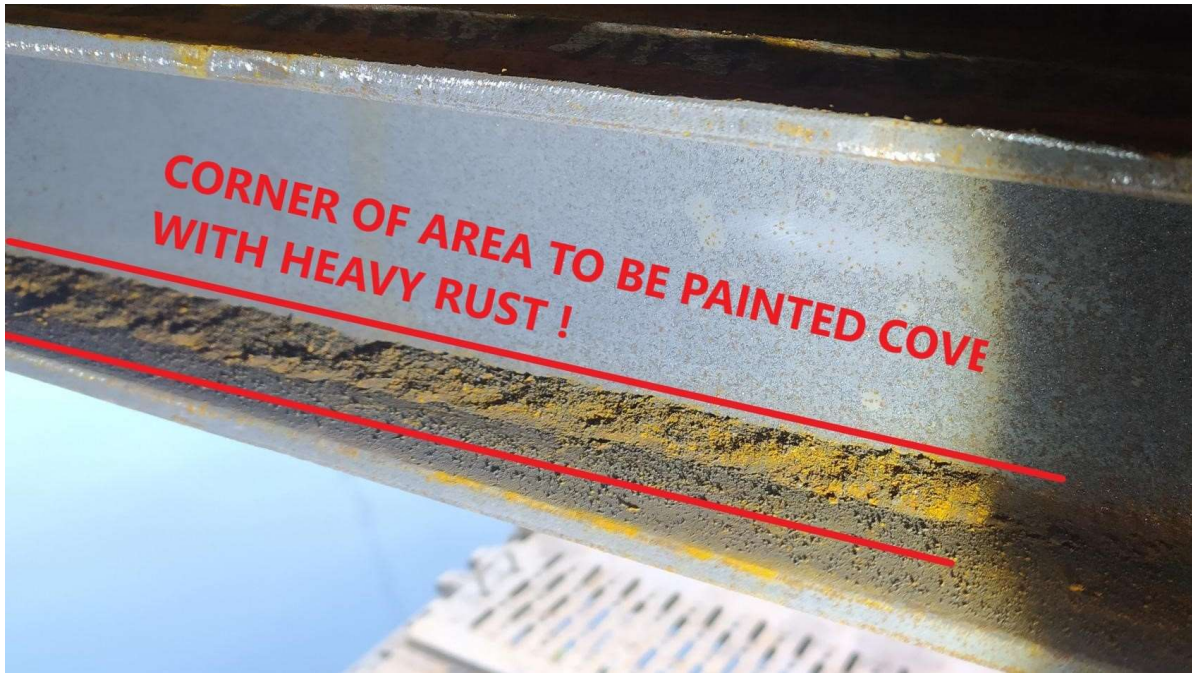
Figure 8: Area covered with heavy rust found during metal inspection prior painting.

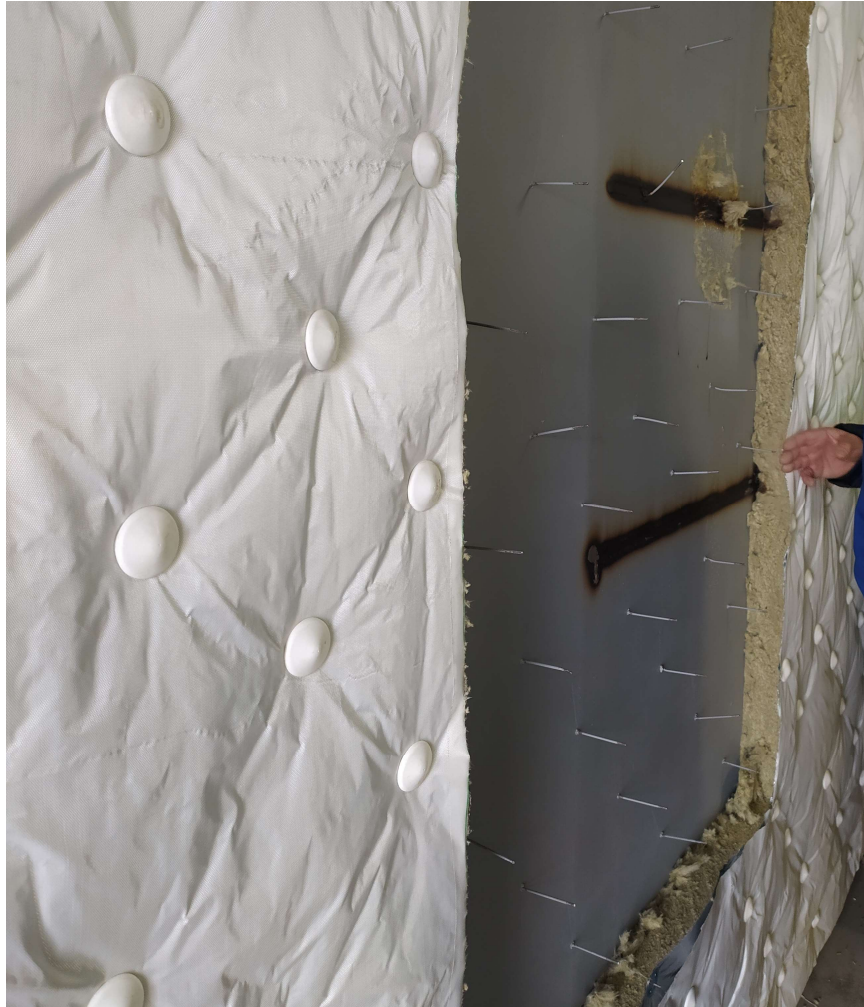
Note that insulation on the burned area must be removed, area re-painted prior re-installment due to welding burns from welding works conducted on the other side of insulated bulkhead.

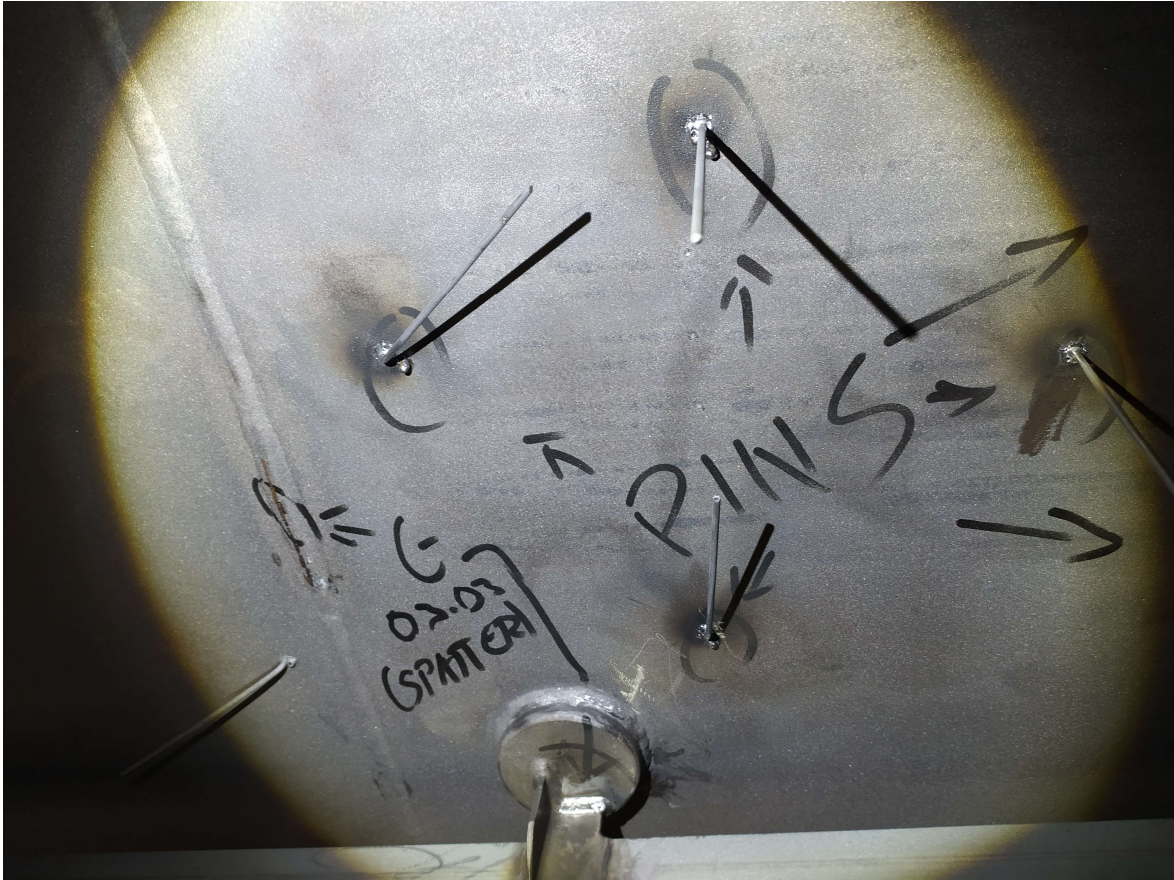
Figure 18: Missing insulation pins discovered by author during inspection re-installed. Note welding dust not cleaned after re-instalment of pins.

Steel surface treatments prior insulation causes challenges for insulating teams. Metal blasting and grinding prior surface treatment damages insulation pin anchorage points to point of perish and the material resistance decreases. For this reason, insulation pins should be inspected and weak or missing pins re-installed prior painting works. Additionally the

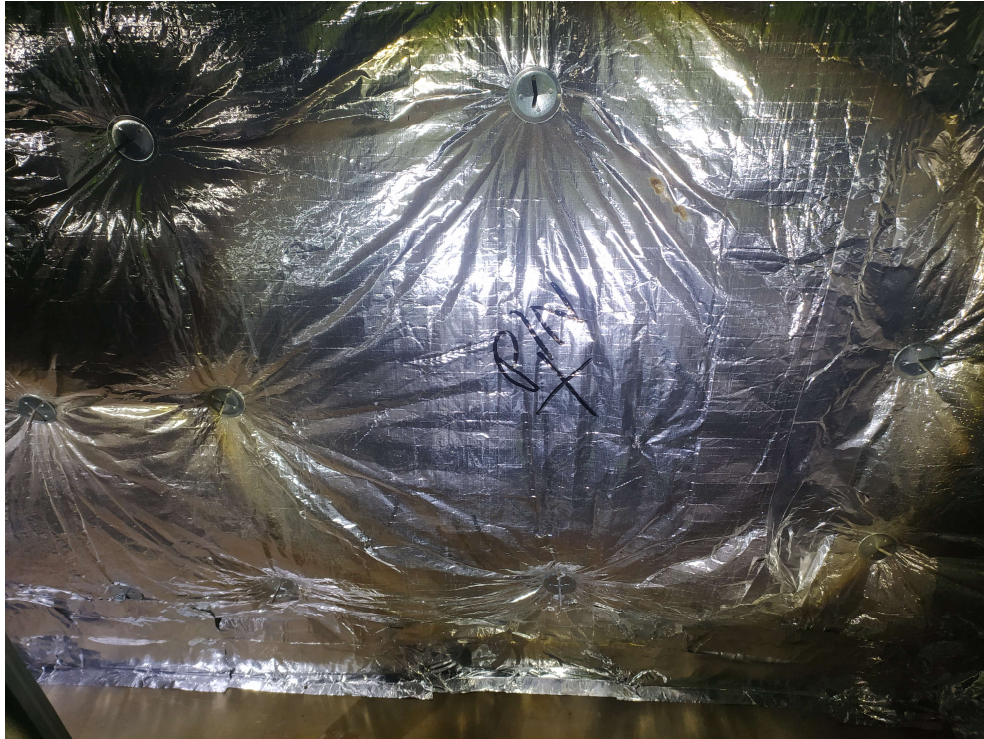
Figure 19: Missing insulation pin discovered by author during inspection of insulation.

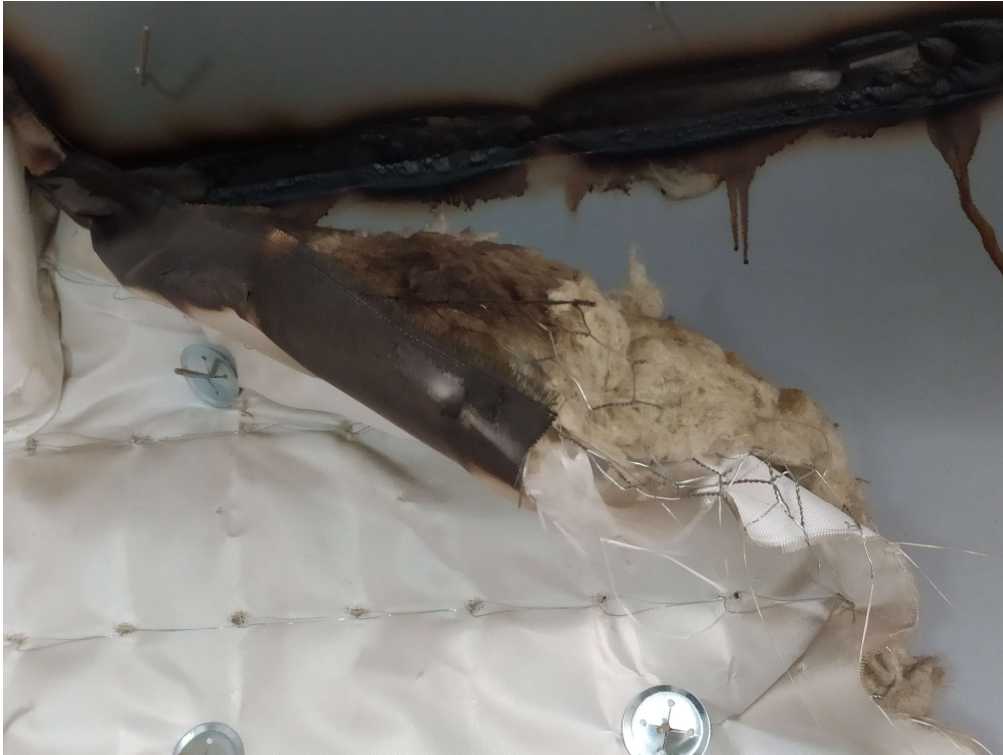
Figure 20: Damaged insulation after apparent welding on upper deck.
The metal surface should be cleaned, re-coated and re-insulated.

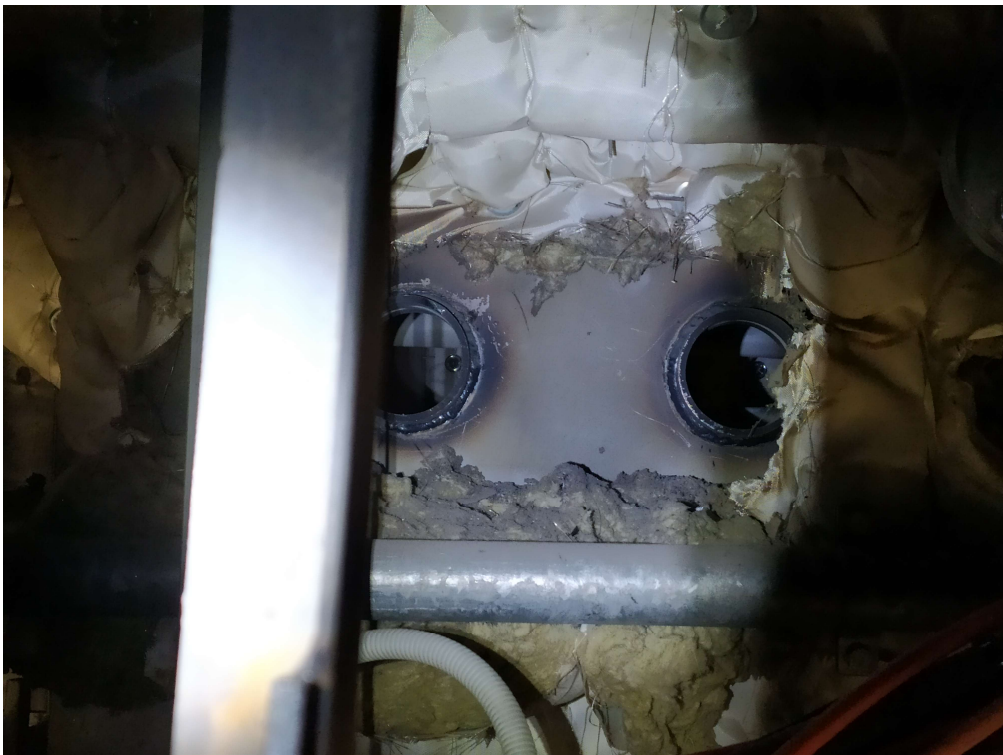
Figure 21: Damaged insulation. Penetrations not done in proper stage result in additional works to restore condition of finished technical area. Penetrations need to be cleaned, coated and re-insulated.
