Ship Bridge Nonconformity and Fire Hazard Mitigation

Degree Thesis, Bachelor of Maritime Management

Title: Ship Bridge Nonconformity and Fire Hazard Mitigation

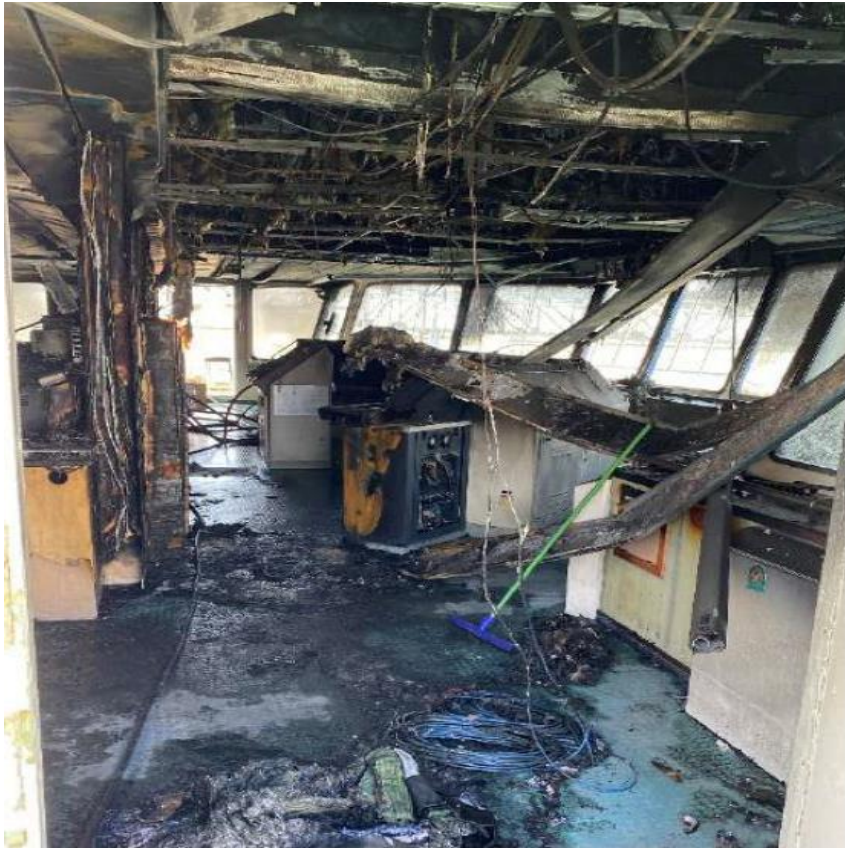
Figure 3. Damage of fire to the bridge. (NTSB, 2023).

The fire caused extensive damage to the bridge, including the destruction of the navigation, communication, and alarm systems, all of which were deemed irreparable. However, the fire did not spread beyond the bridge, leaving the lower decks and other parts of the vessel undamaged.

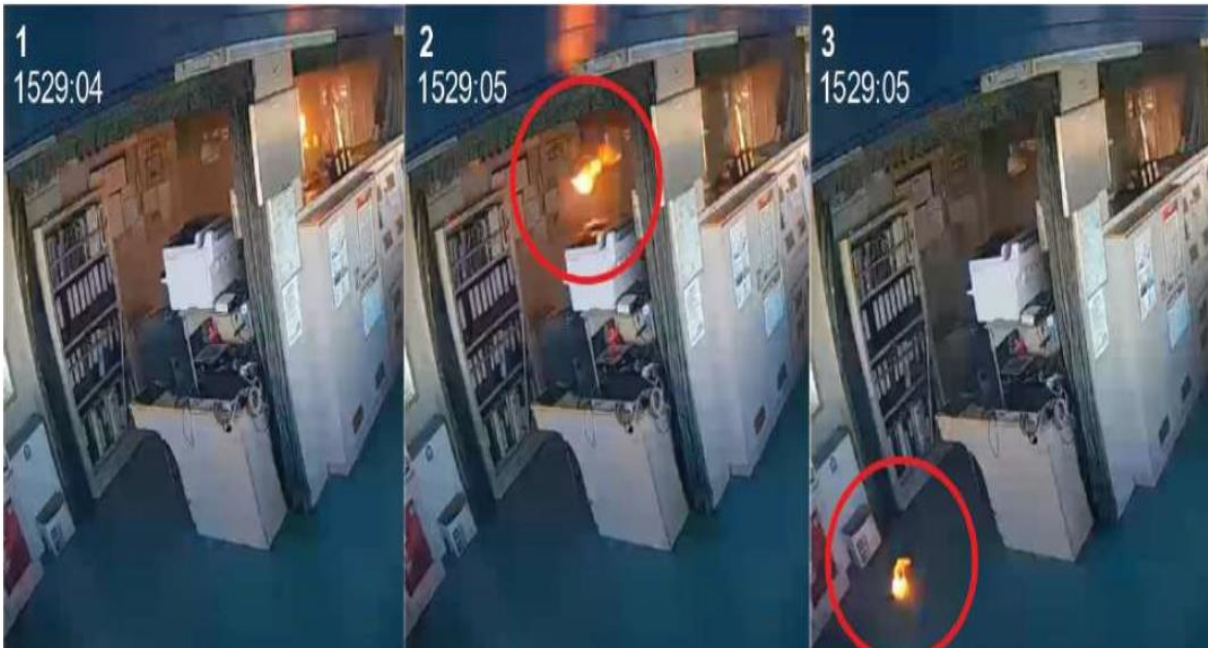
The fire was initiated by the thermal runaway of a lithium-ion battery cell, which is a condition where the cell overheats and undergoes a chemical reaction that can lead to an explosion. This was evidenced by the closed-circuit camera footage that captured an orange flash and

subsequent smoke from the communication table where the batteries were kept (see Figure 4). Moreover, the investigators from ATF discovered the remains of three batteries (one nickel-metal hydride and two lithium-ion) on the communication table. One lithium-ion battery was identified as the source of the explosion, while the other likely exploded due to the heat generated by the initial explosion.

Figure 4. CCTV photos of how the fire started. (NTSB, 2023).

It was reported that the thermal runaway likely ignited nearby combustible materials, causing the fire to spread rapidly across the bridge. The analysis confirmed that the subsequent heat and flames were responsible for total damage to the bridge's alarm, communication system and navigation systems.

The investigation revealed that there were issues with the charging of the batteries on the day of the fire, suggesting potential deficiencies in the maintenance and inspection of the charging equipment and electrical systems on the bridge. If the battery chargers or the batteries themselves were not functioning correctly, this could have contributed to the thermal runaway. The failure to identify and rectify these issues before they led to a fire represents a nonconformity.

The S-Trust incident emphasises the risks associated with lithium-ion batteries, particularly in enclosed spaces like a ship's bridge. These batteries can be dangerous if they overheat and damaged or are improperly charged. This particular incident stresses the need for strict adherence to manufacturer guidelines for battery maintenance and charging. Additionally, the incident suggests the importance of considering enhanced fire detection and suppression systems in areas of a vessel where lithium-ion batteries are stored or charged.

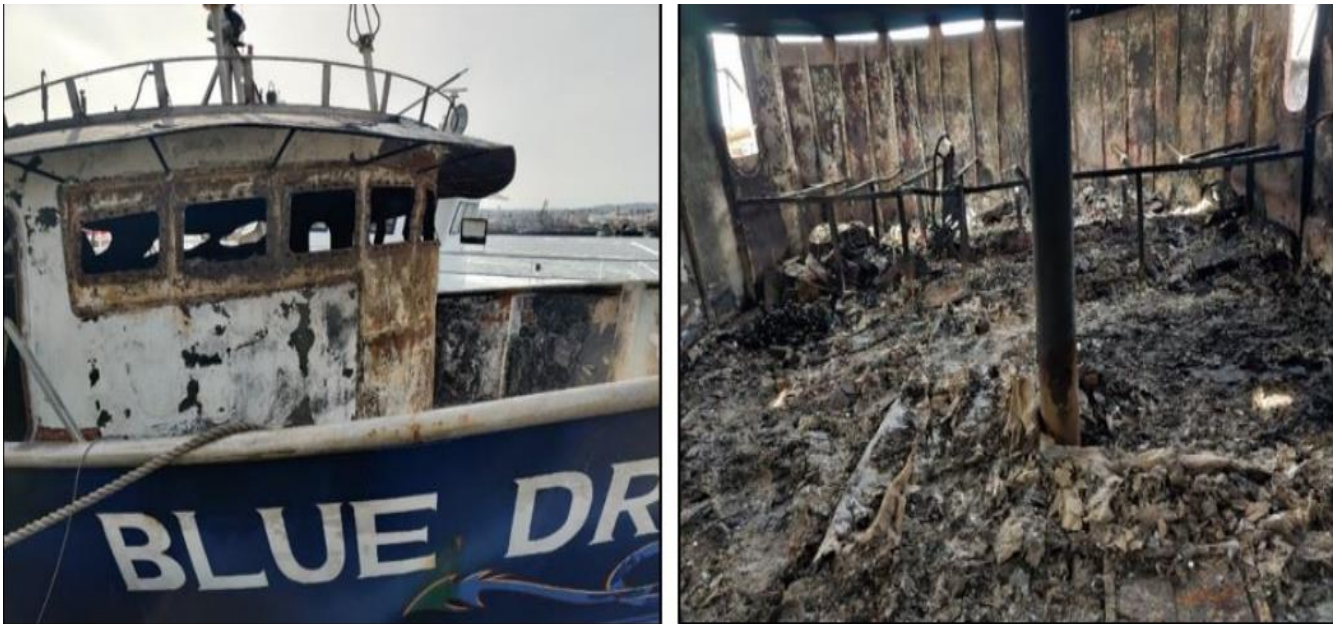
Figure 5. Damage of fire to the vessel. (NTSB, 2022).

The investigation conducted by the NTSB on the Blue Dragon incident suggests that the fire likely originated from an electrical fault under the wheelhouse console. The fire then spread rapidly due to the presence of combustible materials in the wheelhouse and accommodation areas, including wooden construction elements and stored items like paint cans and welding rods. The fire most likely started under the wheelhouse console due to substandard electrical wiring. The console's wiring on a similar vessel, Blue Dragon II, was found to be below marine standards, supporting the theory that an electrical issue ignited the fire.

The extensive use of combustible materials in the vessel's construction and furnishings, as well as the storage of flammable items, contributed to the rapid spread of the fire. The limited firefighting equipment on board, including insufficient hose reach and the reliance on fire extinguishers, was inadequate to control the fire.

The discovery of substandard electrical installations on a sister vessel (Blue Dragon II), which had similar conditions to the Blue Dragon, indicates that the electrical system on the Blue Dragon was likely below the required safety standards. The use of non-marine grade wiring, improper connections, and loose wiring present a clear risk of electrical faults and fires. This constitutes a major nonconformity, as it directly compromises the vessel's safety and could have been a preventable cause of the fire.

Furthermore, the affected vessel lacked a smoke detection system in the wheelhouse, which delayed the detection of the fire and allowed it to spread unchecked. The absence of such a critical safety system is another nonconformity, as it hindered the crew's ability to respond effectively to the fire in its early stages, thereby exacerbating the damage.

Besides, the crew's difficulty in effectively using the water (wash down) hose to fight the fire indicates that the firefighting equipment was inadequate. The hose was either too short or poorly maintained, preventing the crew from reaching the fire. This is a nonconformity that potentially contributed to the fire's uncontrolled spread.

Finally, the Blue Dragon had a high fire load due to the extensive use of combustible materials in its construction, furnishings and the presence of paint cans and welding rods stored beneath the wheelhouse. The improper management of these combustible materials, which is another nonconformity, contributed to the rapid spread of the fire.
