SUSTAINABLE WASTEWATER NETWORK MANAGEMENT IN LEMPÄÄLÄ MUNICIPALITY

Bachelor's thesis
April 2012
Environmental Engineering
Department (TAMK)
Tampere University of
Applied science

Peter Paul Obijaju	Sustainable wastewater network management in Lempäälä Municipality
Final thesis	36 Pages
Supervisor	Hilda Szabo
Commissioned by	Water Utility department of Lempäälä municipality in August 2011

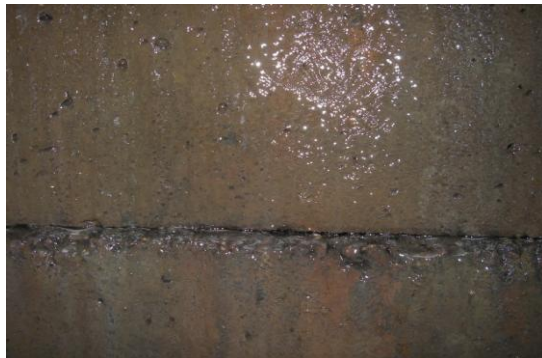
PICTURE5.1Leaks from the walls and seams of the Manhole (Obijaju, 2011)
