IMPROVING THE FORKLIFT TRAFFIC SAFETY AT LOGISTICS TERMINALS

Karri Koskela

Bachelor's Thesis
September 2010

Degree Programme in Logistics Engineering
Department of Technology and Transport

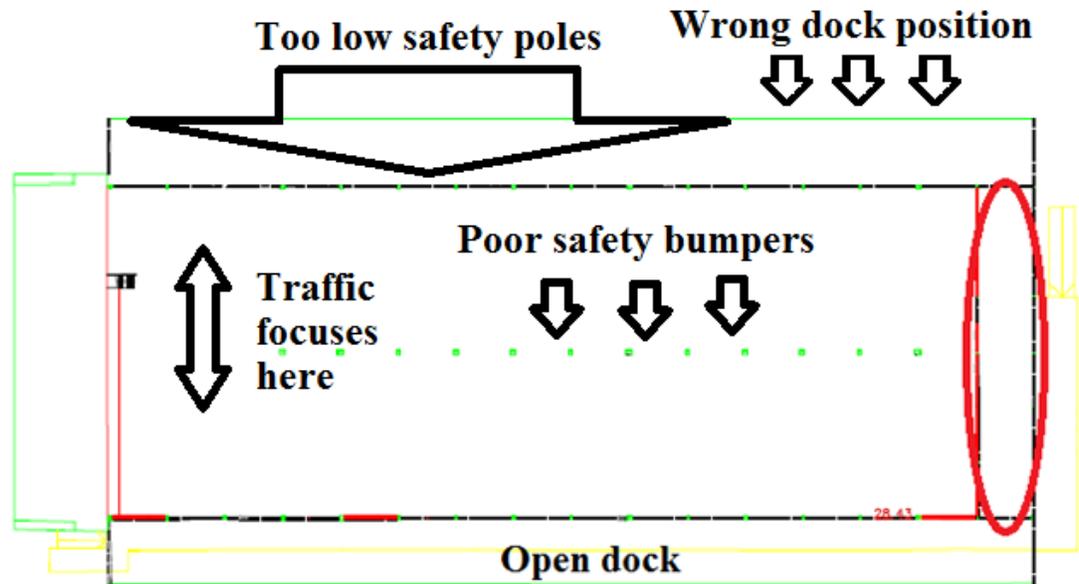
warehouse, one part at the back of the warehouse was filled with goods that appeared to have been there for a very long time (see Figure 6).

FIGURE 6. The layout of the warehouse A, probable unnecessary goods marked with red

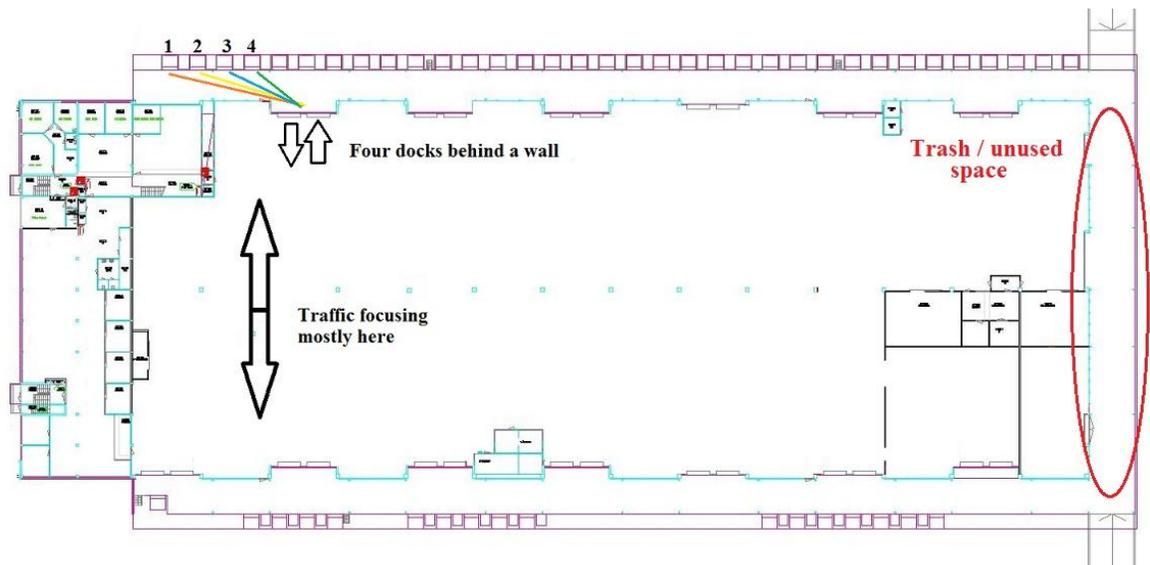
numerous empty pallets, electric pallet trucks, forklifts lying around and some oil spills. Clearly there is no specific place where they should be left. The same issue concerned the pallets with goods loaded onto them. They were as well left lying around. However, the reason for this may be the same as with the A terminal that some goods had been picked up and others were not then moved back to the rows. Something to be noted in this warehouse was that on several occasions the pallets had been put in to the rows very quickly with large amounts of space between individual pallets, similar to the A terminal. The excessive speed while unloading could be noticed in the way the rows and pallets were crooked and put in from different directions in a way that space was wasted making the already limited space even smaller. The limited space could be expanded a little by using more of the now unused space, such as the loading dock at the back. The space limitations are extremely well visible at the office side of the warehouse where most of the traffic appears to be focusing (see Figure 7).

FIGURE 7. The layout and the problems at the terminal C

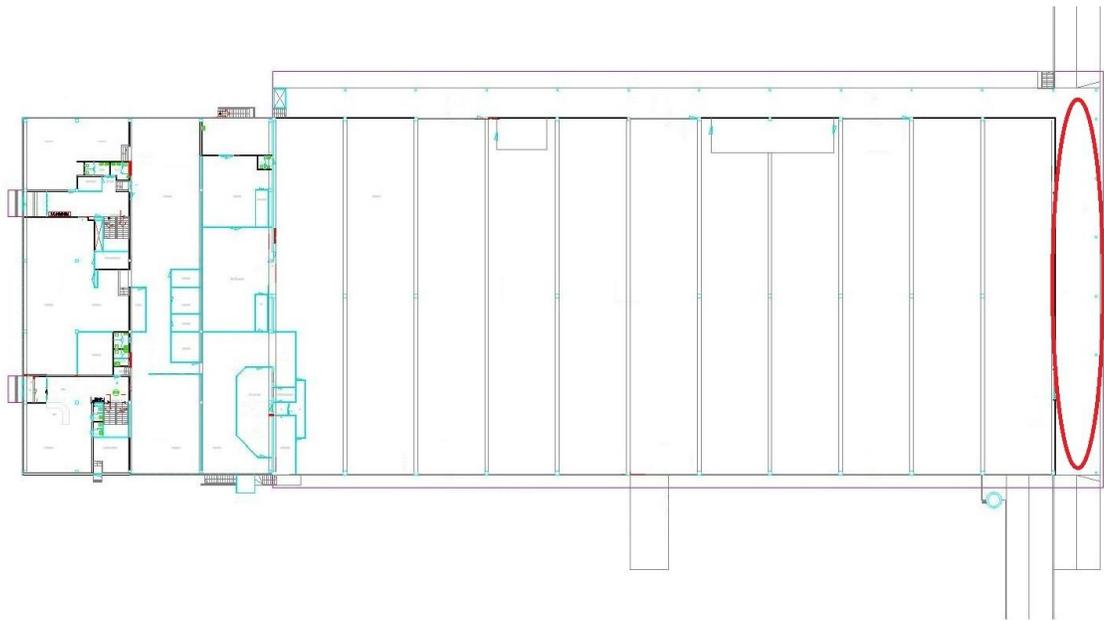
FIGURE 8. The layout of the D terminal, red indicating the dock with excess junk

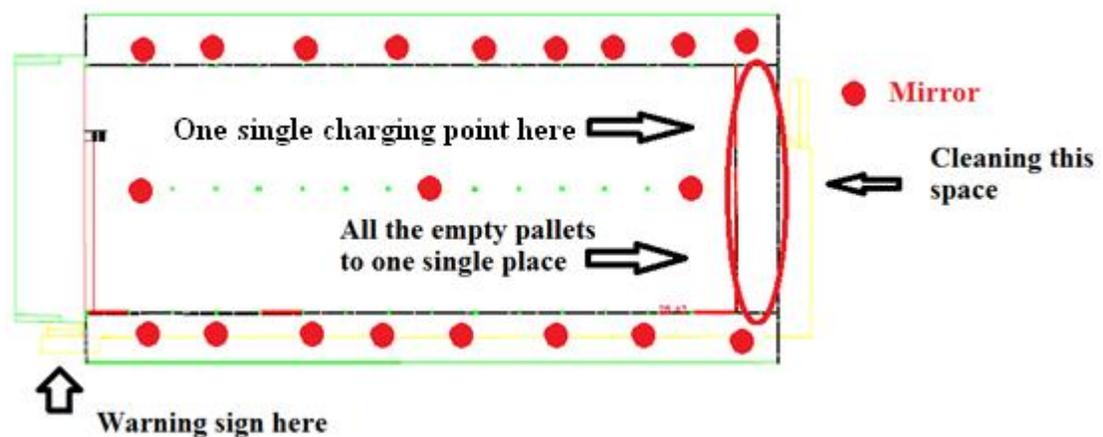
FIGURE 9. Improvements to the warehouse A

The lack of space is very hard to solve without making any structural changes in to the warehouse. The space could be still increased simply by cleaning the warehouse thoroughly and making an inventory. As mentioned in the problems that were spotted during the visits, one part of the warehouse was filled with, what appeared to be, very old goods. This fact became mentioned in one of the interviews. Countless square meters could be freed this way. This saved space could be then used for storing other goods or by building a parking and a charging place for forklifts. At the moment there were several charging points at random locations situated throughout the warehouse when probably one single charging place could make the warehouse clearer and cleaner. The same could happen with empty pallets and they could be stored only into one place instead of several, as at this point (see Figure 9).

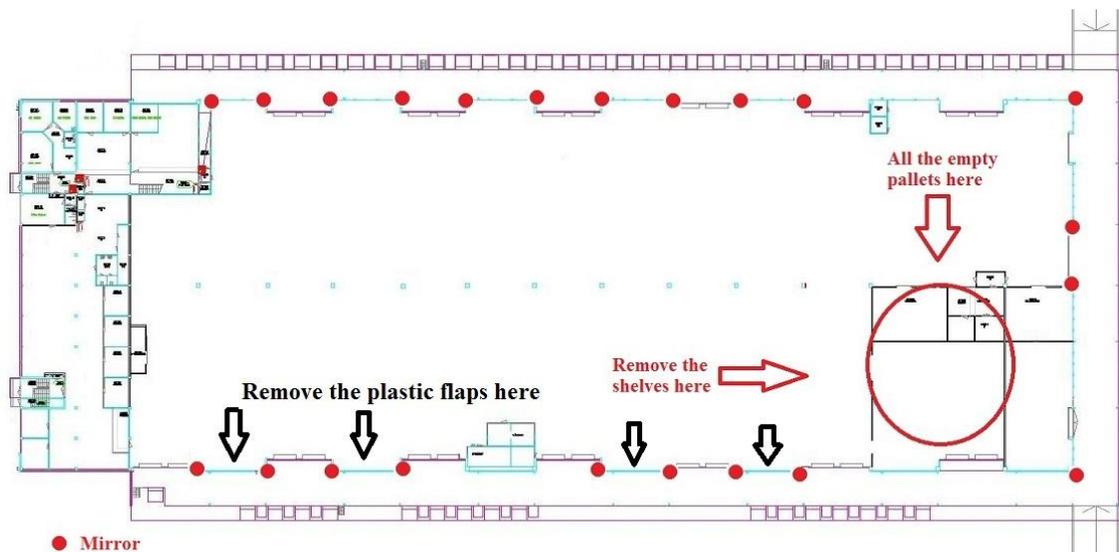
FIGURE 10. Layout and the improvements to the warehouse C

Mostly these issues are related to the overall cleanliness. The empty pallets should be stored in this warehouse only in one place and not just leave lying around for further use. The space for these pallets can be created by removing the shelves that are located in the warehouse currently (see Figure 10). They are not clearly in active use and cause mainly only waste of space. Basically they could be used more actively, but as most of the goods move quickly in and out of the warehouse, there is no need for this amount of long term storage space. This procedure would release carefully estimated at least a space of 100 square meters. This space could be used for storing both empty pallets and goods on pallets. One possible usage for this space could be building a parking place for the forklifts as it already had charging points. Removing the shelves would release a great deal of space for the warehouse to be used for different purpose and make its life time longer. Similar to the warehouse A, mirrors need to be installed to every single corner with poor visibility. These corners are at every single doorway leading to the docks and to the loading dock at the back part of the warehouse. The C terminal had a few signs indicating the routes where the forklifts are driving but they could be increased. The C terminal had countless lights that were not functional and these lights should be fixed as soon as possible. As mentioned, the A- and C terminal were rather similar regarding several aspects, and similar was the forklift traffic as it mainly focused mainly on one side. Near the offices the forklift traffic appeared to be way busier and probably by changing some of the destinations the forklift traffic could be evened in the warehouse.

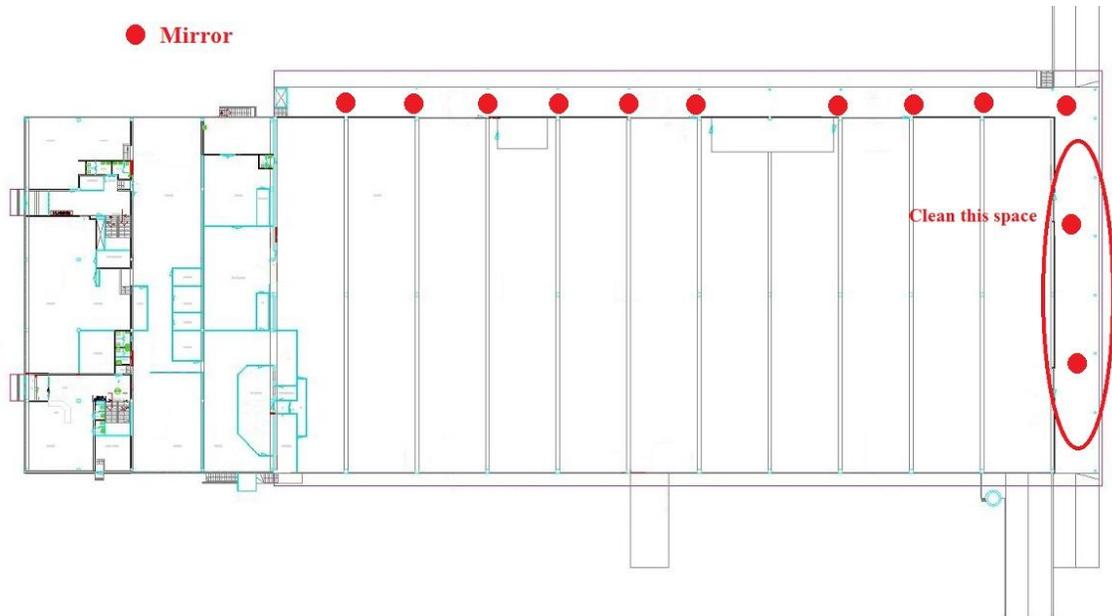
FIGURE 11. The layout and the improvements to the terminal D

The D terminal was the only one using mirrors but even at this warehouse there were not sufficiently of them. Mirrors would make the warehouse safer especially in terms of cornering. Every single doorway should have two mirrors for added visibility to both directions. The terminal D was in the best condition and operated quite safely. However, route markings could be increased. There were already a few markings but additional ones would make sure that everyone moving in the warehouse understands how the forklifts move there. The question of separating the pedestrian traffic from the forklift traffic is virtually impossible to solve. The reason for this is the physical premises and the fact that they are not designed in a way that they would take it into account. In addition, designing and building new passages for pedestrians would be very expensive. The D terminal was very well lit up, and very clear to move already as it is that there is no immediate need for separating the traffics from each other. The only immediate improvements to the current situation are quite small and are meant to improve the cleanliness, create more space and improve visibility in the warehouse (see Figure 11).
