SUSTAINABLE WASTEWATER NETWORK MANAGEMENT IN LEMPÄÄLÄ MUNICIPALITY

Bachelor's thesis
April 2012
Environmental Engineering
Department (TAMK)
Tampere University of
Applied science

Peter Paul Obijaju	Sustainable wastewater network management in Lempäälä Municipality
Final thesis	36 Pages
Supervisor	Hilda Szabo
Commissioned by	Water Utility department of Lempäälä municipality in August 2011

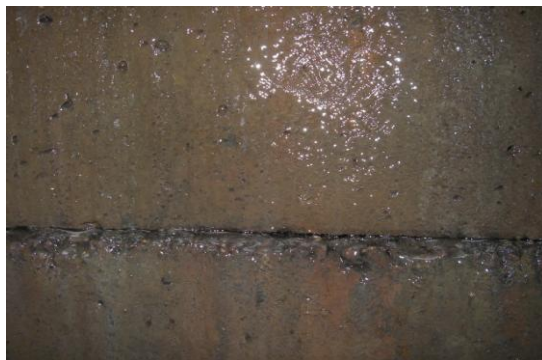
PICTURE5.1Leaks from the walls and seams of the Manhole (Obijaju, 2011)

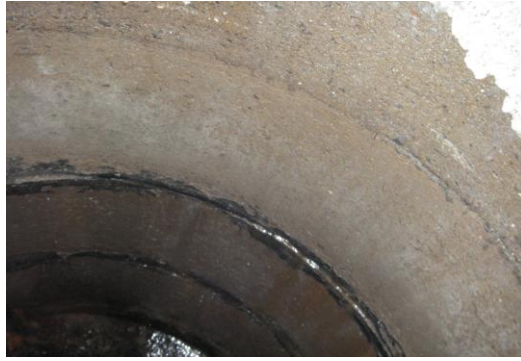
PICTURE 5.2 Leaks from the lower part of Concrete manhole (Obijaju,2011)

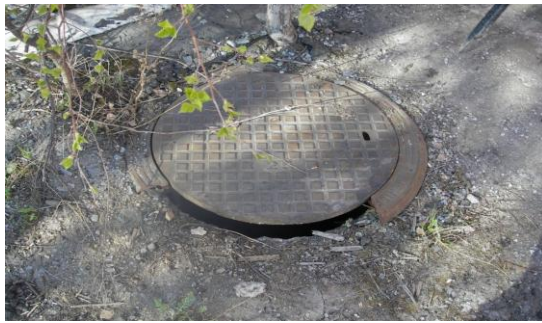
PICTURE 5.3 Broken cast iron frame source of Inflow (Obijaju,2011)

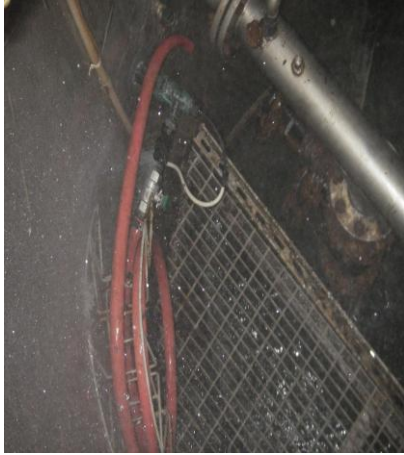
PICTURE5.4 Leaks from the pipe inside pump station (Obijaju, 2011)

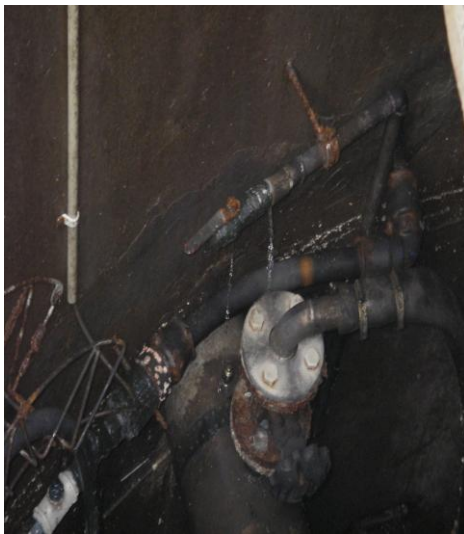
PICTURE 5.5 Little leaks from the pipes in a pump stations (Obijaju, 2011)

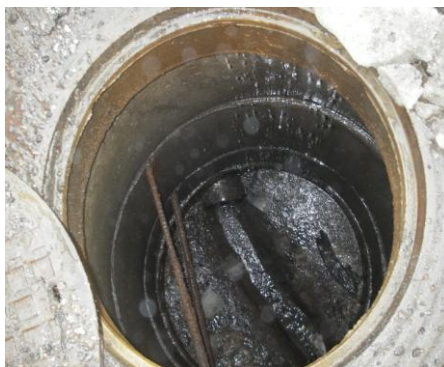
PICTURE 5.1 worn cast iron lid source inflow (Obijaju 2011)

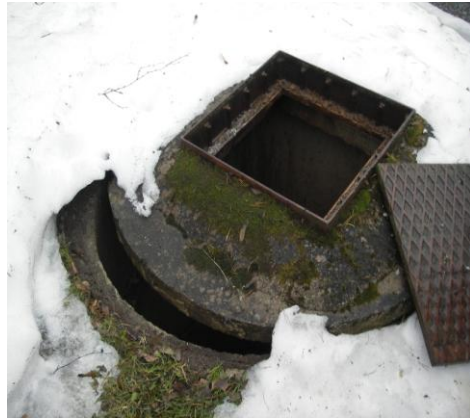
PICTURE 5.2 Frame offset source of inflow (Obijaju 2011)

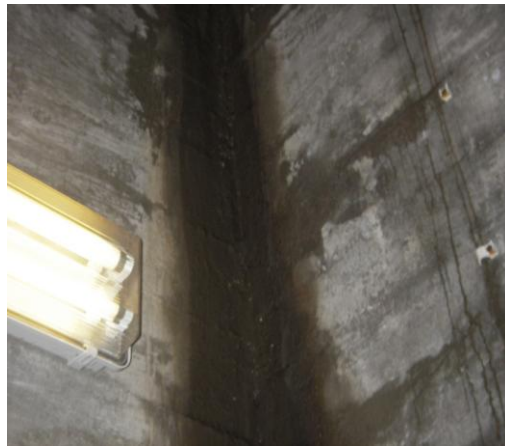
PICTURE 5.3 Infiltrations into a pump station (Peter Obijaju2011)

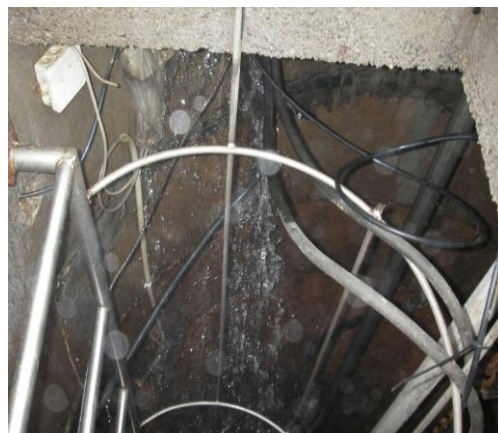
PICTURE5.4 Leaks from the wall of a Pump station (Obijaju2011)
