# Metal stitch reconditioning analysis

Niklas Eurs

Bachelor's thesis

**Title:** Metal Stitch Reconditioning Analysis

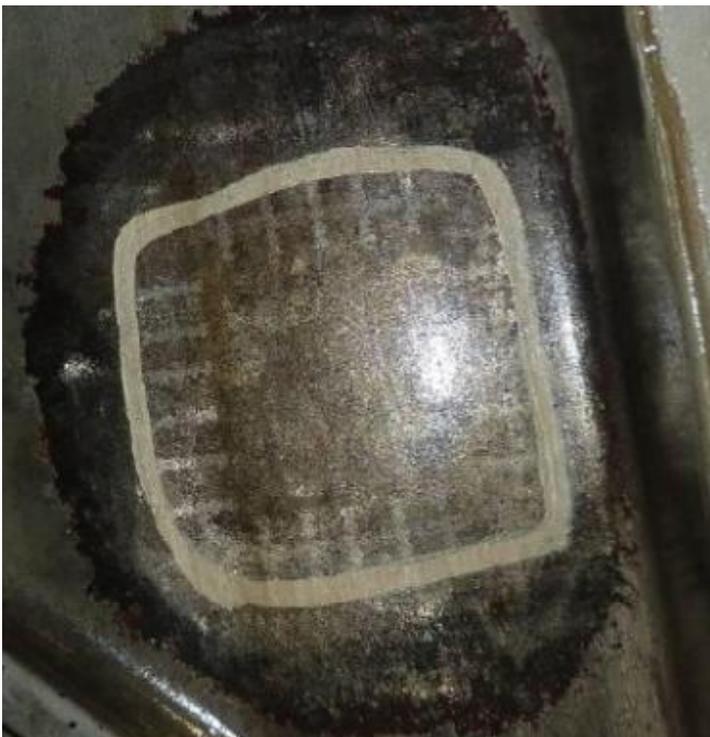
Figure 13. *Repaired wall between A1 and A2*

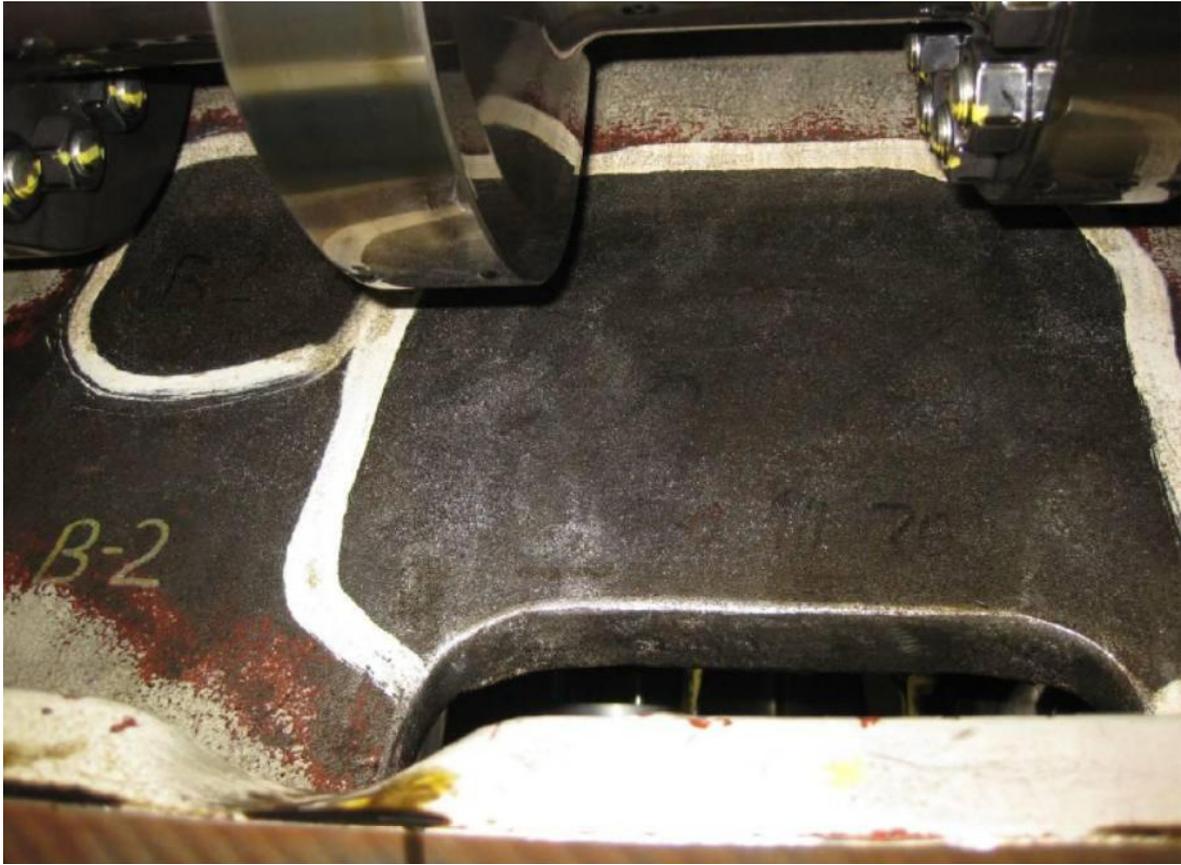
Figure 14. *New parts stitched in place in cambox.*

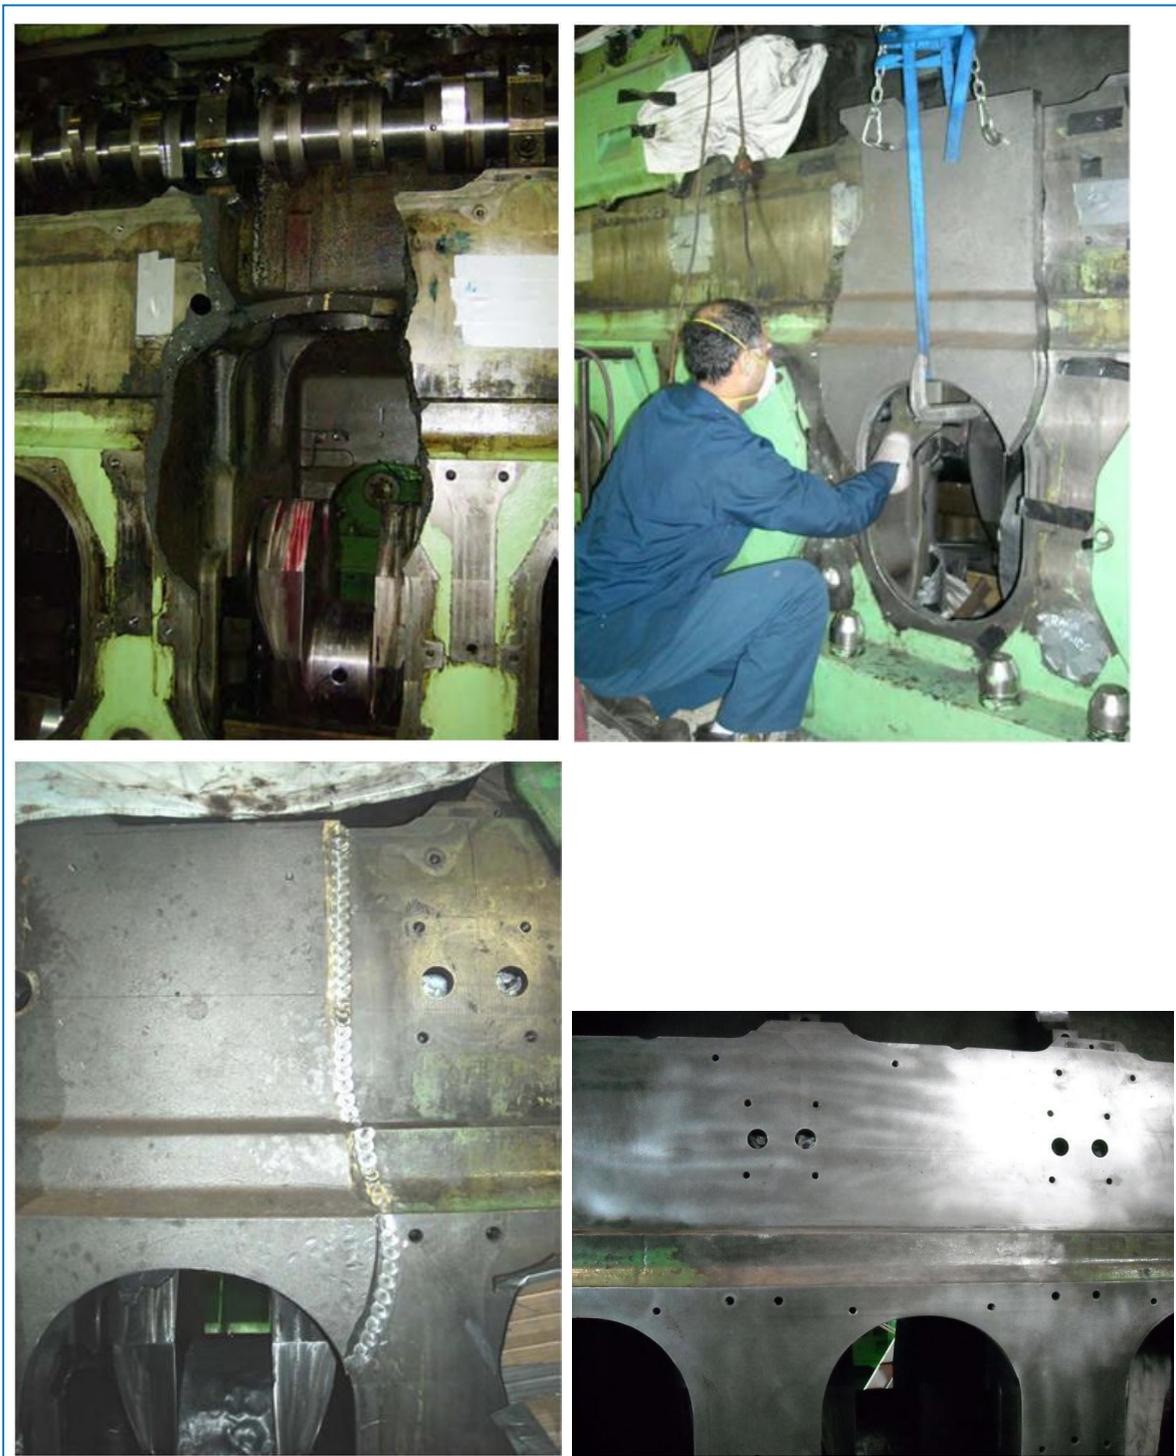
This engine suffered from a major breakdown where loosened engine parts caused a large piece of the engine block to crack and come loose. Also a cylinder liner lower bore was damaged as well as other smaller dents and cracks. The repair was done by LnS.

Figure 18. Repair of Statendam engine.

Repair: The engine block was repaired by stitching in a new cast piece fitting the hole.

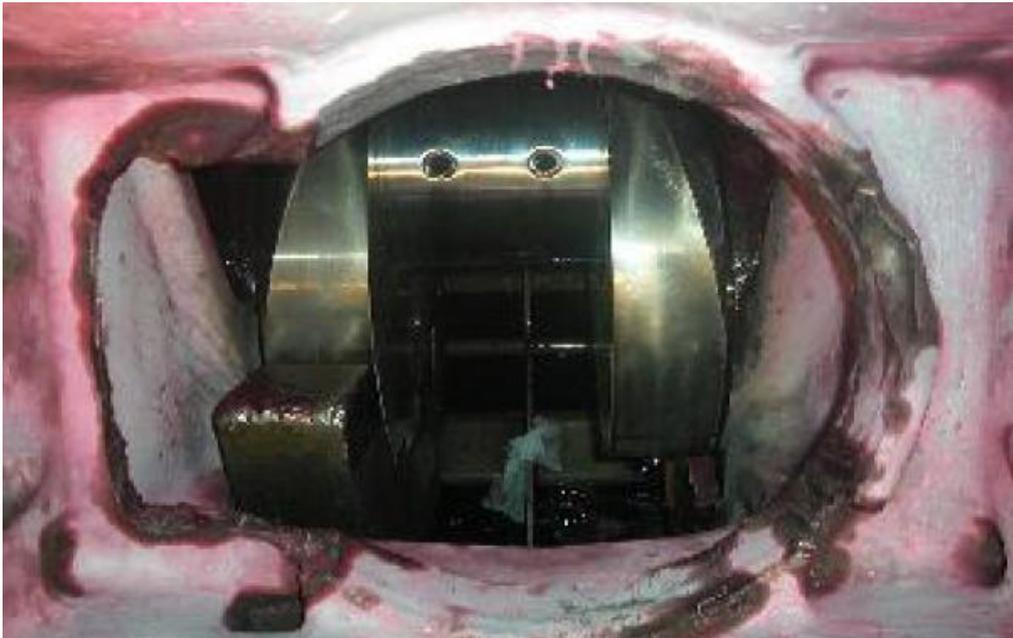
The Vasa 18V32E engine at Nippon Steel had a breakdown in 2011 and Metalock repaired the damaged areas in February 2012. The damages were cylinder liner lower bore and some other small cracks. New pieces were manufactured and stitched into place. After finished stitching and locking, the damaged area was grinded, painted and pressure tested.

*Figure 19. Crack testing of damaged area.*

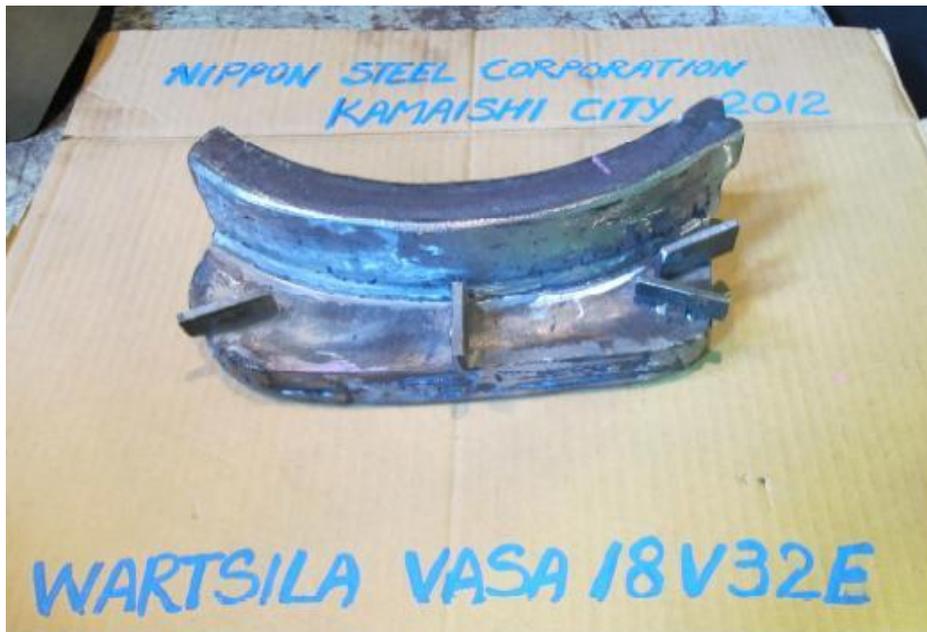
*Figure 20. New manufactured piece.*

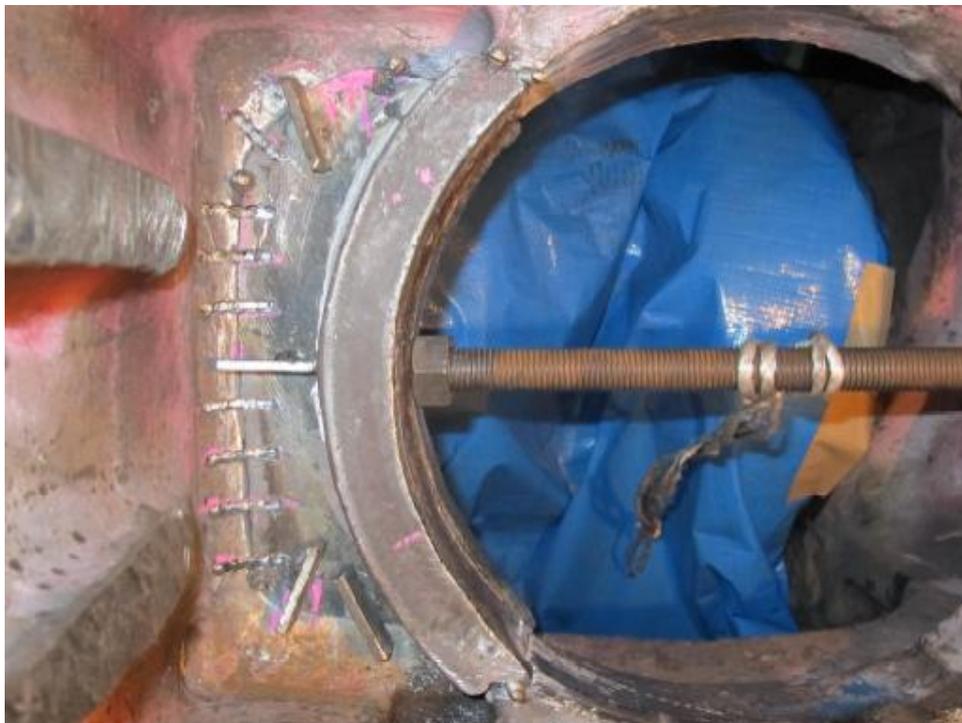
*Figure 21. New piece metalocked into place.*

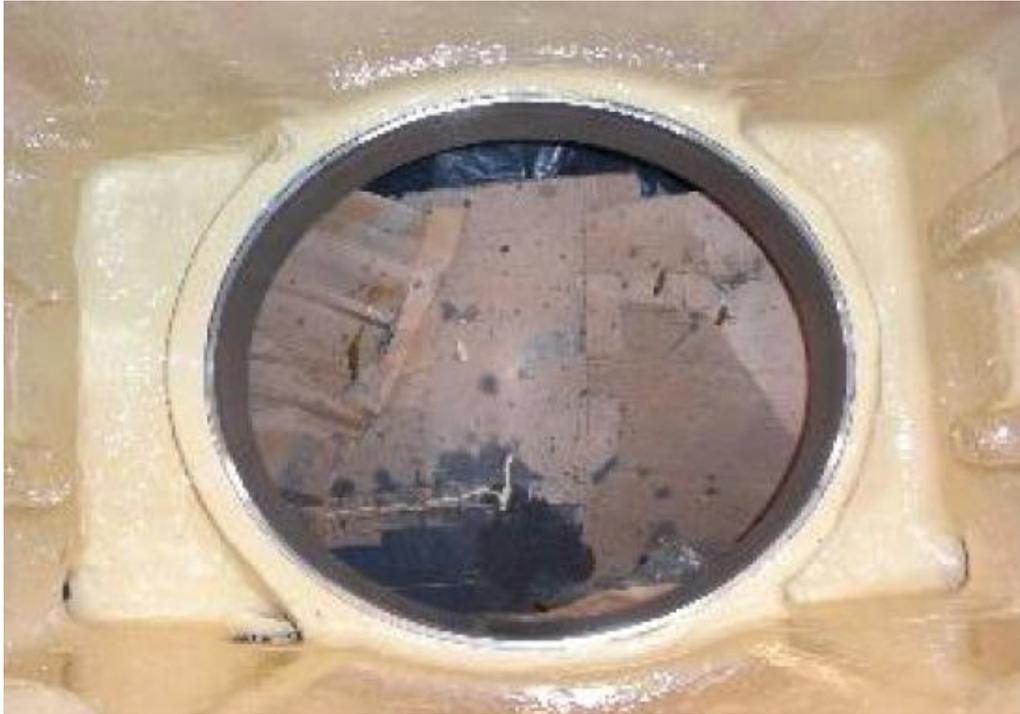
*Figure 22. Job finished and ready for pressure testing.*

Follow-up: The first follow-up inspection was done in July 2012 when the engine had run 800 hours. The engine block was crack- and pressure tested and no abnormalities were found.

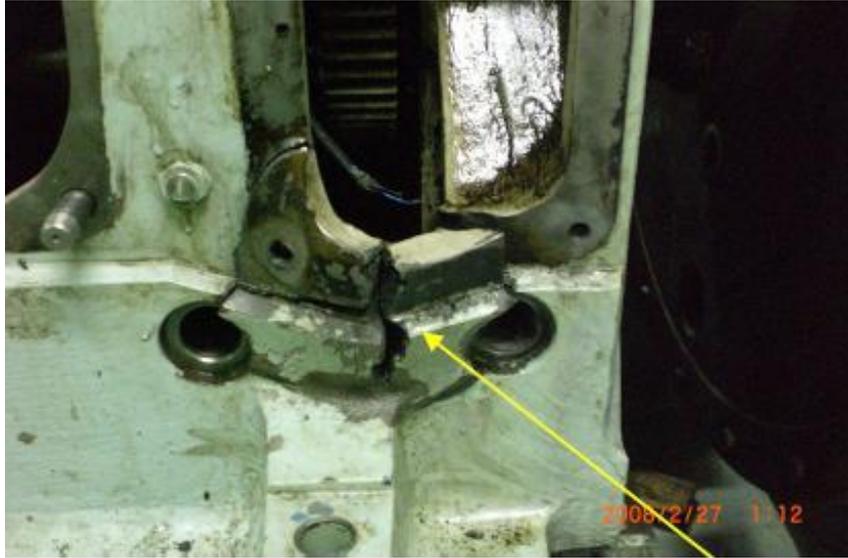
The 4L20 engine on the ferry British Laurel suffered from a engine block damage in 2008 due to a loosened gear wheel. The damage was not that severe, but located in an unusual site on the engine block. Most damages to the engine block occur due to connecting rod or counterweight failure, thus the damages are often located in that area. In this case

*Figure 23. Damaged area.*

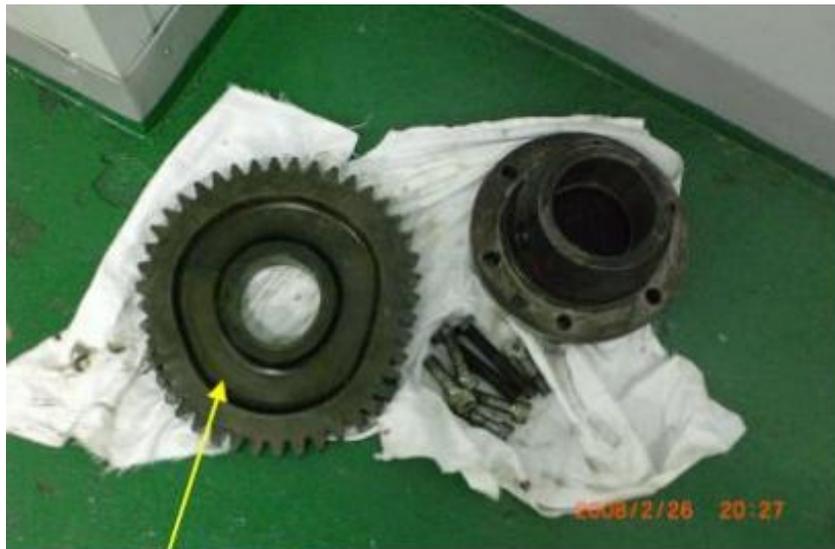
*Figure 24. Loosened gear wheel.*

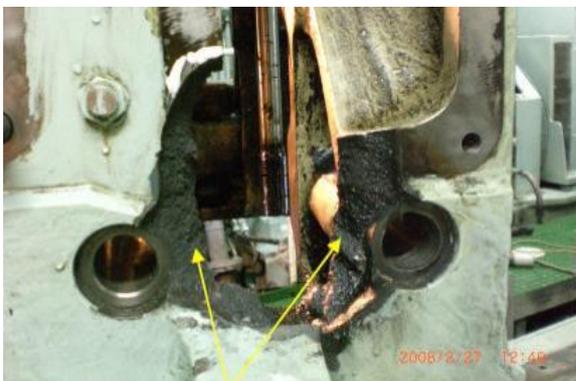
*Figure 25. Cracked parts removed*

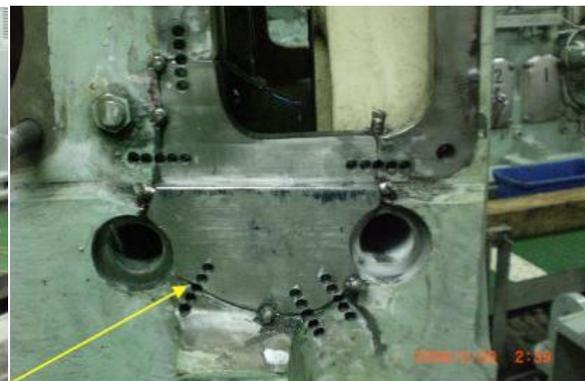
*Figure 26. New piece fitted.*

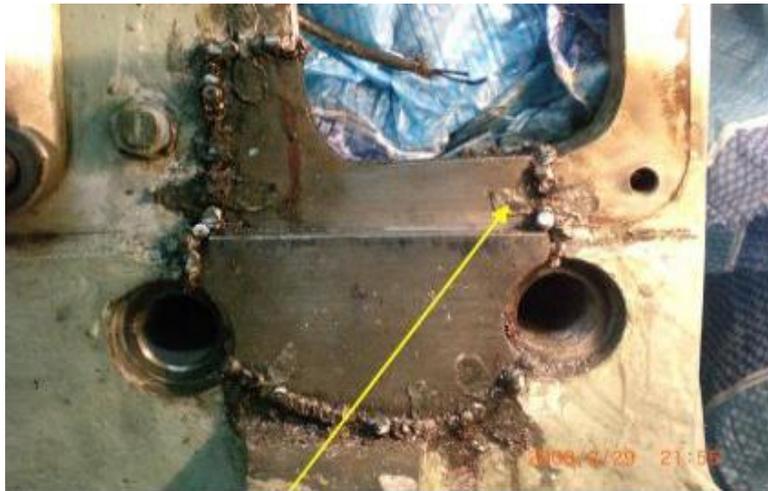
*Figure 27. New part locked with keys and metal lace.*

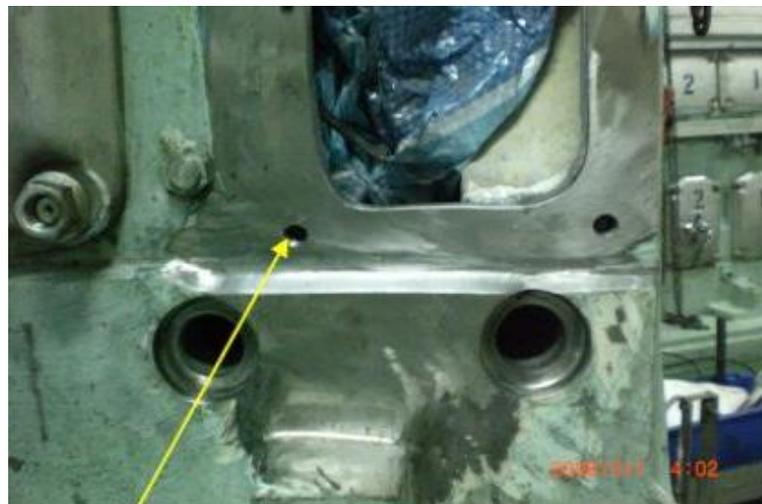
*Figure 28. Finished result.*

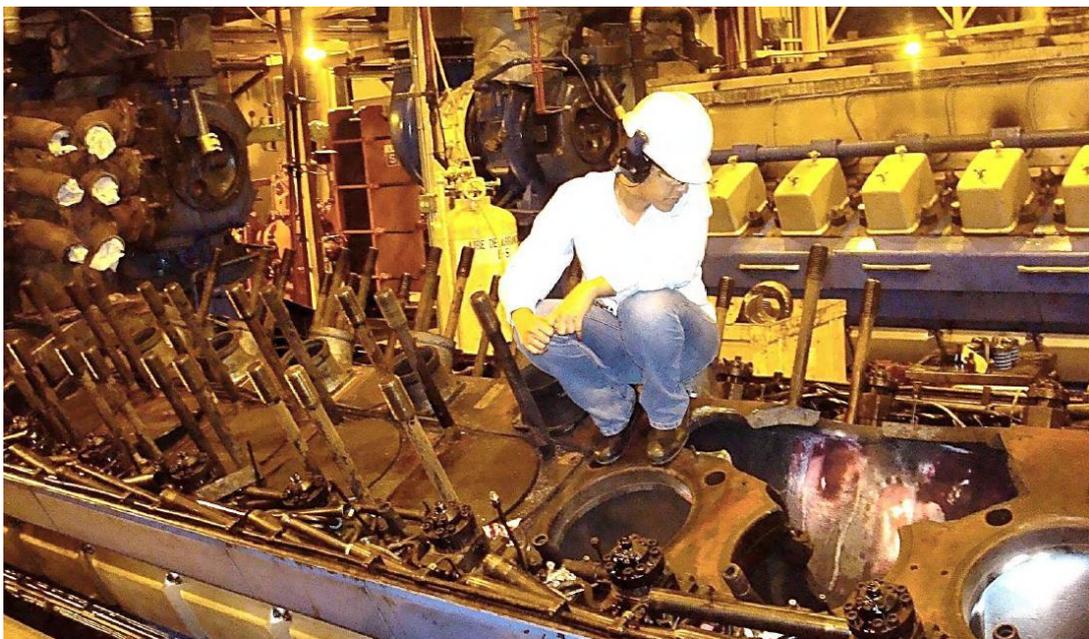
*Figure 29. Large piece of the engine block missing.*

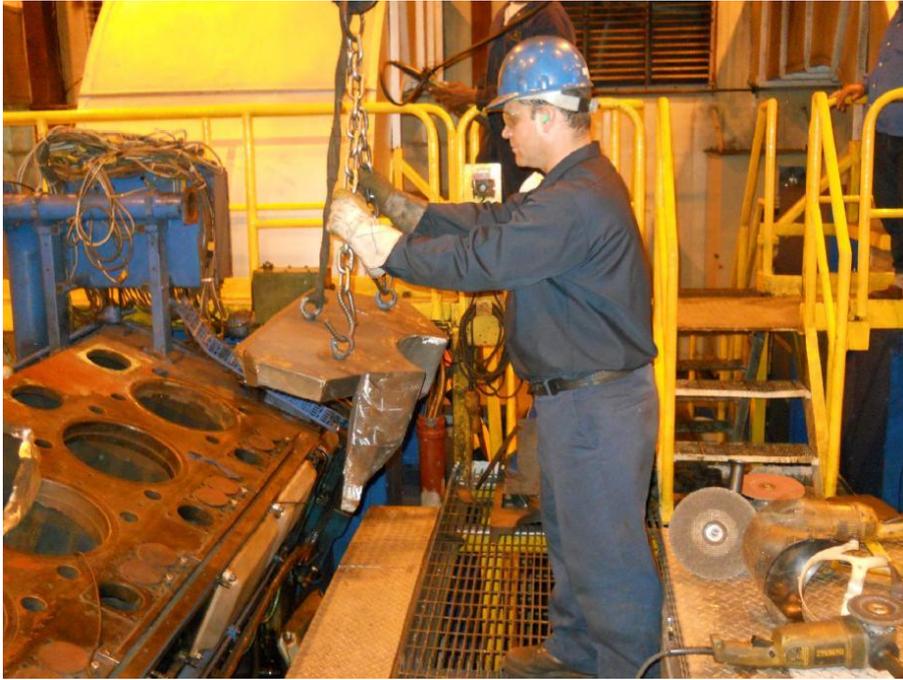
*Figure 30. A new cast piece is fitted into place and stitched together with the engine block.*

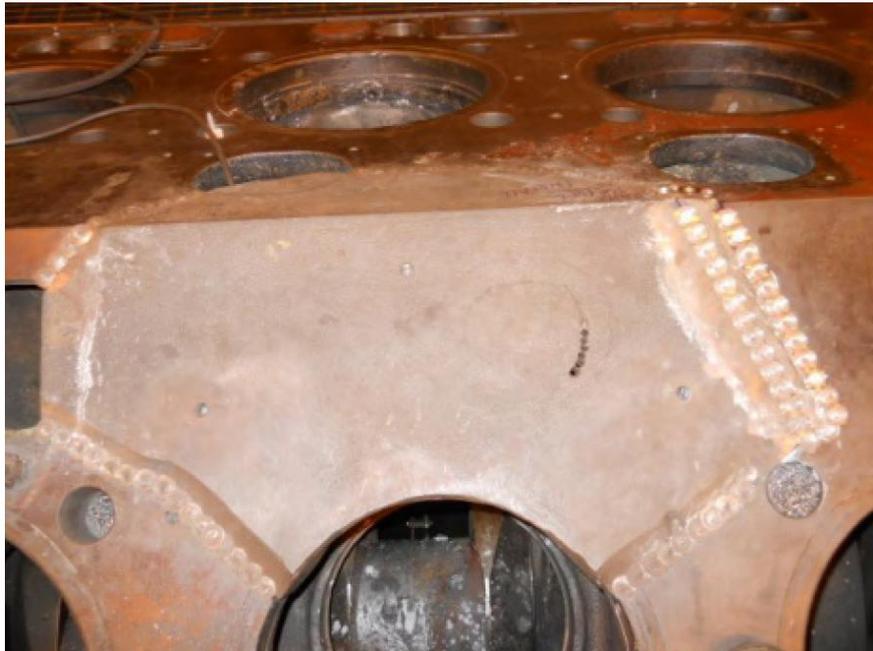
*Figure 31. Stitching with pins done.*

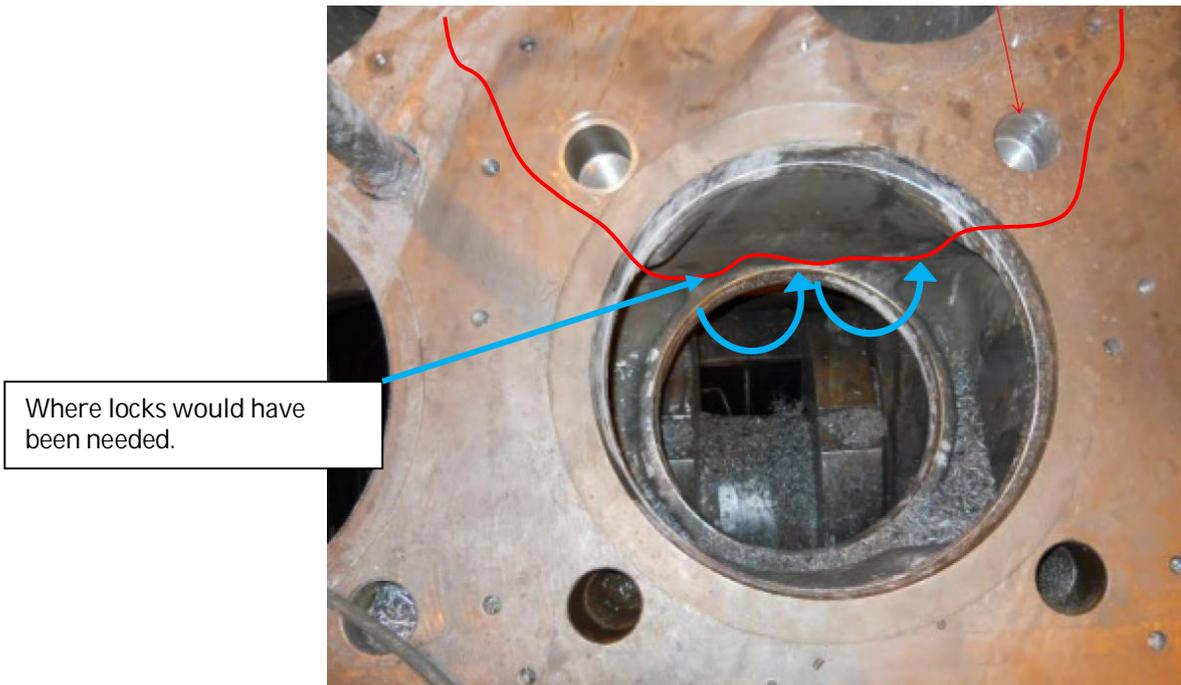
*Figure 32.*

New threaded holes made for the cylinder head bolts.

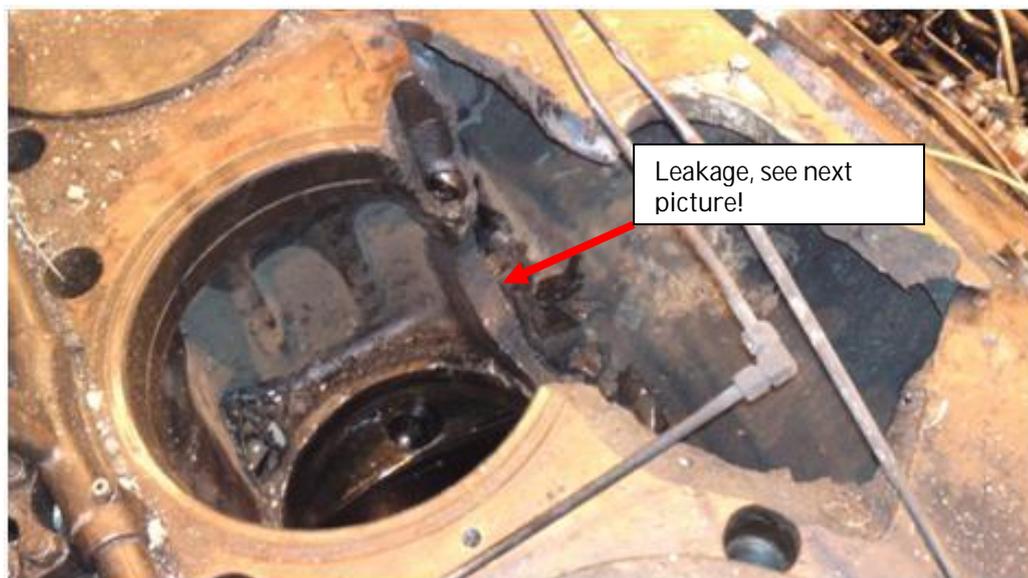
*Figure 33.*

Below the damaged area can be seen:

Because the cylinder head bolts are within the repaired area, the repair will be exposed to high loads due to firing pressure from the cylinder. This means that during firing pressure you will get a great lifting force on the new piece stitched into place.

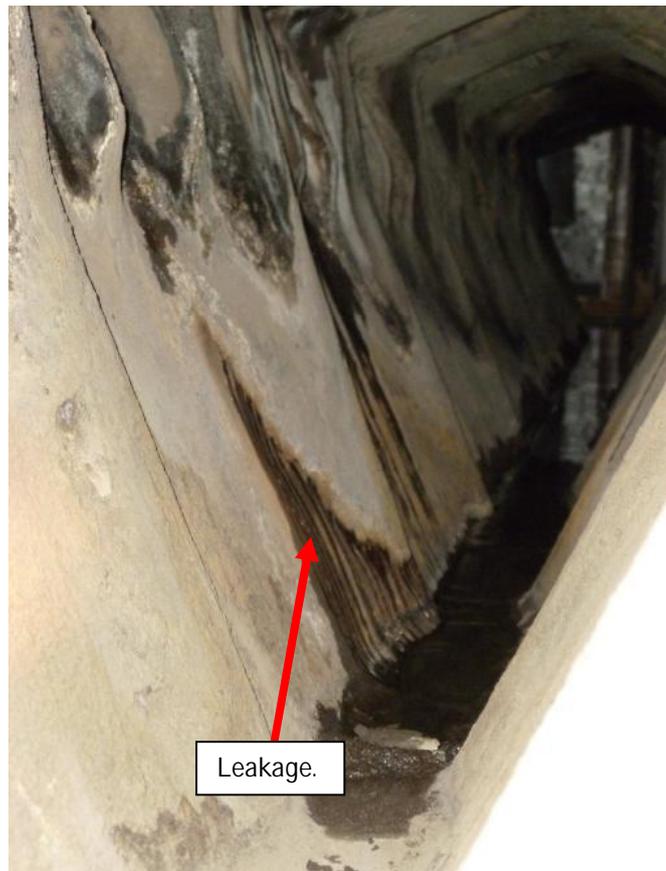
*Figure 34. Leaking repair.*

During Mr. Petri Lautamäki's investigation it was cleared that there were no locks installed on either side of the repair in vertical direction, meaning that forces from firing pressure were led to the new part stitched into place. And due to the lack of locks, the stitching pins had to take most of the forces, which they obviously did not cope with. The reason for the absence of locks is probably that installing locks must be done on a flat surface.

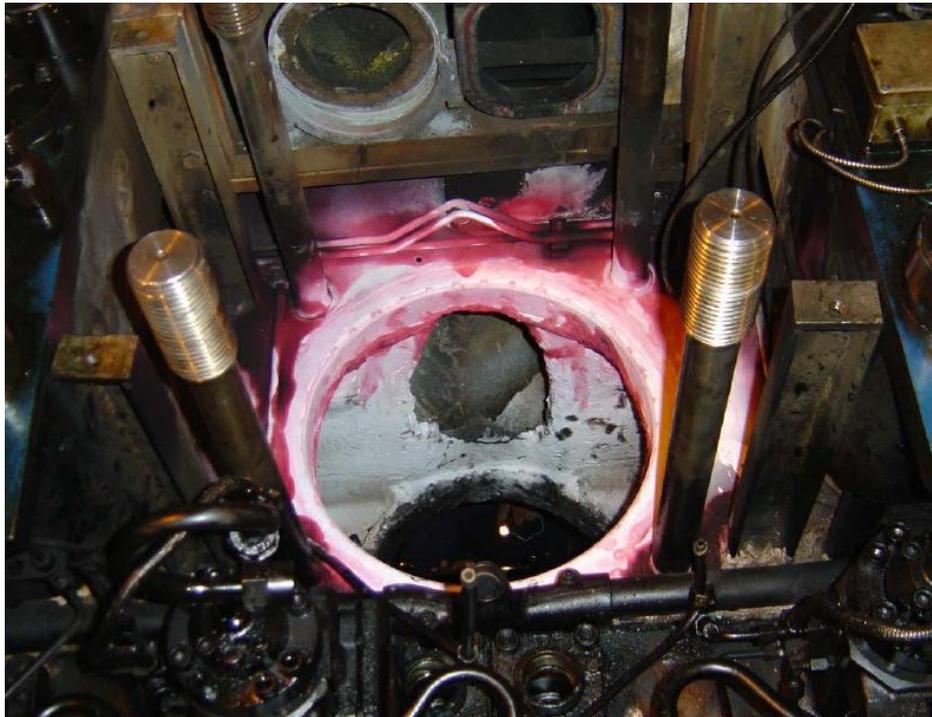
In 2004 the diesel generator #9 at Nejapa Power suffered from damage to the engine block, due to a broken connecting rod. The lower and upper landing surfaces for the cylinder liner were damaged and also two holes in the cylinder liner cooling water space were results of the breakdown. One of the holes was located 12 o'clock through the wall into the receiver and the other 6 o'clock through the wall towards the camshaft. The repair was performed by LnS. New patches were manufactured and stitched into place in the holes, and the landing surfaces were machined to oversize and sleeved.

*Figure 35. Crack testing at damaged site.*

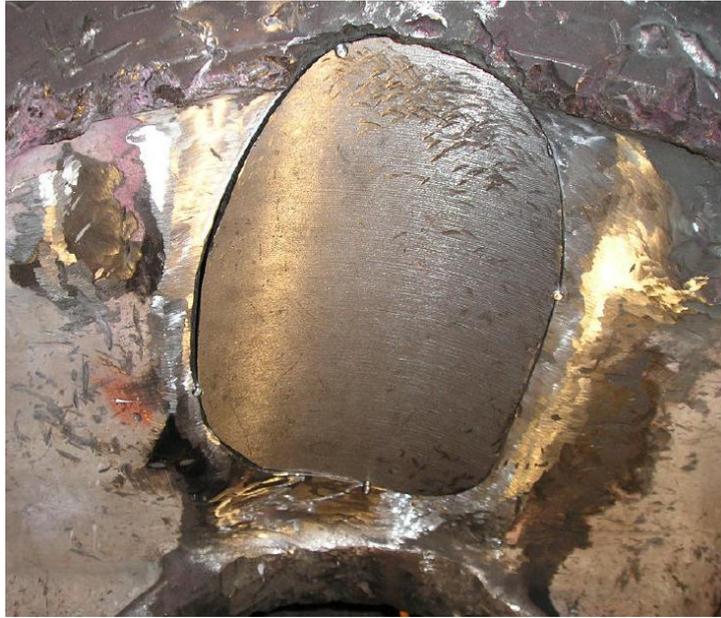
*Figure 36. New patch stitched fitted.*

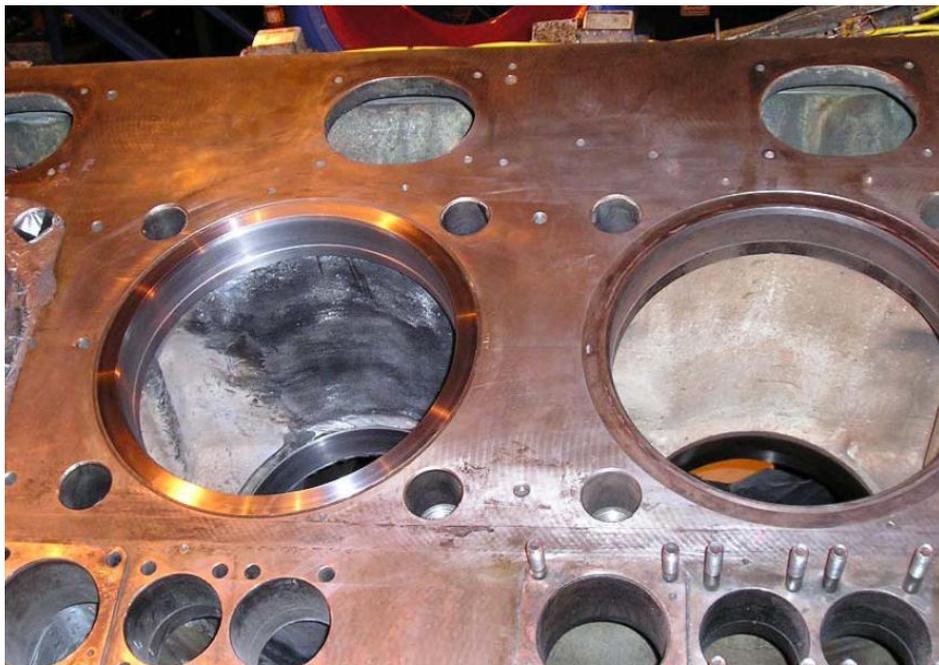
*Figure 37. Finished result.*

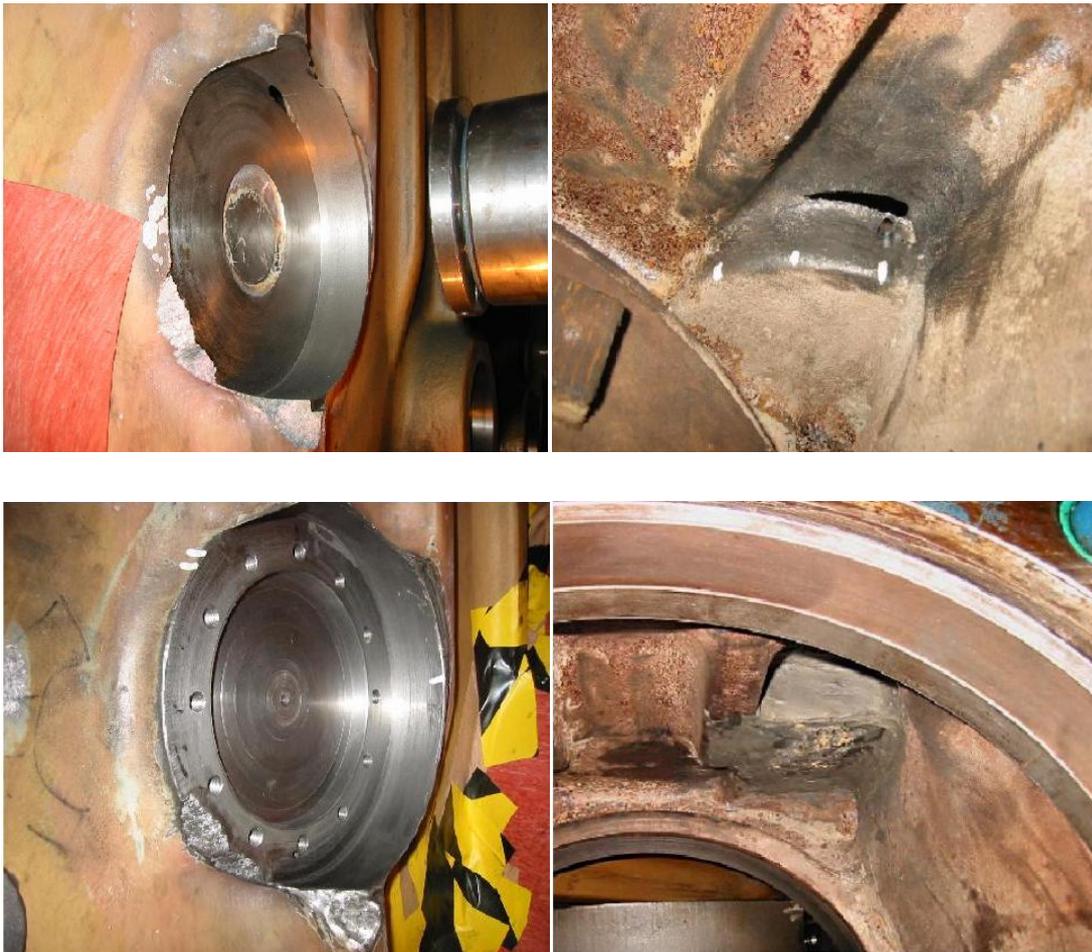
In 2004 the 18V32 at Khulna Power Company had a failure of the fastening screws for the extension piece for intermediate gear. This resulted in a lack of lubrication and bearing seizure. The seizure also affected the bearing housing in the engine block, which had to be machined to oversize for receive an adapter. During this machining mistakes were made and the result was a hole trough the wall into the waterspace around the cylinder liner. The hole was repaired by Ciserv using the metallocking method and steel putty.

*Figure 38. Metallocking of waterspace.*

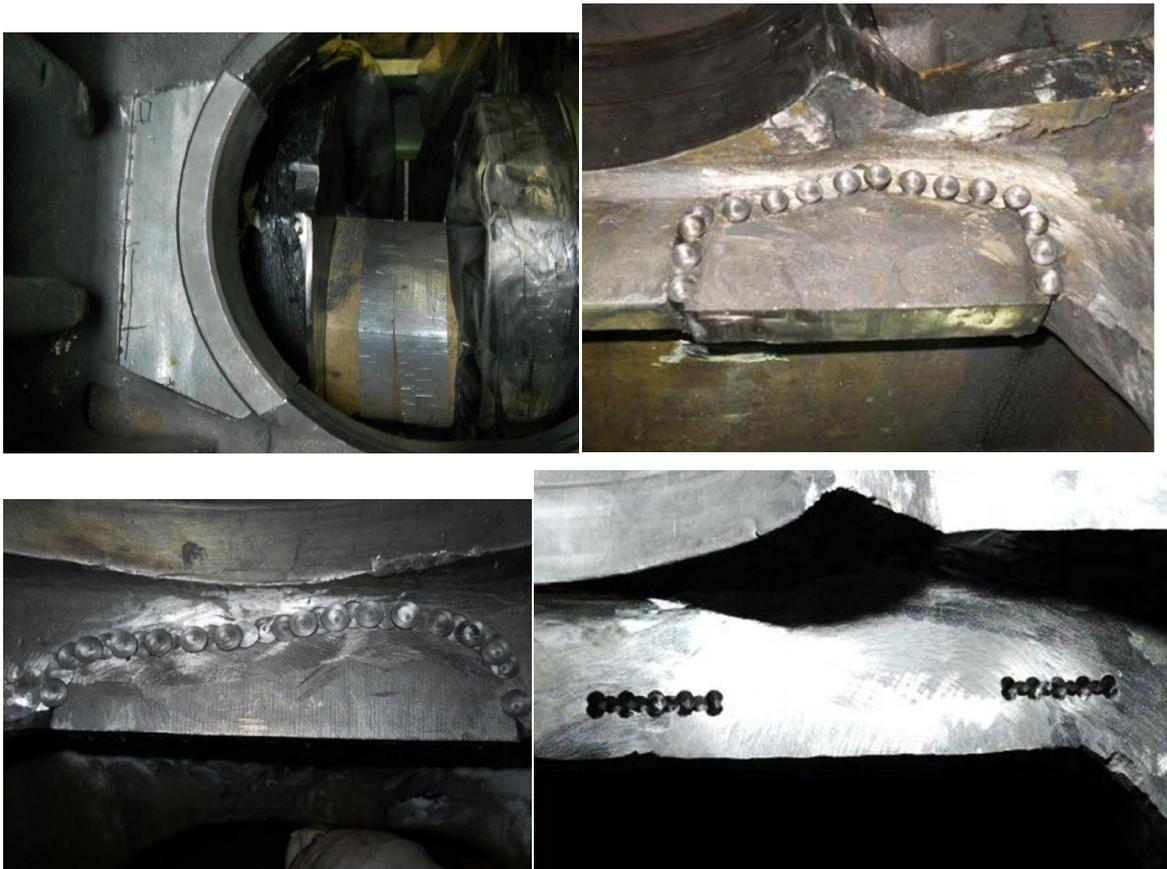
In 2011 the Vasa 12V32 onboard Regatta was repaired by LnS after having suffered from a breakdown that damaged the engine block. Cylinder liner lower bore, a crack into the cooling water channel, inspection door damages and other small cracks and dents were the results of the breakdown.

*Figure 39. Stitching on 12V32 on Regatta.*

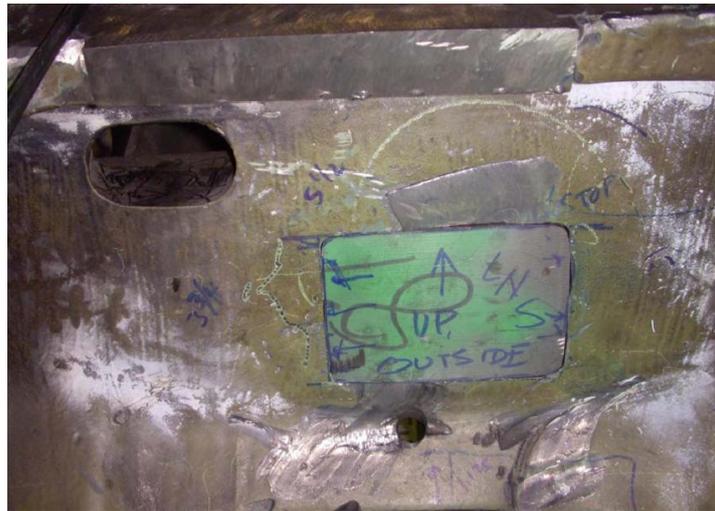
*Figure 40. Damages with new patches stitched into place.*

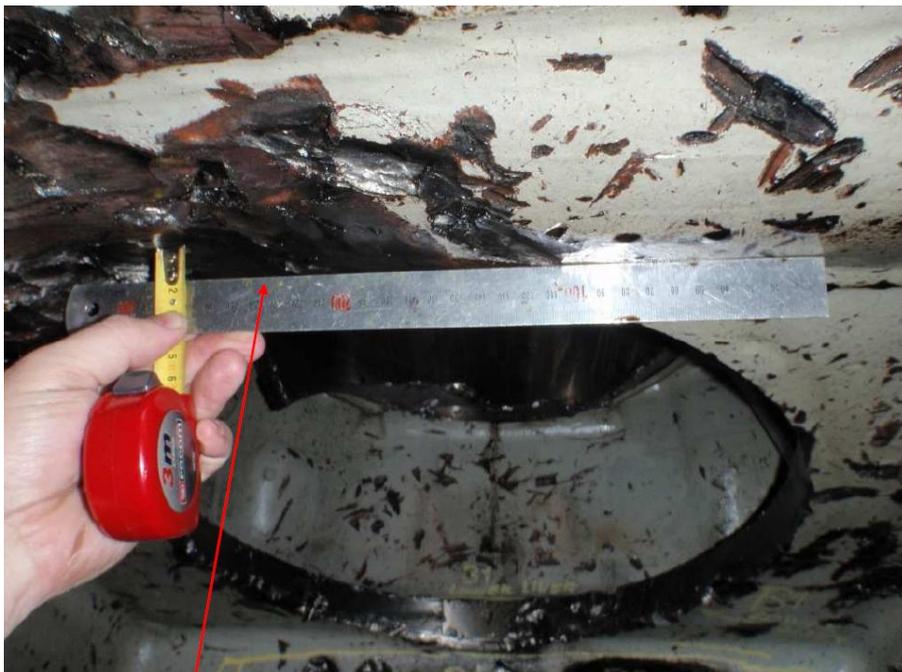
In December 2011 Gaslog Singapore had a breakdown on cylinders A1 and B1, the reason for this was a loosened big end bearing housing. The result of this was damages to the oilsump, crankcase, cylinder liner lower bore, inspection doors and also HT-water channel.

*Figure 41. Damaged HT-water channel.*

The engine block was repaired by Lock n Stitch, by stitching and machining.
