Turbogenerator Stator Problems and Fault Categorization

BACHELOR'S THESIS
APRIL 2024

The aim of the thesis was to recognize and categorize the common failure mechanisms of turbogenerator stators based on factors such as manufacturer, model year or number of poles. The commissioner of the thesis was TGS Finland Oy.

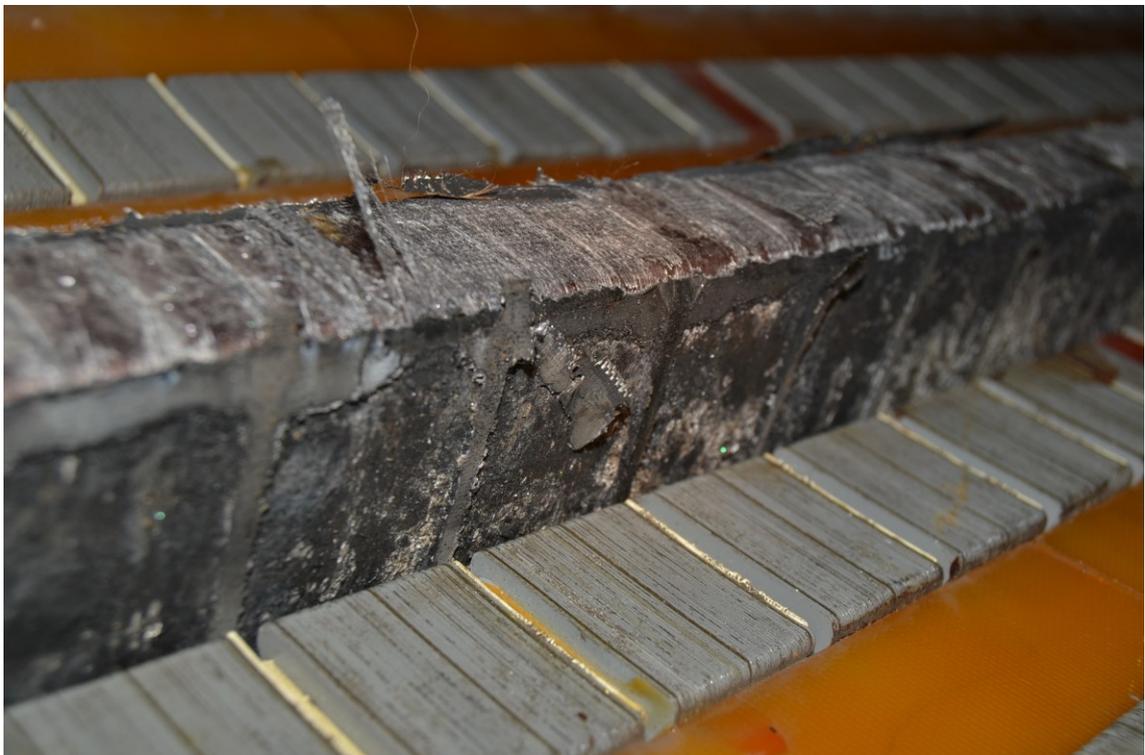
In 2014, after protection relay tripped the generator, it was found by measuring that there was a low resistance ground fault. After pulling out the rotor for proper inspection, a main insulation puncture in a top bar was discovered. The surface of the whole bar was seriously damaged by abrasion caused by vibration and erosion caused by partial discharges. In addition two other bars with signs of vibration was discovered. The damaged winding bar is presented in figure 29.

FIGURE 29. The damaged winding bar partially pulled out of slot (Osmo Koponen, 2014)

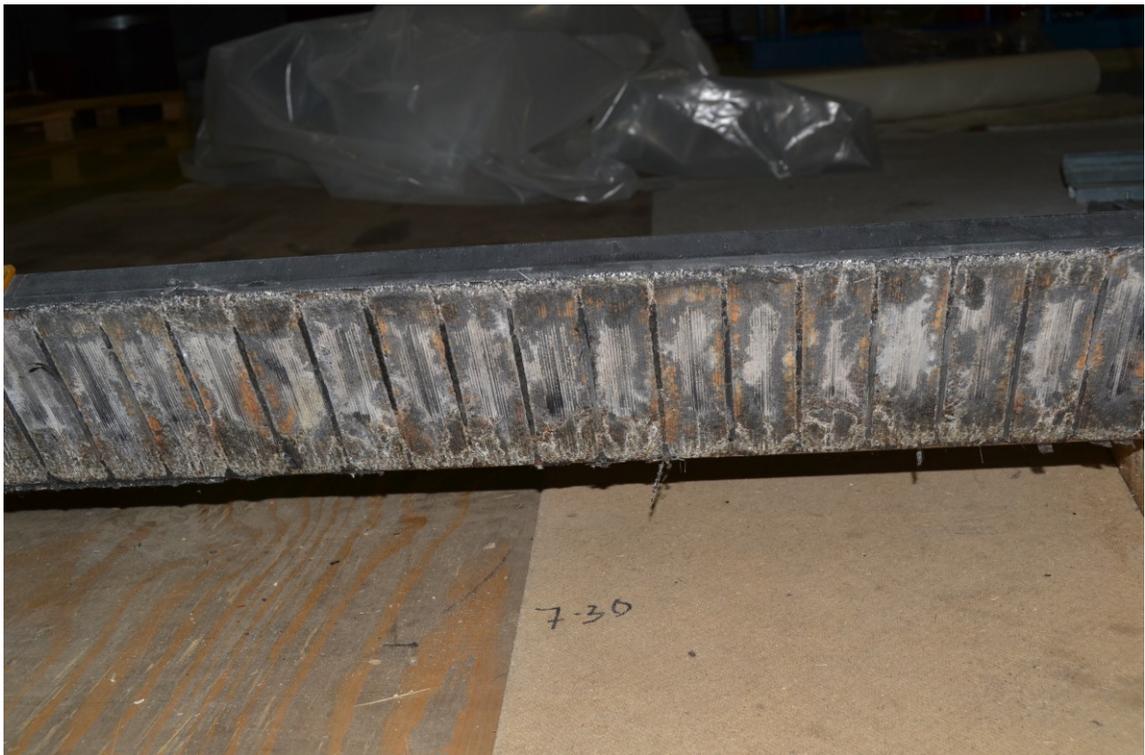
The damage caused to the winding bar by abrasion and sparking can be seen in figure 30. The main insulation was damaged from the whole length of the bar.

FIGURE 30. Abrasion damage on the bar surface (Osmo Koponen, 2014)

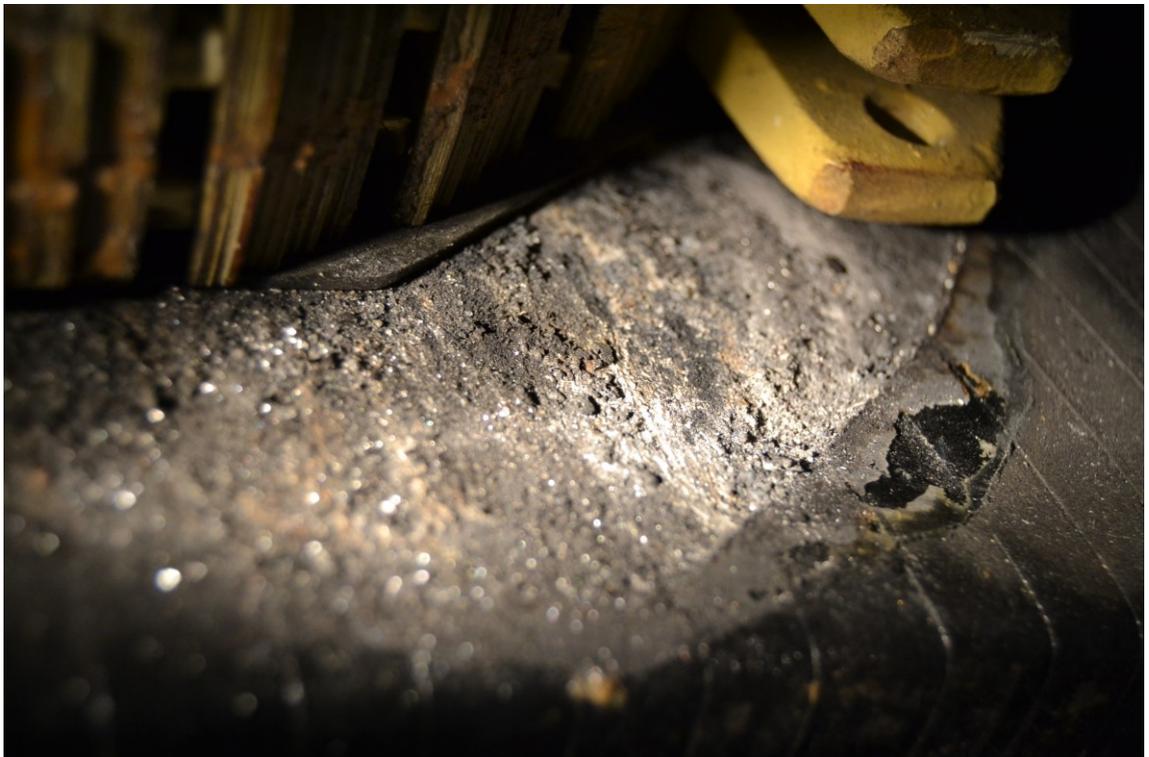
The abrasion led to the erosion of the slot corona protection and main insulation, and eventually electrical breakdown of the insulation and grounding failure. The crater-like erosion can be seen in figure 31.

FIGURE 31. Erosion on the surface of the bar (Osmo Koponen, 2014)

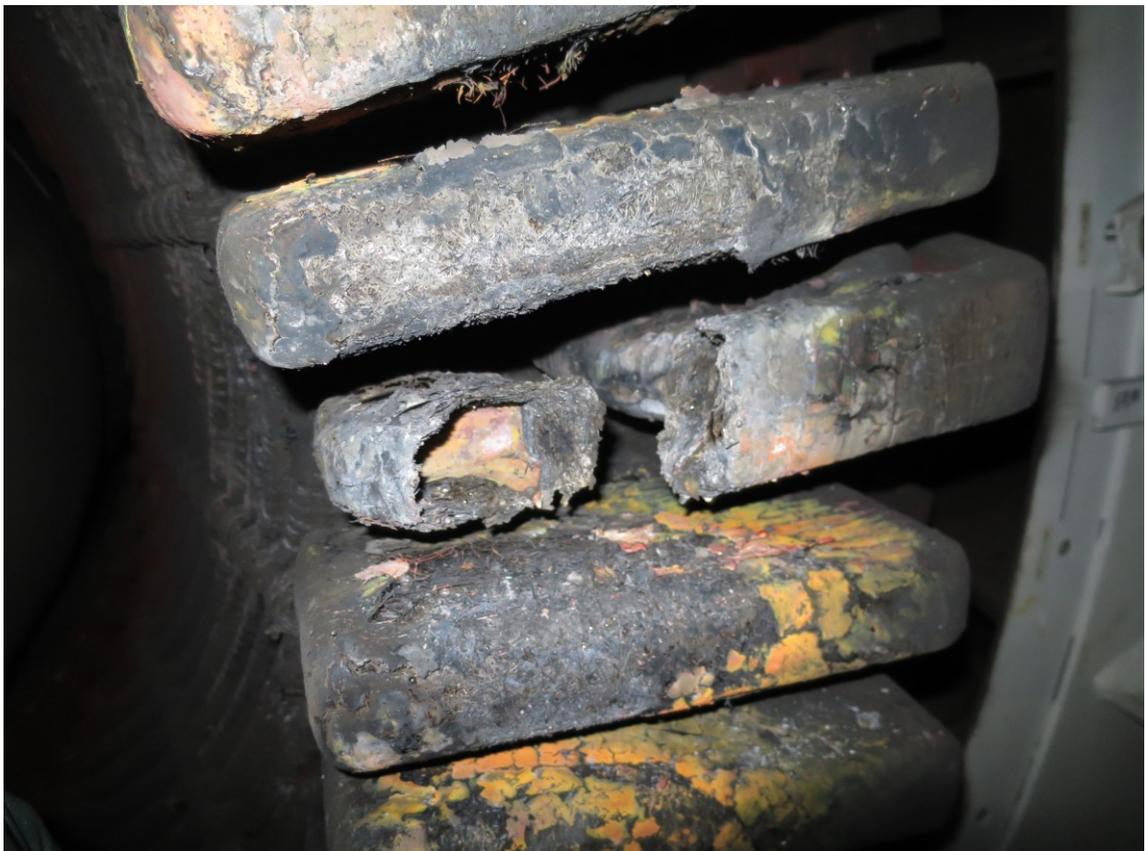
In 2021, protection relay tripped the generator due earth fault. After the generator was opened, there was a discovery of melt copper and major contamination of soot. Inspections revealed that a 10 centimeters long piece was missing from a conductor in a connection to a ring busbar, as seen on figure 32.

FIGURE 32. Melt copper connection (Pasi Lehtiniemi, 2021)

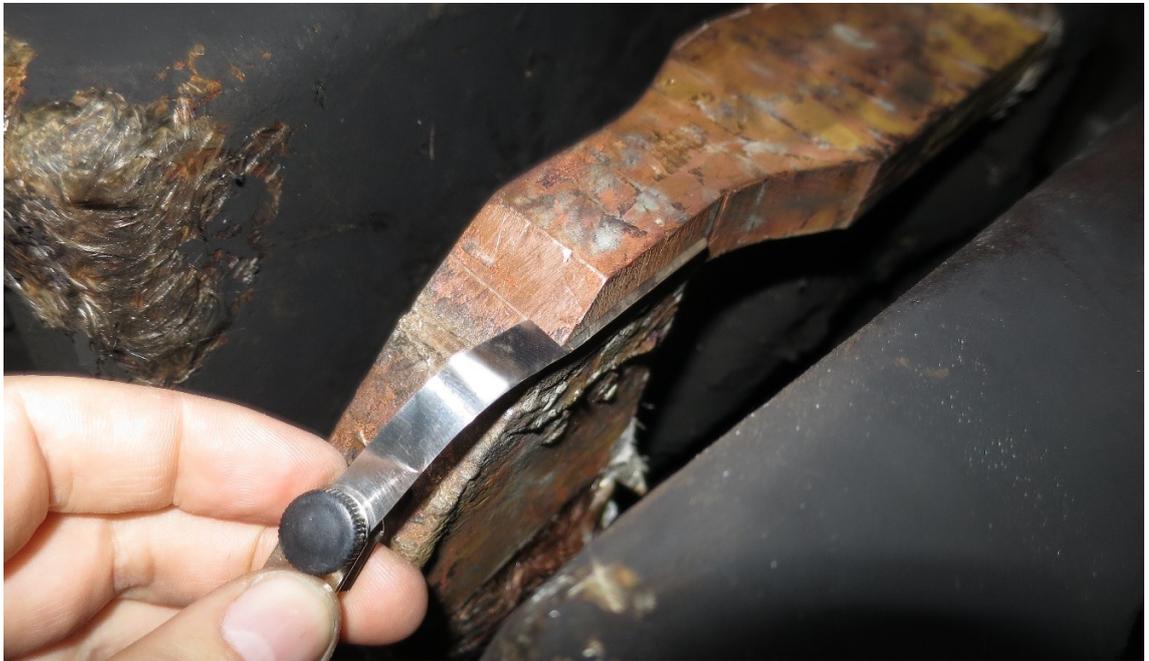
Although the fault spot was destroyed completely, inspections were performed to five similar connections for root cause analysis. It was found that in these connections there was a gap between the two parts, when they should be brazed together. Further inspections revealed pores in other brazed connections as well.

FIGURE 33. Gap between the two parts (Osmo Koponen, 2021)

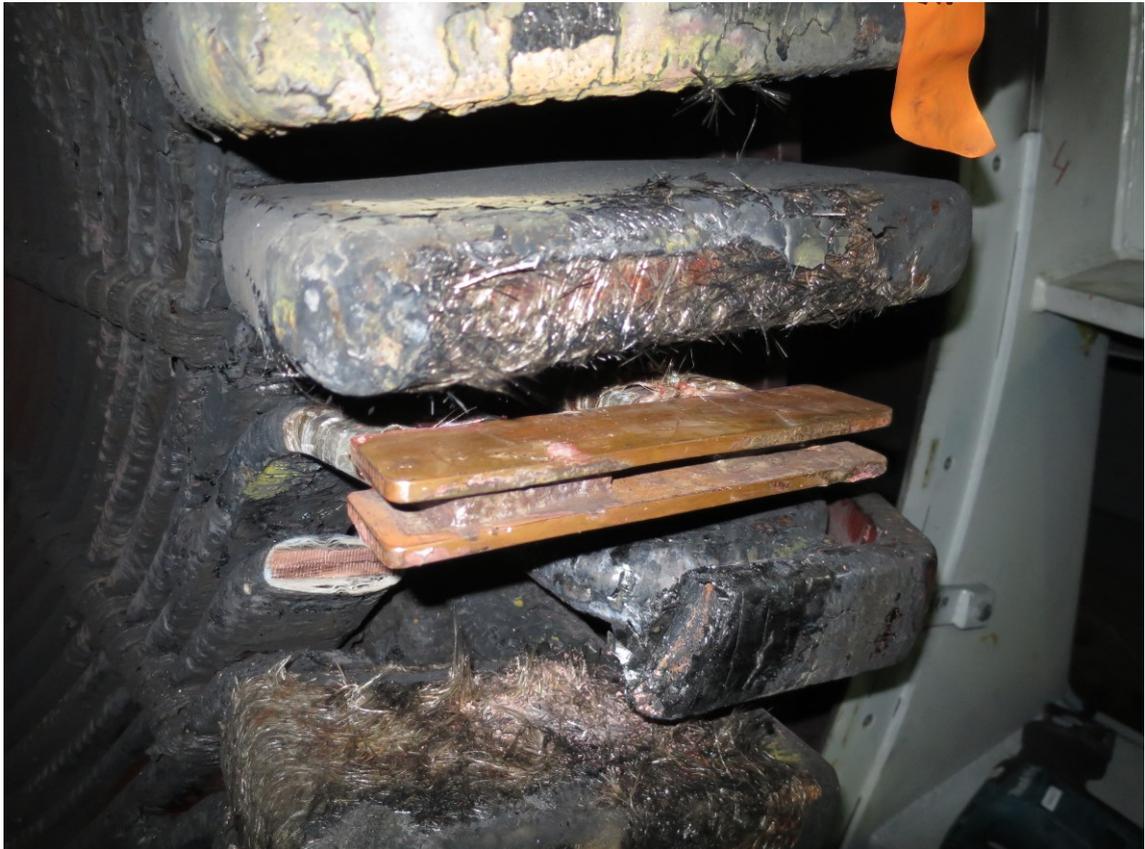
The construction of another damaged winding-turn connection above the fault spot is presented in figure 34. The insulation of the connector had partially melted.

FIGURE 34. Construction of another damaged connection (Pasi Lehtiniemi, 2021)

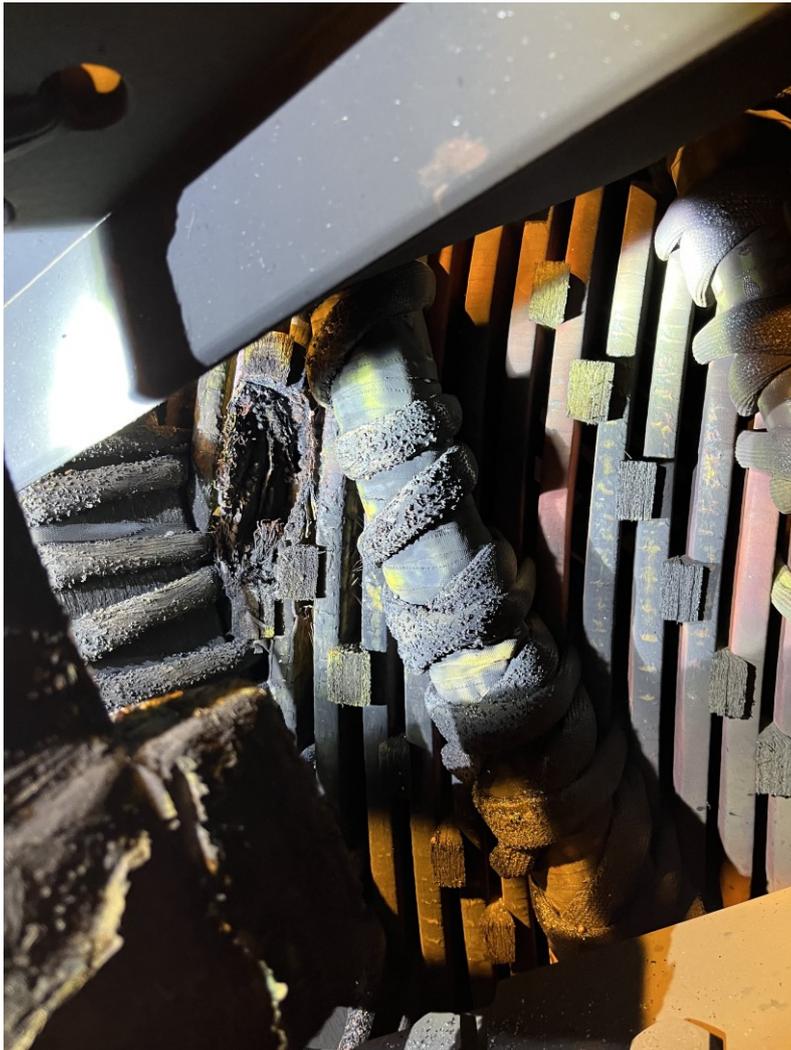
After the shutdown the generator was opened and rotor removed. Visual inspection revealed fault spot on the outer perimeter of the NDE (non-drive end) end-winding, as seen in figure 35.

FIGURE 35. Outer perimeter of the end-winding (Ville Holmstrom, 2022)

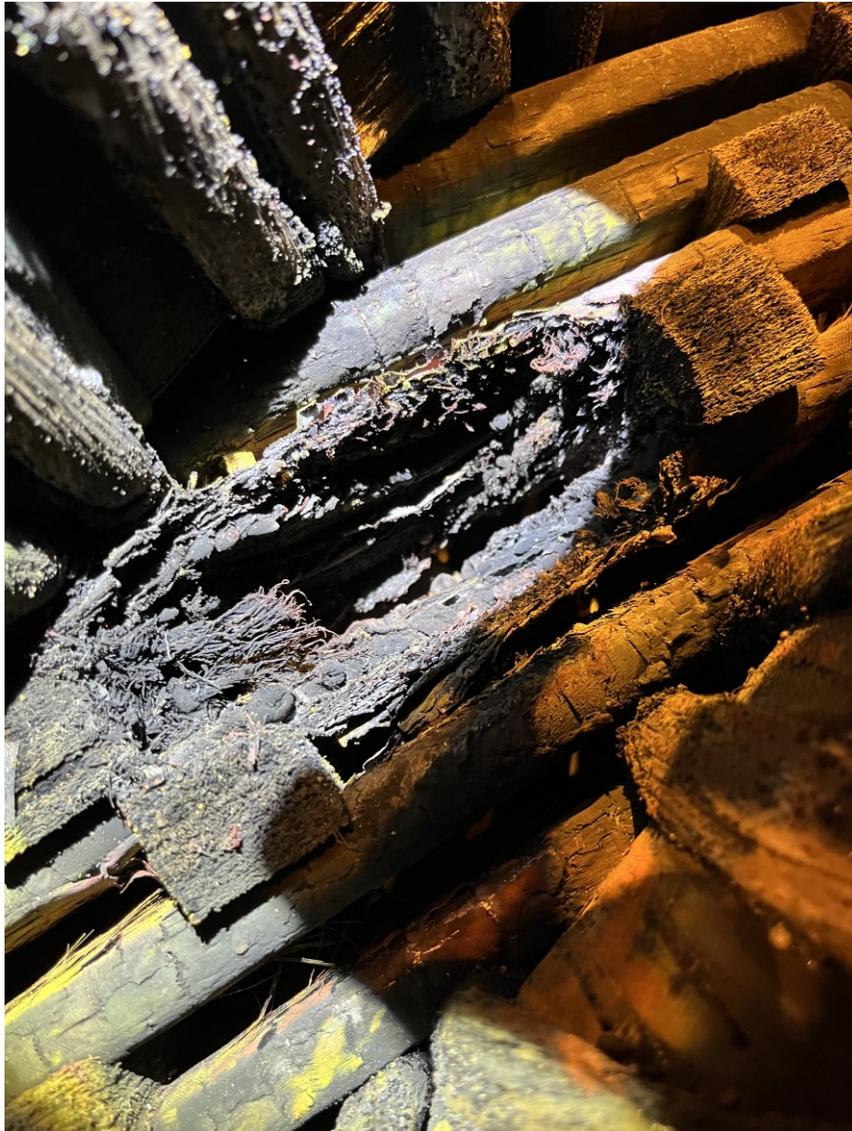
The location of the fault spot was inspected to be between two winding bar ends, as seen on figure 35. The bars were found to be the first bar of the phase V line-end and the second bar in phase W line-end. This means the voltage between these bars was at least near the nominal 10,5 kV rated voltage, and the voltage stress was at highest level compared to anywhere else in the winding.

FIGURE 36. Fault spot on the end-winding (Ville Holmstrom, 2022)

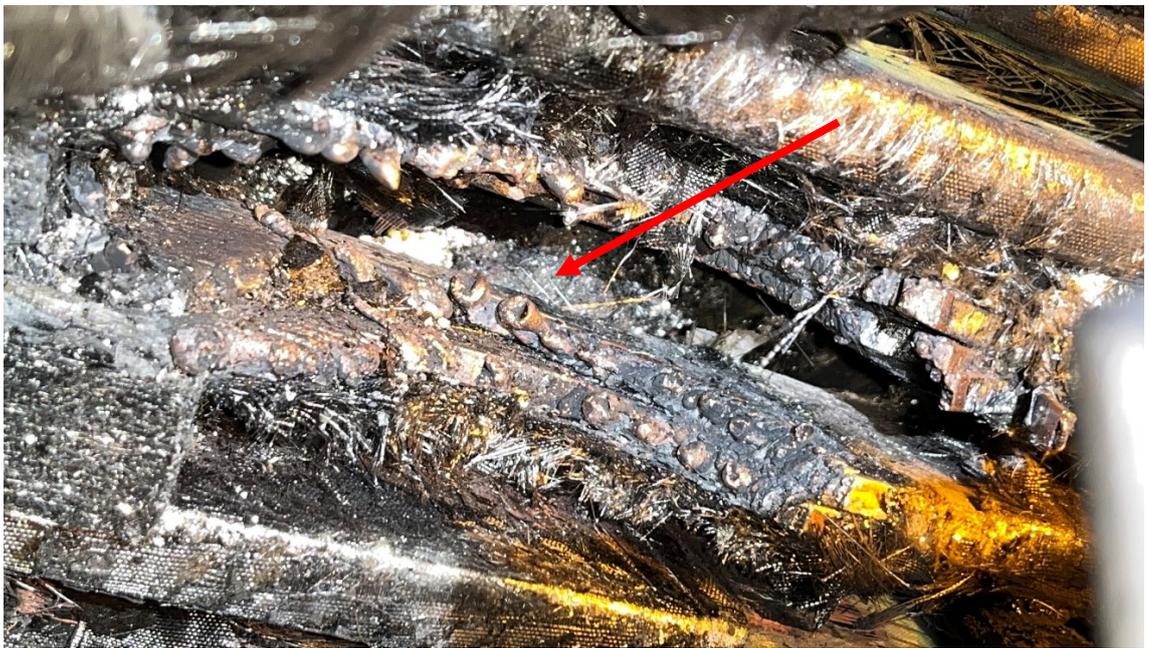
The performed root cause analysis came to conclusion that the most probable root cause was failure caused by a loose component in the winding end support system. In order for a short circuit to occur between the bars, the insulation of the winding bars had to been punctured on both sides. It was found that there had been a winding support block exactly in the middle of the fault spot, as seen on figure 37.

FIGURE 37. Remains of a support block in the middle of the fault spot (Osmo Koponen, 2022)

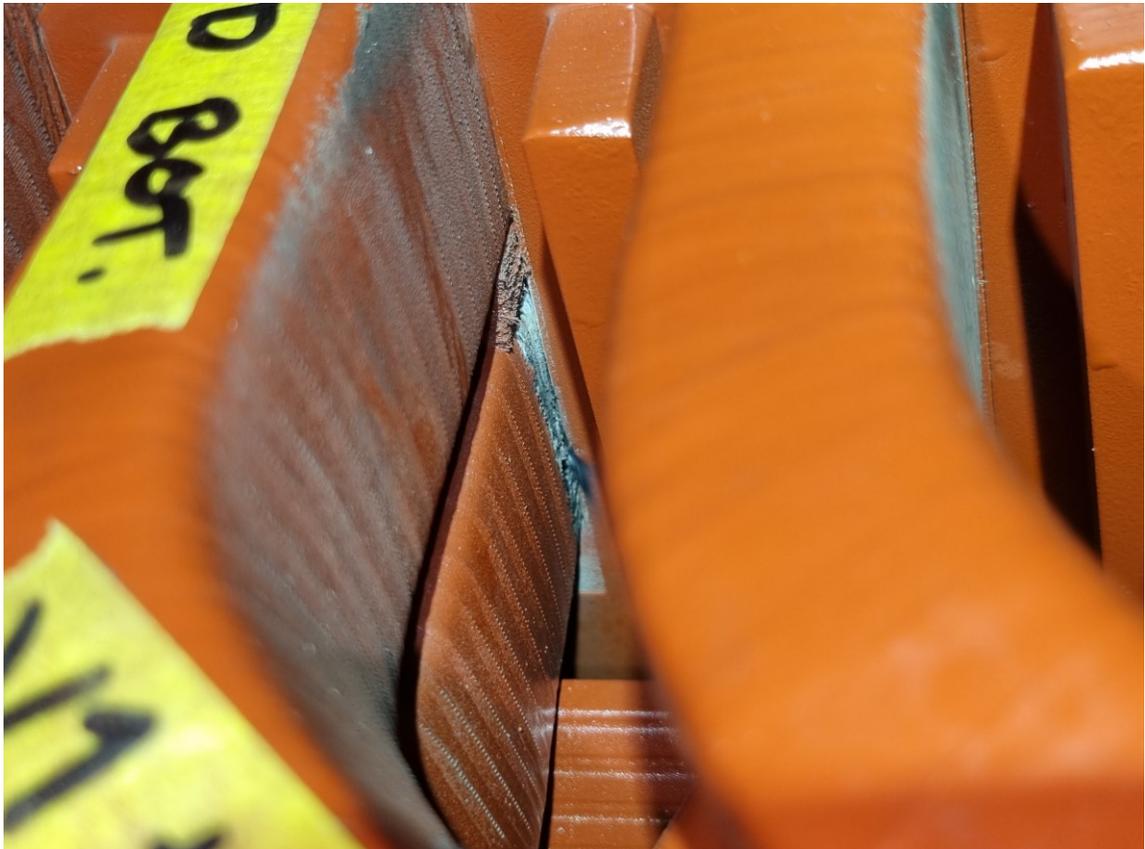
In 2022, protective relay detected an earth fault in phase V. Measurements confirmed a grounding fault in the stator winding, and the rotor was pulled out for further inspections. The fault spot was located in the DE (drive-end) slot exit area, near line-end of the winding. Visual inspection revealed that the insulation of the winding had been damaged by erosion caused by partial discharges. The fault spot is presented in figure 39.

FIGURE 38. Fault spot in the bottom bar slot-exit area (Sami Lehtola, 2022)

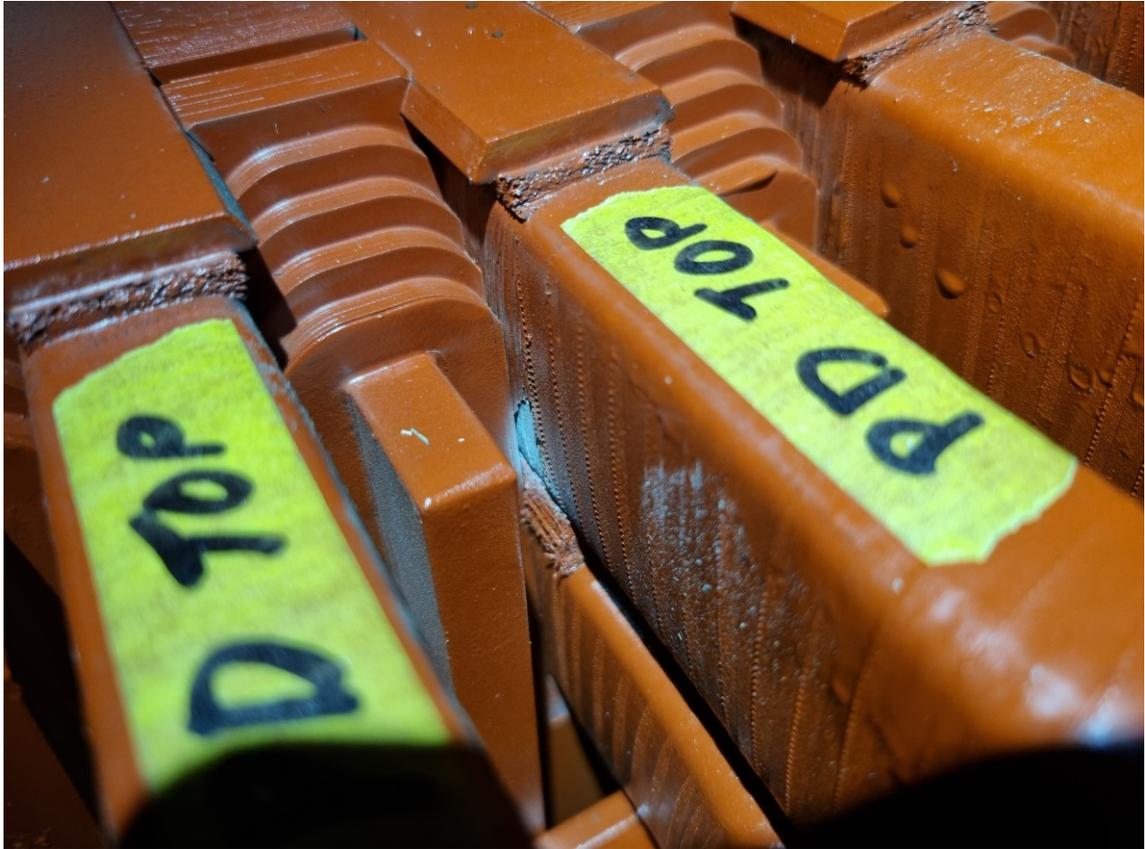
In addition to the grounding fault spot, further inspections revealed multiple similar spots with signs of partial discharges. Approximately 20 spots were found on both NDE and DE winding ends, in the top and bottom bar slot-exit areas, as presented in figure 39.

FIGURE 39. Signs of partial discharge activity in the slot-exit area (Sami Lehtola, 2022)

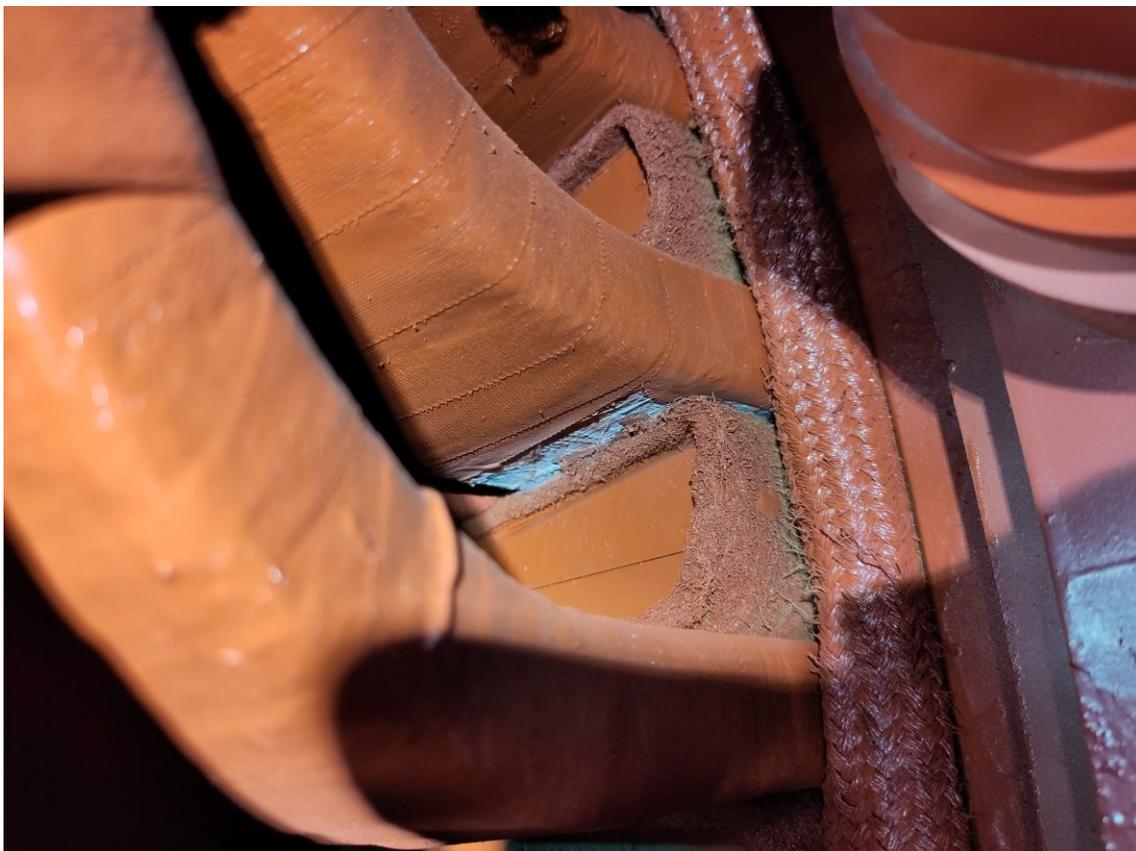
Appendix 1. Surface erosion in slot exit area

FIGURE 40. Surface erosion from discharges in slot exit area (Veeti Korpelainen, 2023)

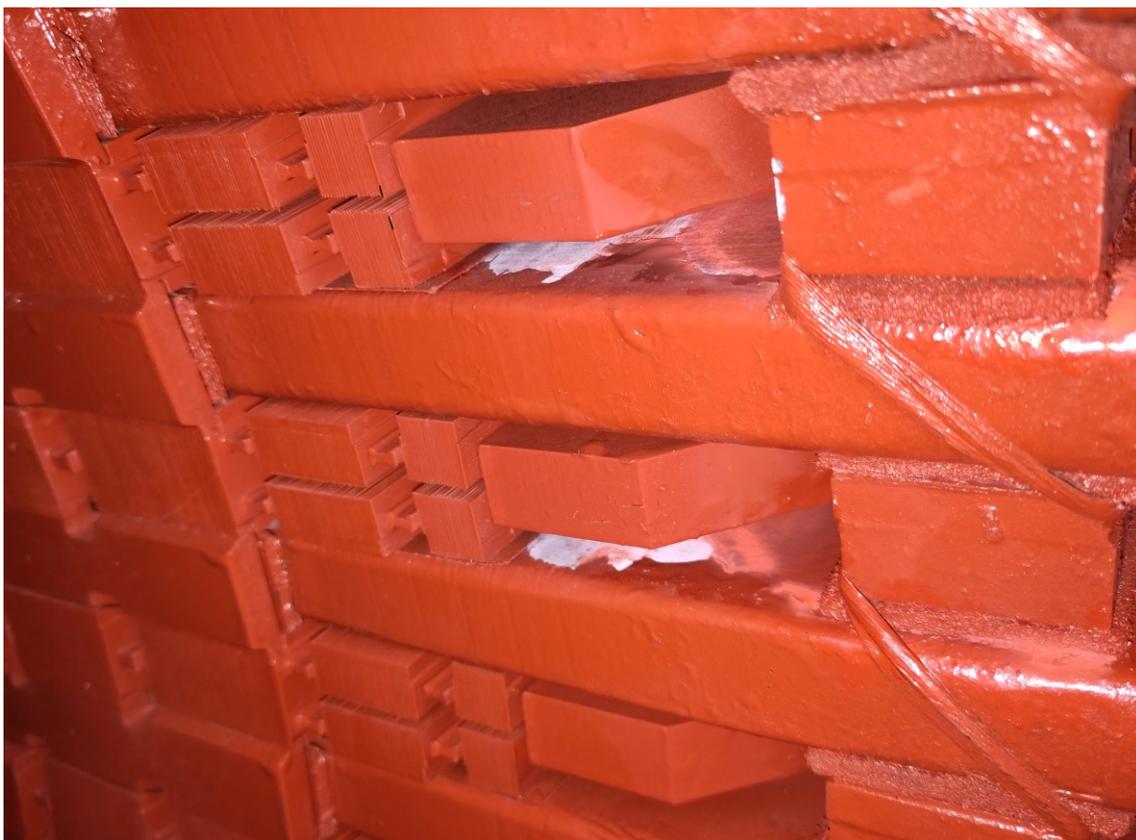
Appendix 2. Surface damage in winding slot-exit area

FIGURE 41. Major surface damage in winding slot-exit area (Veeti Korpelainen, 2023)
