The Accessibility of Cultural Attractions for All Senses in Kerava

Aino Laine, Mila Toivanen
Degree Programme in Tourism
Bachelor's Thesis
September 2015

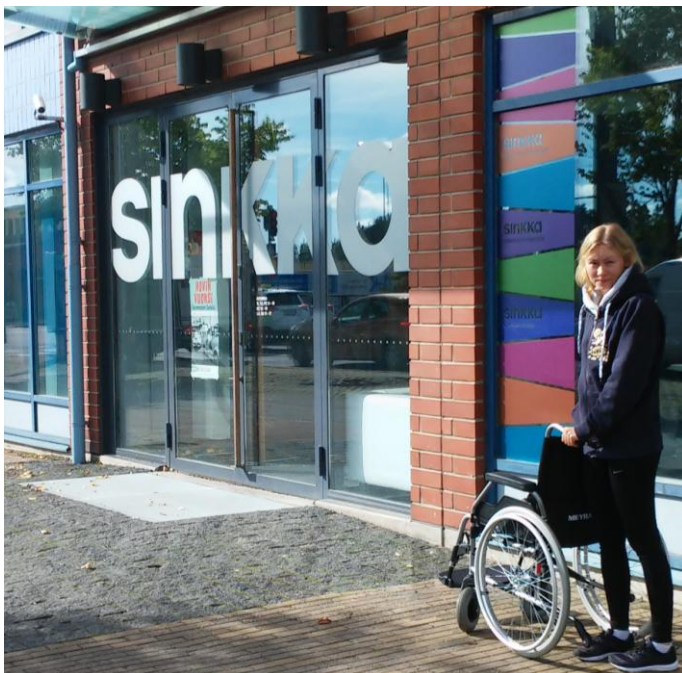
The main entrance to Sinkka is on the street level with a small level difference that has been corrected with a ramp (Image 1). There are two heavy doors on the entrance, neither of which is automatic. The service counter for the museum and the cafe was high for a customer in wheelchair or for a short person as seen in image 2. Benches and tables were placed in the lobby next to the service counter and cafe area. The staff is extremely helpful and professional with expertise in accessibility matters. A member of the staff highlighted the personnel's willingness to help in all situations by explaining that if the architectural design does not allow the use of services for all customers, the personnel will do its best to provide it in another way, for example assisting a customer in the entrance and whenever needed. All the information, brochures and signs are written in English and Finnish. Around the corner from the service counter there was a clear floor map indicating the customer areas and exhibition halls.

Image 1: Main entrance (Toivanen, 2015)

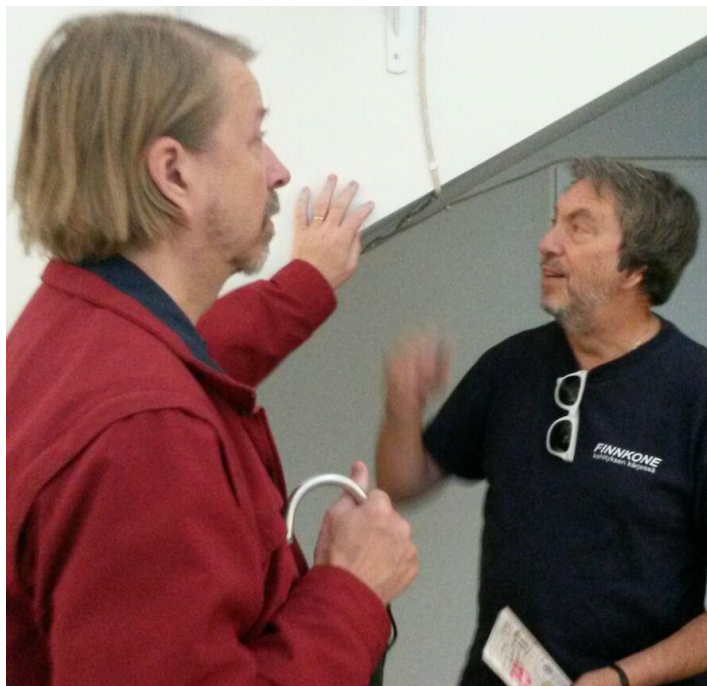
The contrasts were good with dark gray floors and white walls. Lighting was adequate but in the exhibition halls with films there were minimal lighting and black walls that could cause perception problems for those with impaired vision. The whole exhibition area had no thresholds or other level differences. The only negative remark was in the cellar floor that had an inclined ceiling due to the staircase (Image 4), located right in front of a doorway. This ceiling had no contrast stripe and could cause incidents for unaware customers. The signalization was good, except for the elevator that had only a small text in the upper corner of the door. There was only one call-button for the elevator along with two small screens indicating the vacancy and floor of the elevator.

Image 4: The inclined ceiling in the cellar floor (Laine, 2015)

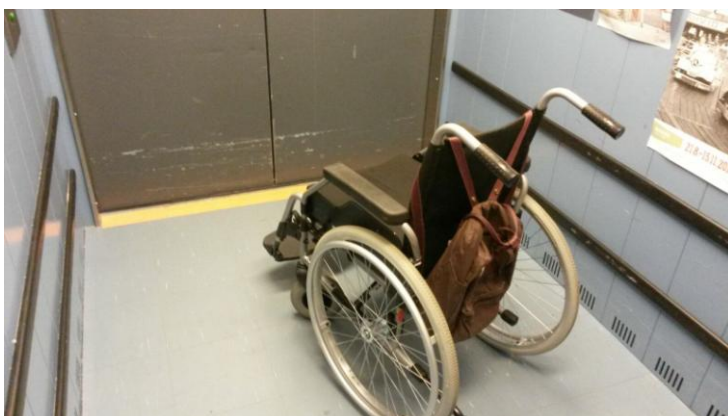
The elevator was large, designed for transporting paintings and large exhibition objects. The door was heavy and had no audio signal for its arrival. There was more than enough room for a wheelchair and other persons (Image 5). However the elevator had no inner doors so the walls moved with the elevator causing a risk for the customers. There was no audio guidance or Braille writing. Obligatory emergency buttons and weight capacity were written inside the elevator as well as the buttons that were distinguishable by touch. The stairs were dark gray with contrast stripes and made of material that prevent slipping. There were embedded railings with light on the other side and normal railings on the other.

Image 5: Inside of the elevator (Laine, 2015)

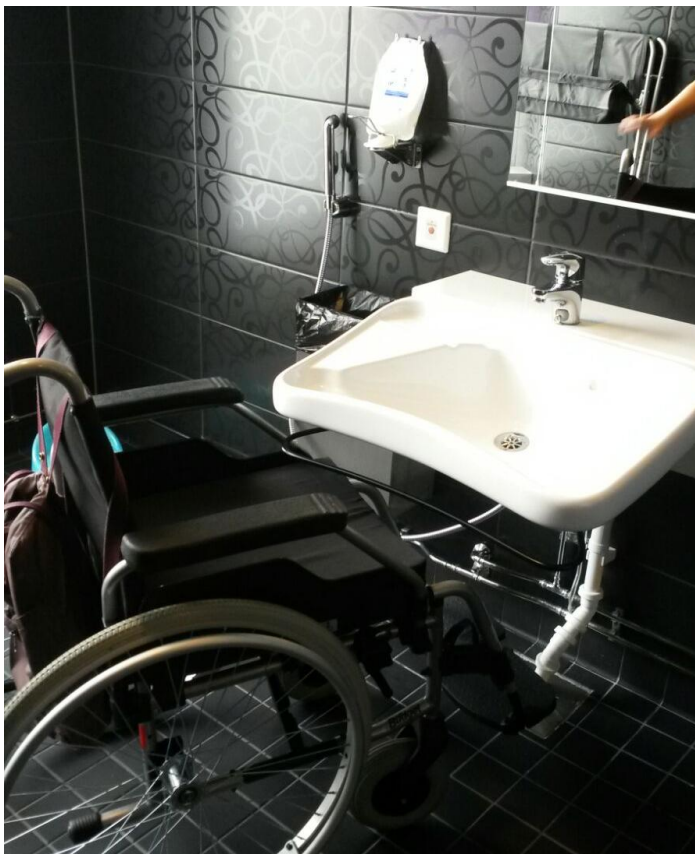
The interior of the accessible toilet was completely black with patterned tiles, thus creating a clear contrast with the white sink and toilet (Image 7). There was a large window that let in natural light and the overall lighting was sufficient. The toilet seat had railings and an emergency alarm cord right next to it. The sink had enough space under it for a wheelchair but it was hard to reach the soap and the paper towels. There was also a foldable baby changing station and railing on the door. The toilet was on the street level and was signaled with an accessible symbol. The non-accessible toilets were located in the cellar floor and had a sign indicating the location.

Image 7: The accessible toilet (Laine, 2015)

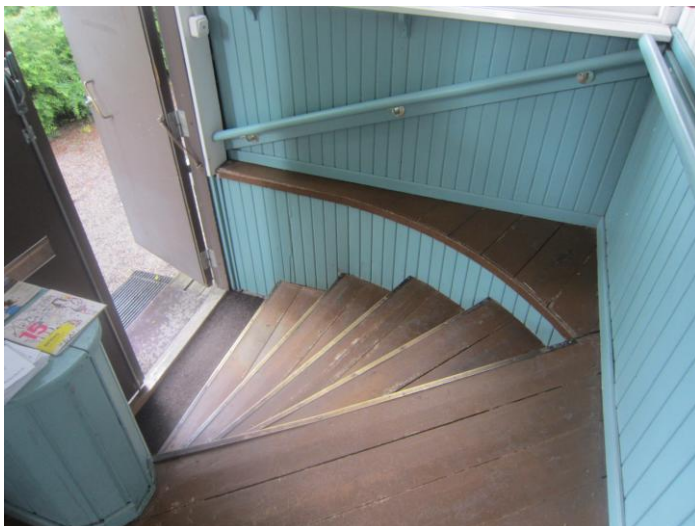
Due to the entrance's narrow stairs as seen in Image 8, Gallery Alli is not accessible for customers with reduced mobility or disability equipment such as a wheelchair or a rollator. Being an art gallery, the place is not relevant for those with severe visual impairment. For this reason the research in Gallery Alli was conducted without the visually impaired test users.

Image 8: Staircase to the Gallery (Toivanen, 2015)

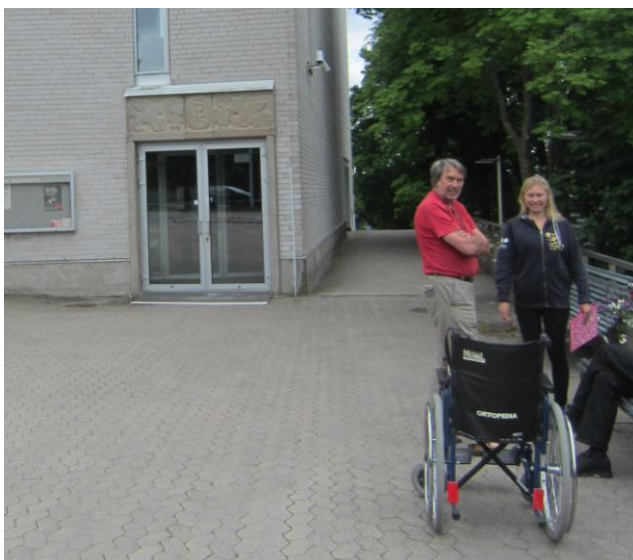
The main entrance to the church did not have an automatic door. The church lobby had plenty of space for a wheelchair and the lighting was adequate. The lobby led straight to the service hall. The side entrance to the church was not accessible for a wheelchair since the door is not automatic and there is a high threshold of 4 cm. The side entrance opened straight to the parlor with a long table and seats around it. The floor was dark blue.

Image 11: The main entrance to the church (Toivanen, 2015)

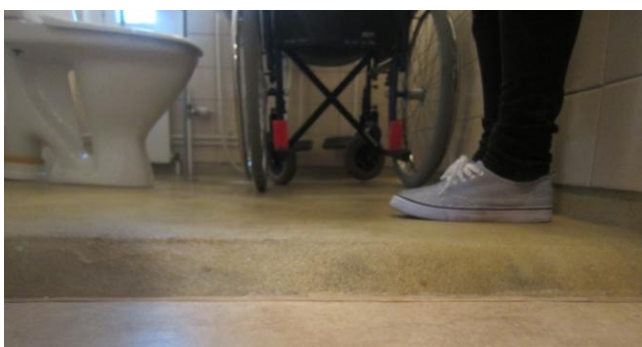
The church has an accessible toilet downstairs by the parlor. The toilet has good lighting and enough space. There were relevant railings and the sink had enough room under it. The coat hook was placed low but there was no emergency alarm available. In the congregation center the accessible toilets is located upstairs, right by the entrance. The toilet had little space and there was no emergency alarm. The threshold had an inclined ramp made of concrete forming a level difference between the corridor and the toilet (Image 17). It was accessible without a helper but with some difficulties in exceeding the ramp. The lighting was sufficient in both toilets.

Image 17: The threshold of the accessible toilet in the congregation center (Laine, 2015)

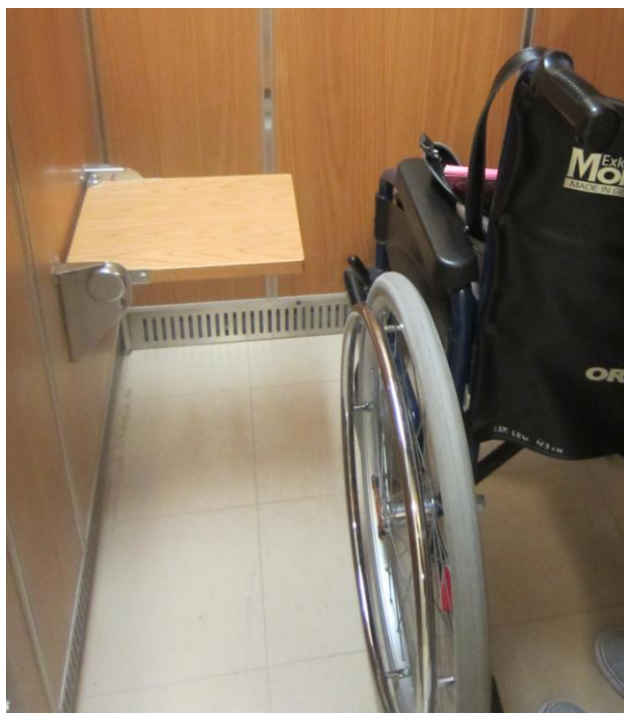
inside and enough room for a wheelchair and a helper. There was no audio signal on the arrival and the door was non-automatic. Inside the elevator there were the obligatory emergency buttons and weight capacity information. There was no audio guidance or Braille indicating the floors, just two embossed buttons.

Image 18: The inside of the elevator in church (Laine, 2015)

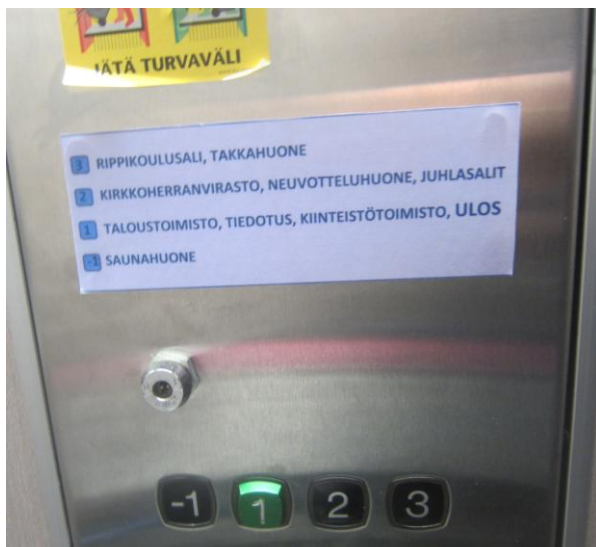
The congregation center's elevator was behind two corners and two fire doors with weak signalization from the upstairs lobby. The threshold to the elevator was 2, 5 cm high and the door was heavy and non-automated. There was no audio guidance or audio signal for the arrival of the elevator and the door had no window. The numbers on the buttons could not be distinguished by touch, except for the first floor that was carved. There was also a sign with a description for each floor. The space inside was adequate for one wheelchair and a helper.

Image 19: The buttons inside the congregation center's elevator (Laine, 2015)

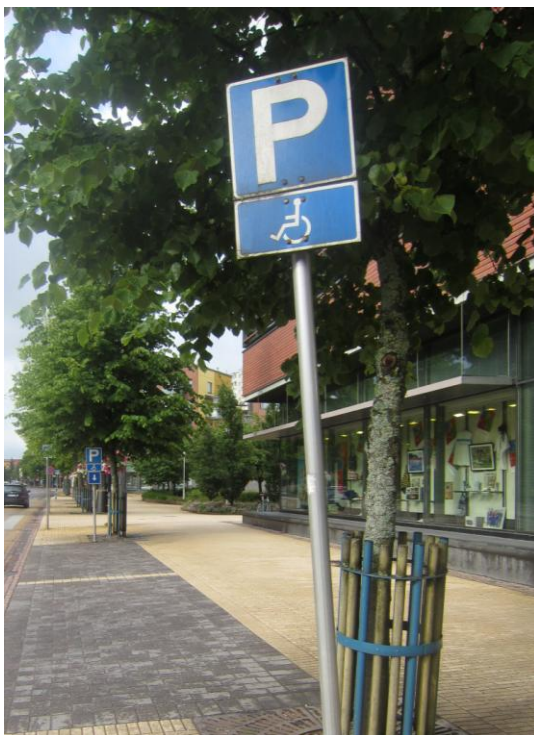
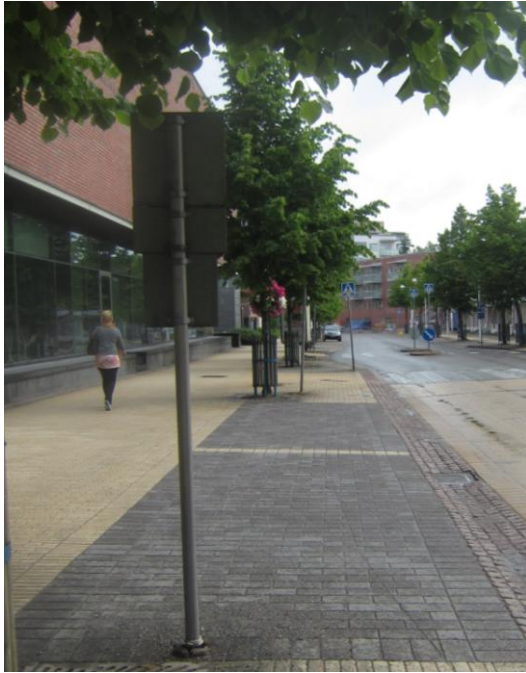
The library is close to the railway station and the entrance can be reached by parking a car right in front of it. There are two accessible parking places in the corner of the building. They are signaled only on one side, when arriving from the center one can only see the backside of the sign (Images 20 and 21).

Image 20: The accessible parking place sign (Toivanen, 2015)

Image 21: The accessible parking place sign from the other direction (Toivanen, 2015)

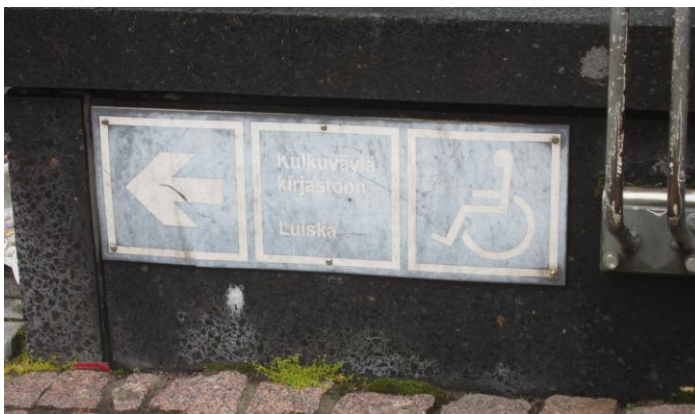
The main entrance consisted of stairs with four steps equipped with a railing. There were no contrast stripes and the doors were not automatic and heavy. The entrance for persons with reduced mobility was located at side of the building equipped with a ramp and a door that could be opened by pressing a button (Image 24). The signalization was poor as Image 22 illustrates; the sign was worn off and situated low, next to a bicycle rack causing the bicycles to occasionally cover the sign.

Image 22: The accessible entrance sign outside the City Library (Jaakkonen, 2015)

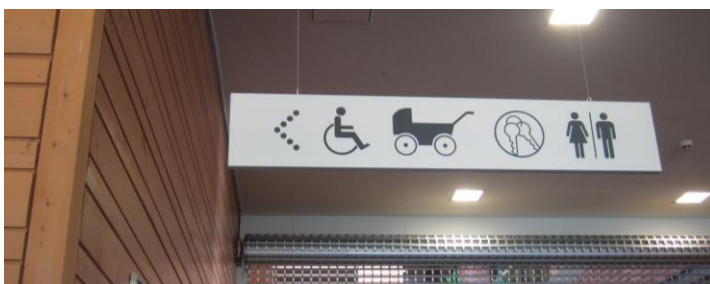
In the lobby there were good signs where the toilets and lockers were situated. However, the accessible toilet was around a corner with no clear signalization on the door. There are no thresholds too high in the library service area for a person with reduced mobility.

Image 23: The toilet signalization (Jaakkonen, 2015)

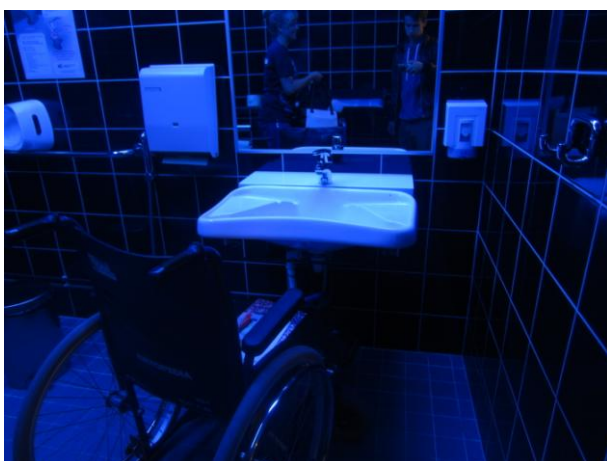
The toilets were located right next to the side entrances and were clearly signaled, with the exception of the accessible toilet which was poorly signaled and located around the corner from the other toilets. In the toilet there were automatic blue lights and the door was locked with a note saying that it is opened by request. The toilet was spacious enough and had railings both on the door and on the toilet. There was also a baby changing station in the toilet next to the door which made the entrance narrow; the station could be folded against the wall but the mechanism was heavy and not easy to use. There was no alarm button in case of emergency and the door was not automatic. The sink had room under it for feet when sitting in a wheelchair. A hook to hang a coat or a bag was situated low enough.

Image 28: The main accessible toilet (Jaakkonen, 2015)

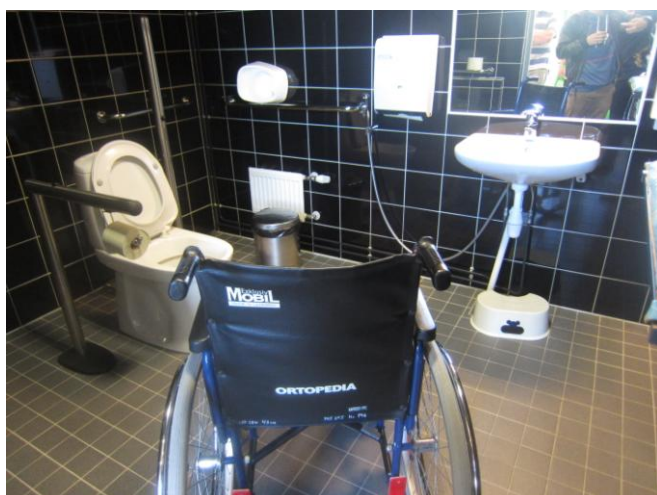
There was also another accessible toilet in the children's area but with no signalization of an accessible toilet. In this toilet the light was normal and sufficient, and there was more room

Image 29: The second accessible toilet (Jaakkonen, 2015)

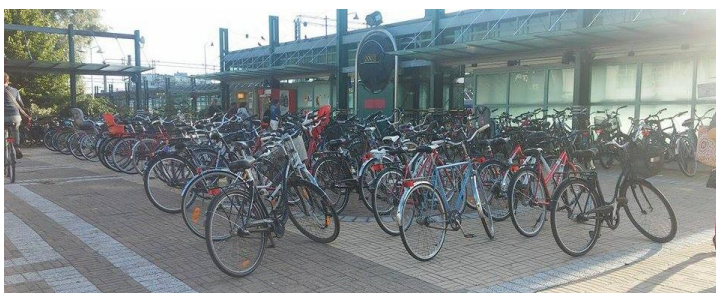
Overall image of the accessibility of the station is adequate. There are no level differences in the station area and the signalization is good. The positive remarks are the renewed audio and announcement systems that are clear and spoken in three languages; Finnish, Swedish and English. There are also digital information boards next to each track announcing the arriving and departing trains. The negative remarks are the gap between the track and train making it hard or even impossible to get onboard the train in a wheelchair without a helper. Also, the station building is not easily accessible with heavy non automatic doors and tight spaces. The bicycle racks at the station are insufficient causing the fairway to get easily blocked with bicycles as illustrated in Image 33. On the other hand there is a ticket vending machine right by the station so it is not necessary to go into the building in order to buy a ticket. The machine is operated by a touch screen but tickets can be bought from the R kiosk or on the train. The toilets however are located in the station building and are not free of charge. The station tunnel leading to the center and pedestrians' street can be found in each track, enabling access to the tracks in case the elevators don't work.

Image 33: Bicycles in front of the station (Toivanen, 2015)

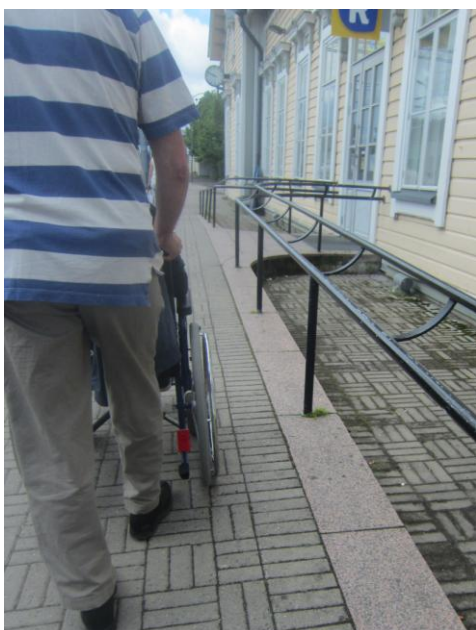
The entrances to the station building are located on two sides, one of them with a ramp (Image 36) and the other with stairs. The ramp has railings that prevent falling off and provide support. The double doors are heavy and non-automated with a reasonably high threshold that cannot be easily passed without a helper. The vestibule between the double doors was narrow and caused problems for a wheelchair user without a helper. All in all with the high threshold, double doors and little space the station building was inaccessible without a helper. The customer area consists of a cafe and an R-kiosk. The space between the shelves in R-kiosk was narrow. The toilets are not free of charge but there is an accessible toilet together with women's' toilet. The toilet is spacious and well-illuminated and the toilet has railings. The sink had enough room under it for a wheelchair and the door was light and easy to open. The coat hook however was placed too high.

Image 36: The wheelchair entrance (Jaakkonen, 2015)

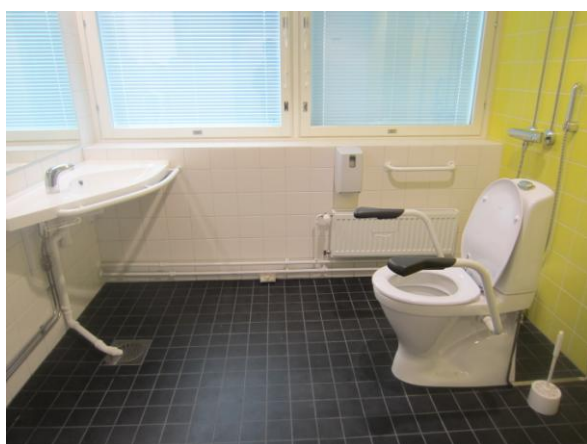
On each floor there was an accessible toilet in the same location. The toilet was well signa- lized and spacious. The only problem with the accessible toilet was that there was an auto- matic light which did not recognize the customer until they reached the sink. When the light- ing was on it was bright and sufficient. There were railings on the toilet and in the door, as well as a coat hook low enough. Also an alarm cord was available in case of emergency. The sink had enough space under it and was on a suitable height for a wheelchair. There was also a baby changing station in the toilet that could be lifted up against the wall.

Image 45: The accessible toilet (Jaakkonen, 2015)
