Magnetic Resonance Imaging facility planning

Climate conditions versus image quality

Master's Thesis

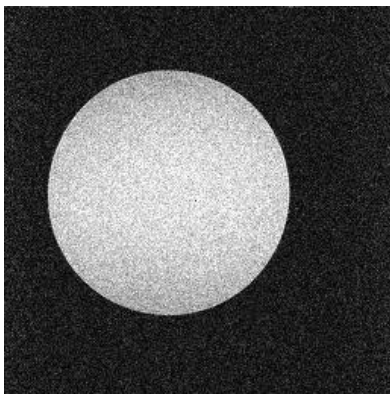
Figure 6 Disturbance on MR test image

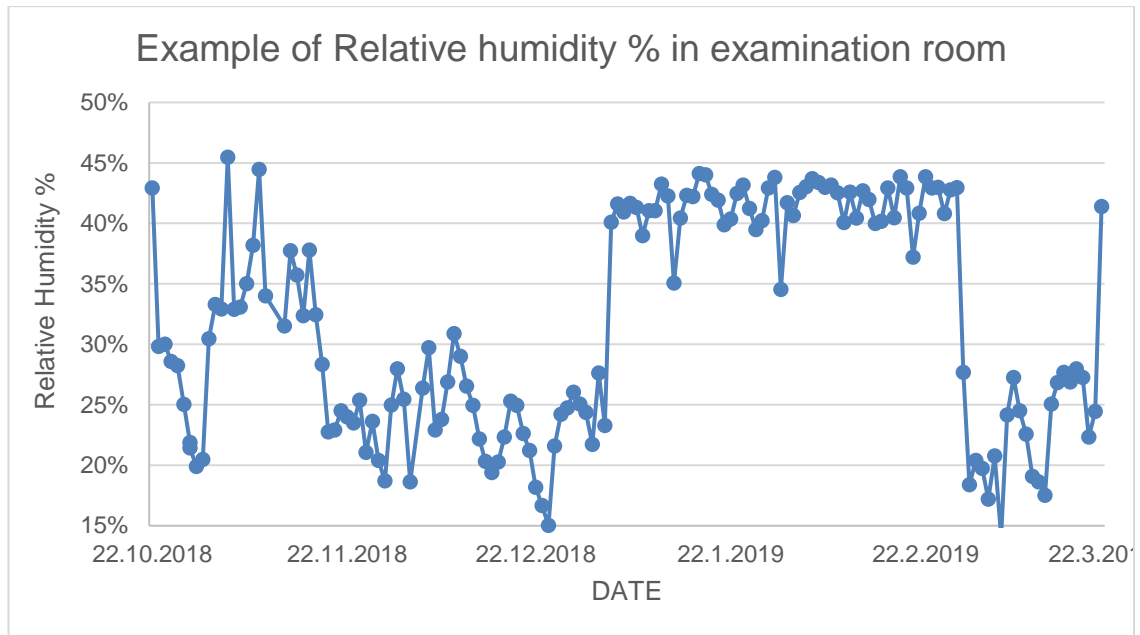
Figure 21 Example of “Relative humidity %” in examination room

From Figure 21, it can be seen that “Relative Humidity %” -value changes a lot. 22-Dec it has been just 15%, which is a really low value. On 3-Jan it jumps just above specification to 40%. This causes system major Image Quality issues. This is easily seen in Figure 22. On this particular system, QPI values are almost all the time more than 50, which means 50 times more than specification.

Humidifying can be taken care of when planning a new department or facility but in old buildings and small private clinics, this is not easy and may cost a lot. One example for an easily adjustable humidifying system can be like this:

- Hospital main climate condition system makes rough adjustment for air to get relative humidity level near specification.
- Near the imaging system air can be fine humidified with local climatic system
- The whole system is connected to the facility automation system. This is important in order to get alarms if, for example, a humidifying fault occurs.

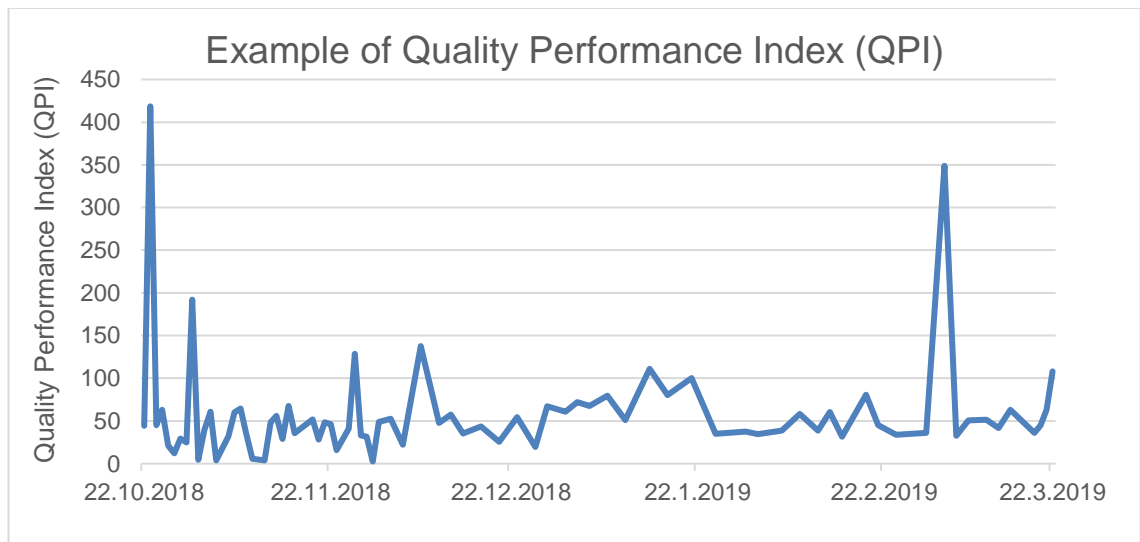
Figure 22. Example of “Quality Performance Index (QPI)” –curve

The chart in Figure 22 shows so high QPI values that the system clearly suffers bad image quality issues all the time.

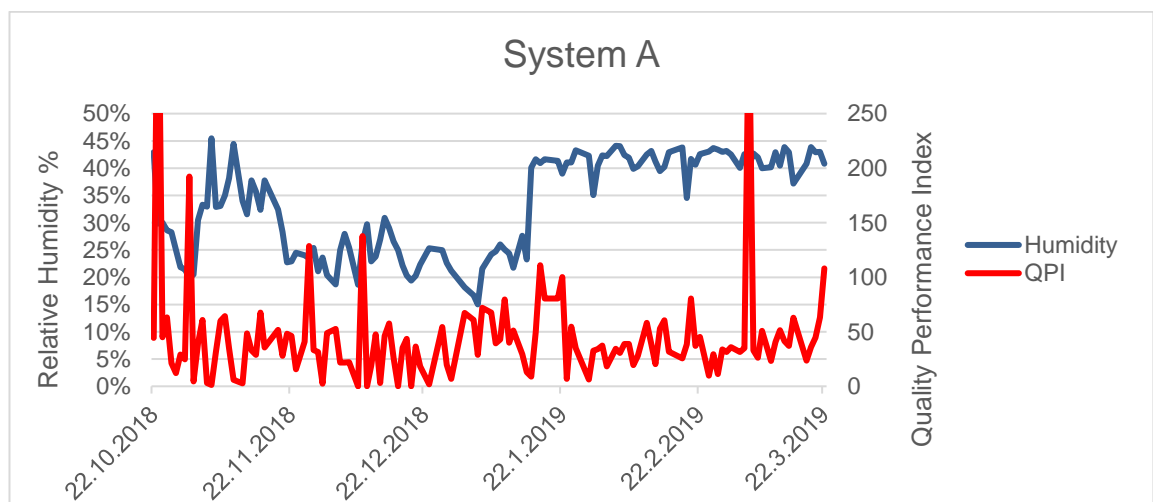
System A has faced several image quality issue periods during its service time. On that time when System A was installed, it was the top model on Philips MRI fleet. This is a good example of an MRI facility where the environmental specifications were not taken seriously in construction planning and implementation phases. This has been causing severe problems for the image quality and therefore not even such a high end MRI system has not reached its potential. Problems are easily seen in the Figure 23 chart. During this period of time QPI is all the time over 1, which means major issues with image quality. The highest peaks of the index went over 400, which means that the scanned images were not usable. At the same time humidity is below specification (40-70%). The MRI system installation site and climate conditions are like in a regular office building. The MRI department does not have its own extra humidifying device on “air in” ducts, which means that the climate conditions are almost impossible to adjust to MRI needs.

Figure 23. System A. Lot of IQ issues, humidity below specification most of the time

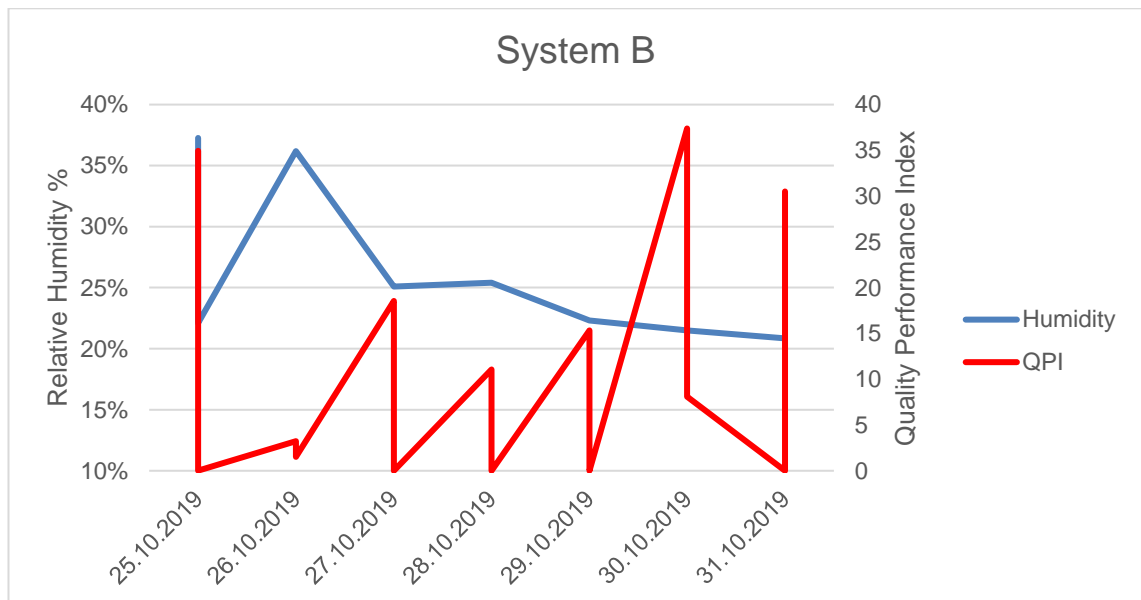
This MRI system was inspected because users had reported about image quality issues with the system. The system log file was inspected and analysed. The log file showed a lot of high level QPI events during that specific period. The humidity was also below specification values. These factors can be seen in the System B chart in Figure 24. There are high QPI peaks on 25-Oct, 27-Oct and so on. The facility service inspected the facility's climate conditioning system and noticed that the main humidifier was broken. The humidifier device was fixed and the image quality reverted to normal after a few working weeks. This correction cannot be seen in this chart because data from that time was not available. It is really important that also hospital facility devices are working as they should.

Figure 24. System B Humidity below specification, major image quality issues

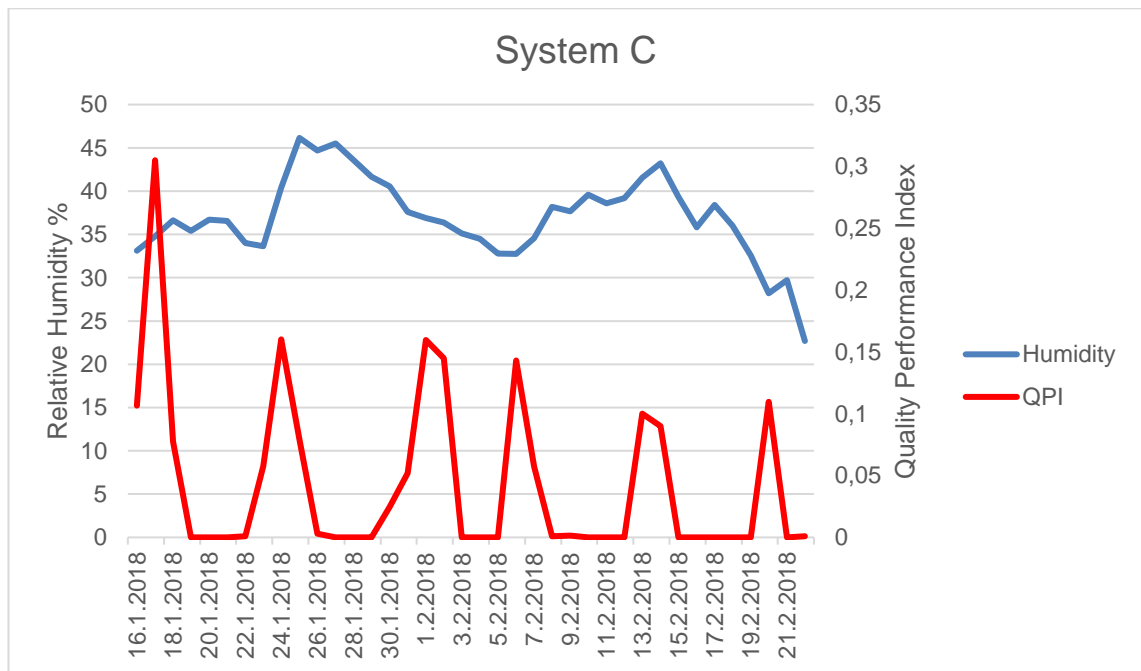
System C

The Philips remote service team noticed that the relative humidity % in the system's examination room was not maintained on the specification levels. The system is highly used, and must be on working condition all the time as a high priority. The humidity problems were caused by an issue with the climate condition system and this was fixed in time before major image quality issues occurred. Analyzed data is shown in Figure 25. Humidity starts to go down on 14-Feb and drops below specification on 15-Feb. The data also tells that, low, still below 1.0, QPI values occurred already. Values below 1.0 normally do not cause any issues for images. In this case, the climate conditioning system malfunction had not influenced neither the MRI system nor the department workflow before the malfunction was fixed.

Figure 25. System C. Humidity changes, no IQ issues, still below 1.

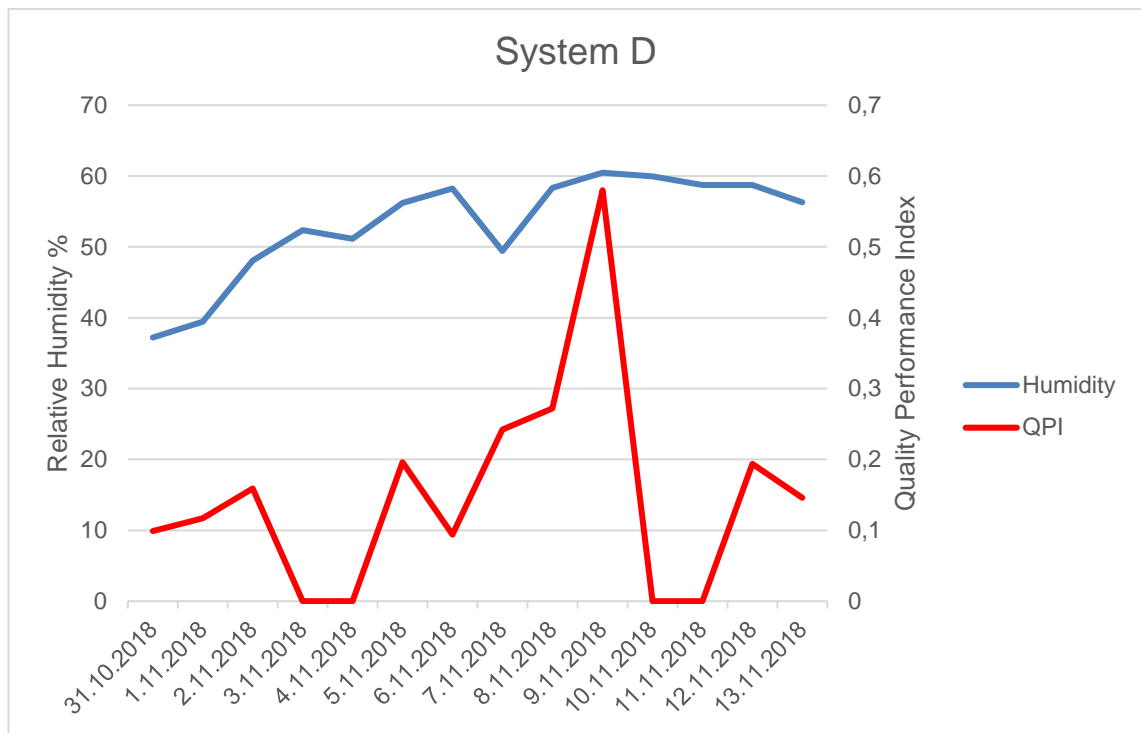
System D

The system is working according to specification. No errors are reported. During planned maintenance it was noted that relative humidity varied too much during the days. If the fluctuation in humidity is too high, it can lead to moisture condensing on surfaces. This is a risk for electrical equipment in the room. The facility service department was asked to re-adjust the climate conditioning system. The cause of the problem was found to be a broken extra humidifying device on the MRI department air inlet. The facility's main air-conditioning system tried to keep conditions right and this caused massive fluctuating; this can be seen in Figure 26. On 1-Nov humidity was 39% and on 2-Nov 48%. The local humidifying equipment was replaced and the humidity control returned to normal on 9-Nov. In this case no abnormal behavior with the MRI system happened, nor was the system affected by condensing moisture on surfaces.

Figure 26. System D. Humidity fluctuating.

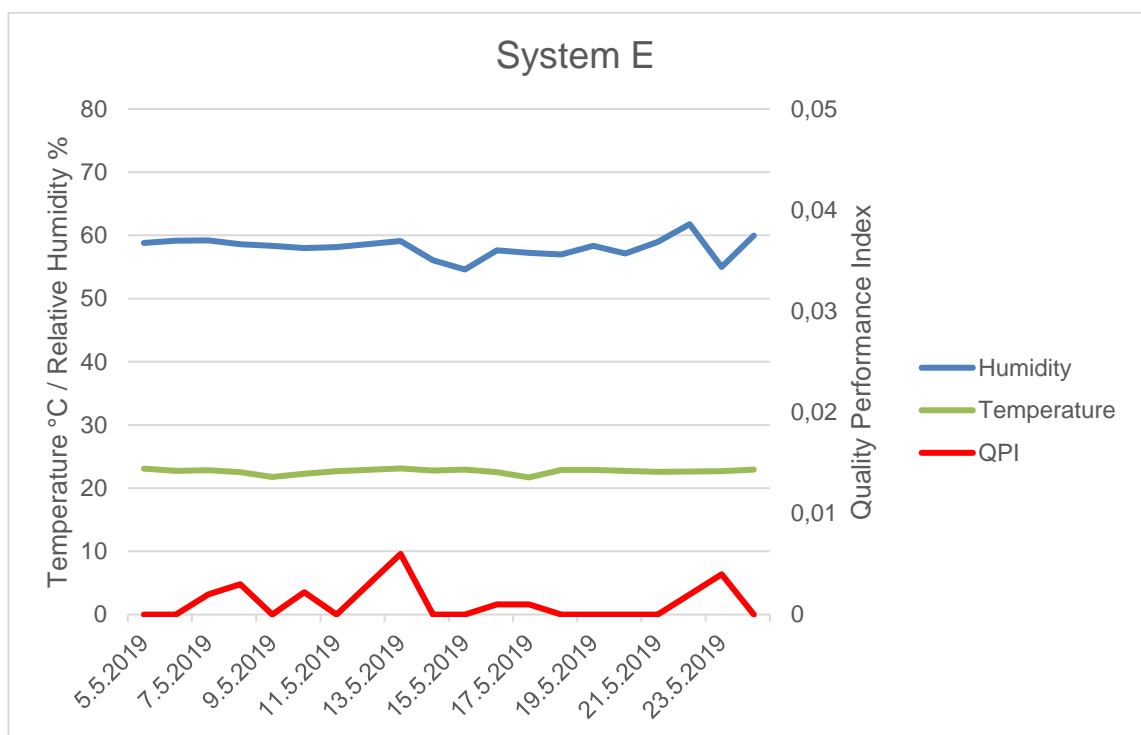
System E

Users had reported an intermittent issue: the images were sometimes unclear. Images looked like as if they had been shifted or vibrated. This caused rescans on particular examinations. The system was inspected and found to be working according to specification. Image quality errors were not detected by the system. Problem solving was continued and then the users reported that some patients had complained about uncomfortable examinations due to warming up and sweating, “feeling like in a sauna”. This behavior was investigated more and it was noticed that the temperature in the examination room was a little over specification (18-20 °C). High temperature combined with high relative humidity (see Figure 27) made the patients feel uncomfortable. This combination causes patients to move and leads to unsuccessful and non-diagnostically valid scans. Unsuccessful scans lead to longer examination periods and to facility workflow peaks. Image quality is on a good level, QPI values are very low, the highest value is 0.005, a way below specification 1.0. The temperature curve together with humidity and QPI values brings more clarity to this case. The facility services was asked to adjust the climate condition system. Temperature and humidity was adjusted little bit lower and this solved the issue, no more complaints from patients or reports from users regarding unclear images.

Figure 27 System E. Small QPI values, with high temperature and humidity
