Screw Corrosion after 720 Hour Salt Spray Test

Kari Kaikkonen
Bachelor Thesis
February 2016
Mechanical and Production Engineering
Oulu University of Applied Sciences

The objective of the thesis is to study corrosion of the screws in a base station after 720 h salt spray test. Screws with different coatings were tested and the performance is compared to the current solutions.

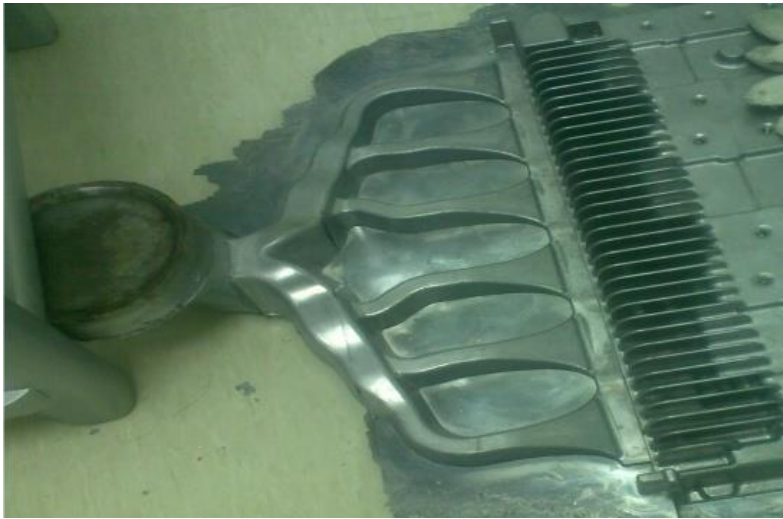
FIGURE 1. *Die-casted unit with the leftover aluminum*

Die-Casted aluminum plates were ordered from mechanics supplier. Aluminum type is AlSi10Mg, which is normally used in telecom mechanics. By using the same materials it was possible to simulate real material conditions in testing. The aluminum plate used in the testing is a leftover from the die casting process. In the process molten metal is forced under high pressure in to mold cavity. In the mold cavity there are two hardened tools used, which are machined in the shape. Die – casting is quite simple way of manufacturing products, but on the other hand it has large capital costs due to mold investment.

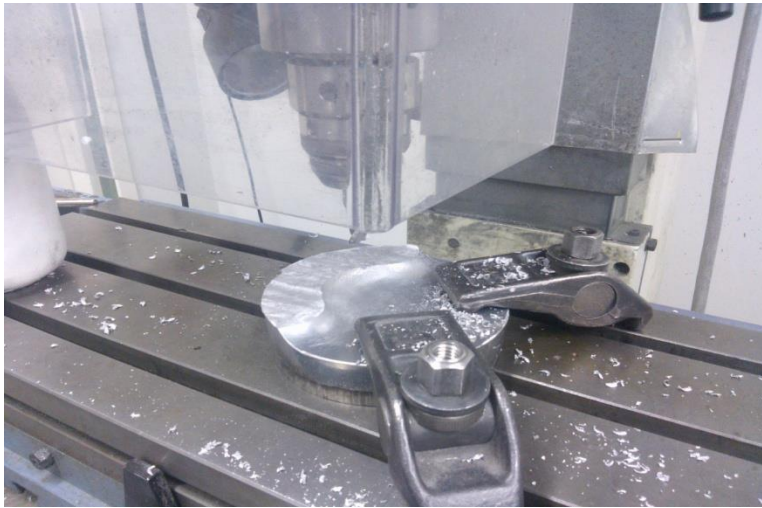
FIGURE 2. *Machining of the aluminum plate*

The surface of the premachined AlSi10Mg aluminum plates were machined in order to achieve even surface for drilling the thread. Machining was done by Serrmac milling machine.

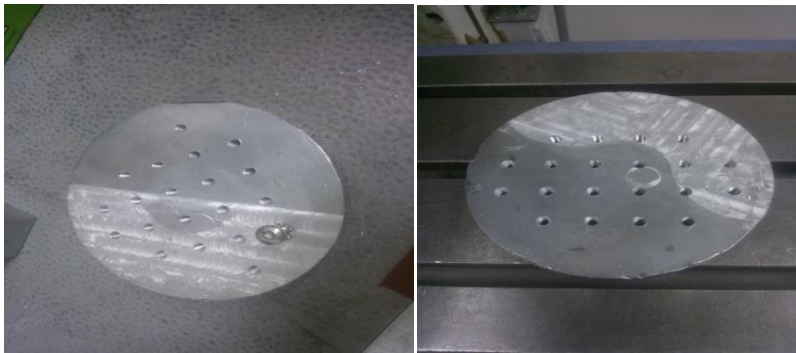
FIGURE 3. *Drilling the thread and assembly of the screws*

The first phase was to drill the hole to the machined aluminum plate. Totally 20 holes were drilled to the each plate. The size of the drill was 5 mm. Next phase was to drill the thread to the aluminum plate by using 6 mm thread drill. The drilling was done by Serrmac drilling machine.

Each screw was assembled with the 6 Nm torque to the aluminum plate. Assembly was done with calibrated tool. This is the usual force used in real environment when base station products are assembled. The aluminum plate was again tightly fastened to the working bench to secure right angle and avoid any unevenness in drilling.

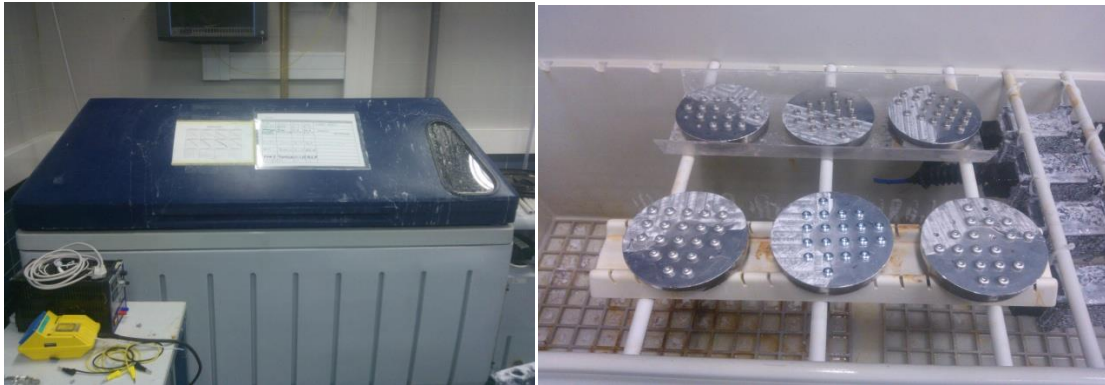
FIGURE 4. *Test chamber for salt spray test*

The corrosion resistance in telecom equipment is tested in salt spray test. The salt spray test is standardized corrosion test method for corrosion resistance of materials and coatings. The appearance of the corrosion is measured after determined time of testing. The salt fog test is commonly used, because it is relatively cheap, fast and easily repeatable test to perform. In telecom equipment the used standard is Telcordia, General Requirement for Electronic Equipment Cabinet. In the test products are exposed for salt spray in the test chamber for 720 hours. The temperature is $+35^{\circ}\text{C} +1.1^{\circ}\text{C} / -1.7^{\circ}\text{C}$. Compound is 5% sodium chloride and 95% water. All mechanical features should continue to function satisfactorily after exposure to salt spray for 720 hours. After the test no visible signs of corrosion are accepted including stress corrosion, cracking or pitting. Test chamber used in this test is Vötsch VSC/KWT 450. This test method is used in Nokia also

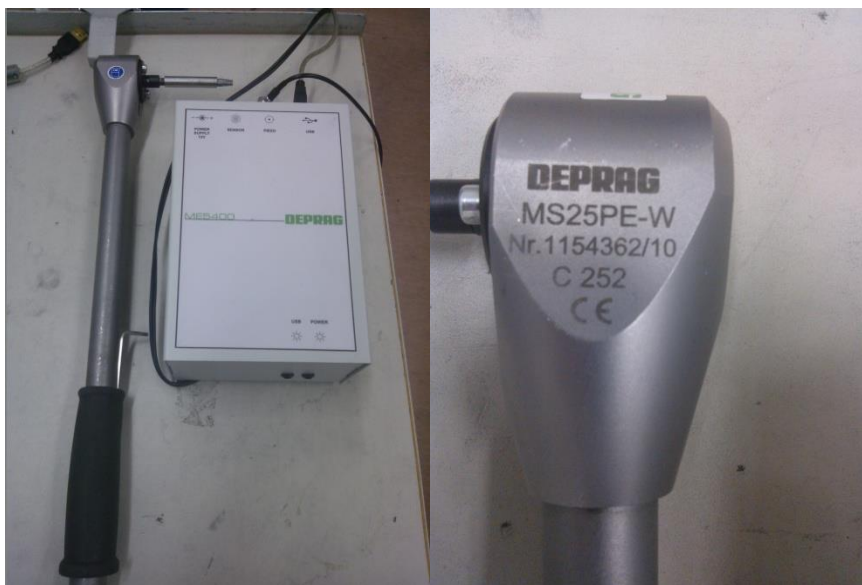
FIGURE 5. *Deprag ME5400 measuring equipment*

Torque test is typical test performed for the screws. By testing the products manufacturers and OEM: s are able to simulate real environmental conditions in the field. At the same time product quality and design can be verified. Deprag ME5400 measuring equipment is connected to PC. The screwdriver with the bar is rotated 360° to measure the torque value. At the same time system displays a graph and torque over time. It also shows the highest value of the torque needed.

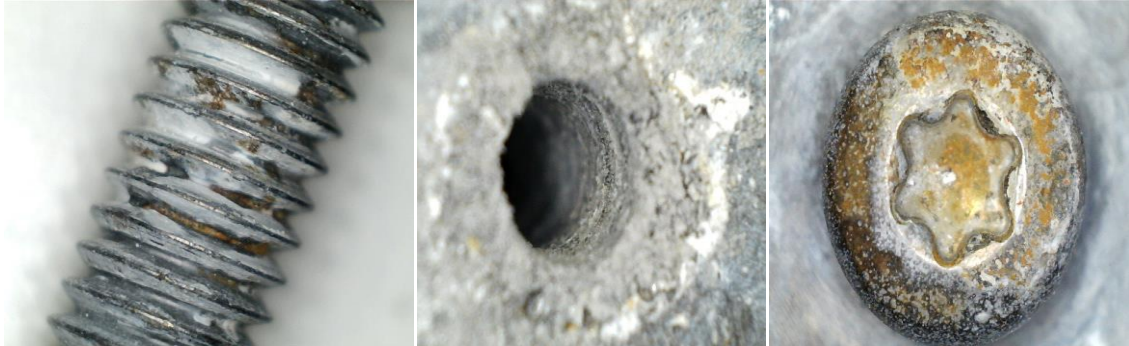
In the new tested screws, figure 11 shows no visible signs of corrosion are found in any of the 3 areas of inspection. In figure 9, there is a sign of red rust in the aluminum thread. Signs of friction can also be seen in the screw thread. In figure 10 some signs of beginning rust can be seen in all 3 areas and the performance seems to be very poor compared to the other tested screws.

FIGURE 10. 10B21 Zn, thread and head of the screw after salt fog test

The new screw types with the new coatings were SUS304 with Delta Tone coating, 10B21 Zn and SUS304 with Zintek coating. There were some variable results among the new screw types. In SUS304 with Zintek coating there was no significant issue with the visual or torque test. The screw opened properly without friction. Situation was a bit different in the torque with SUS304 with Delta Tone. Some signs of friction can be seen in the screw thread. Also in the visual inspection a spot of corrosion can be seen in the aluminum thread. In the screw 10B21 failure in the visual – and torque test can be seen. The torque values are clearly the highest and there are visible signs of the starting corrosion in all three areas of the figures.

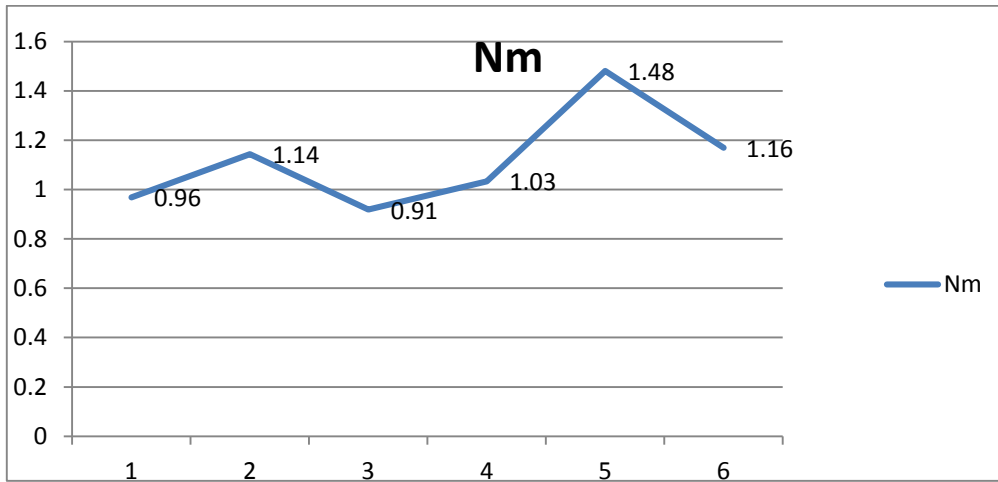
FIGURE 12. SUS304 waxed M6x30

In the screws already in use a trend can be seen in the graphs. In figures of 12, 13 and 14 the graphs do not have significant deviations. Tested screw reaches the maximum torque in the very early phase of rotation. After that screw opens easily and no friction exists.

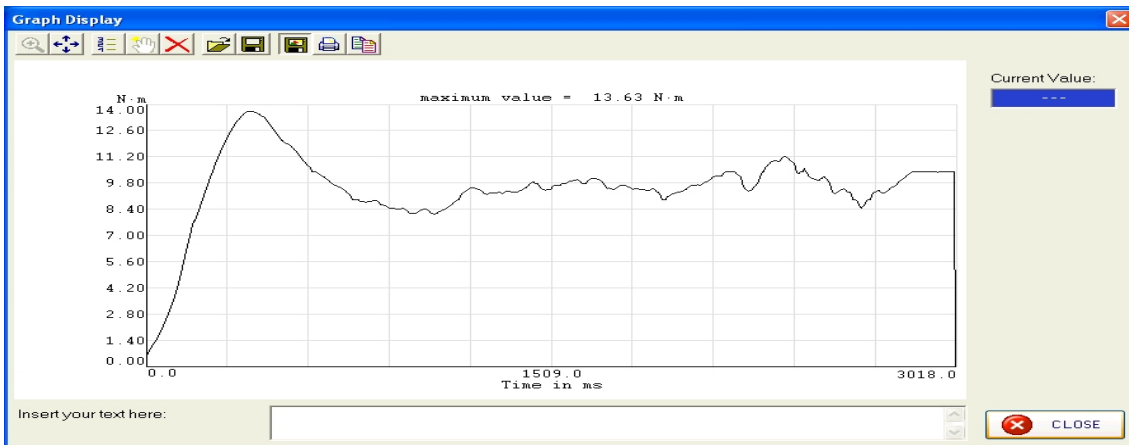
FIGURE 16. 10B21 Zn M6x30

On the contrary figure 16 shows significantly higher value in opening the screw and also friction during the whole test is visible. Performance varies a lot from the other screws in the test being much worse compared to the other tested screws.
