Renovation of Buildings with Timber Pile Foundations in Europe

Master Thesis

Construction and Real Estate Management

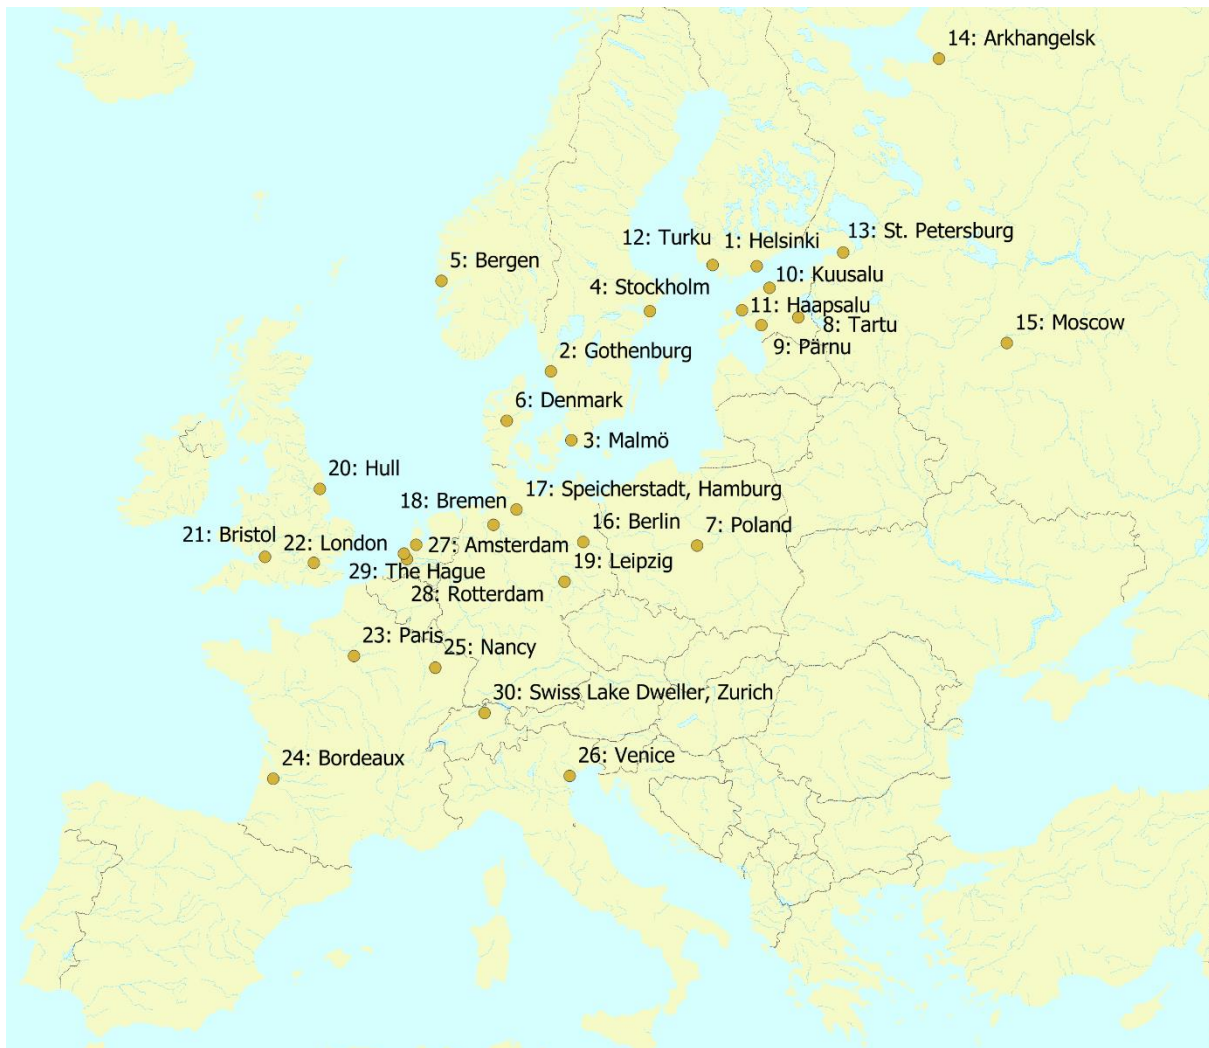
Figure 6 Locations of wooden pile foundations for buildings in Europe

There is no systematic database for wooden foundation piles in entire Europe but nevertheless, the usage of wooden foundations is widespread. (Klaassen & Creemers, 2012) The map in Figure 6 shows locations of known wooden pile foundations used under buildings and show the city and geographic location in Europe.

Location Index in Figure 6	Reference
1 – 11, 13-29	(Klaassen & Creemers, 2012)
12	(Lehtonen et al., 2010; SSAB, 2017)
26	(KÖPPL, 2012)
30	(Keller & Lee, 1866)
31	(Jovanovic, 2002)

Table 1 Reference for indexed pile locations in Figure 6

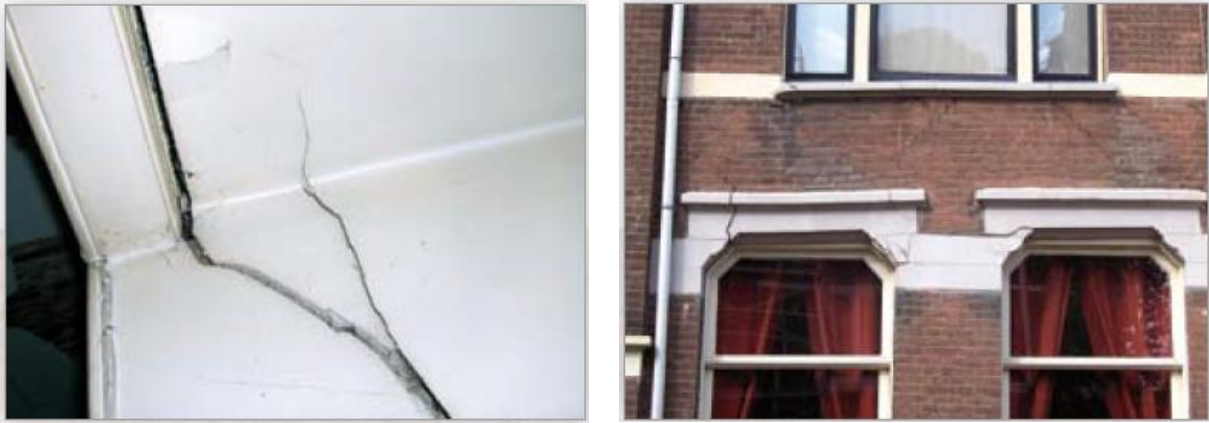
Figure 11 Pictures showing cracks on the inside and outside of the building (VROM, n.d.)

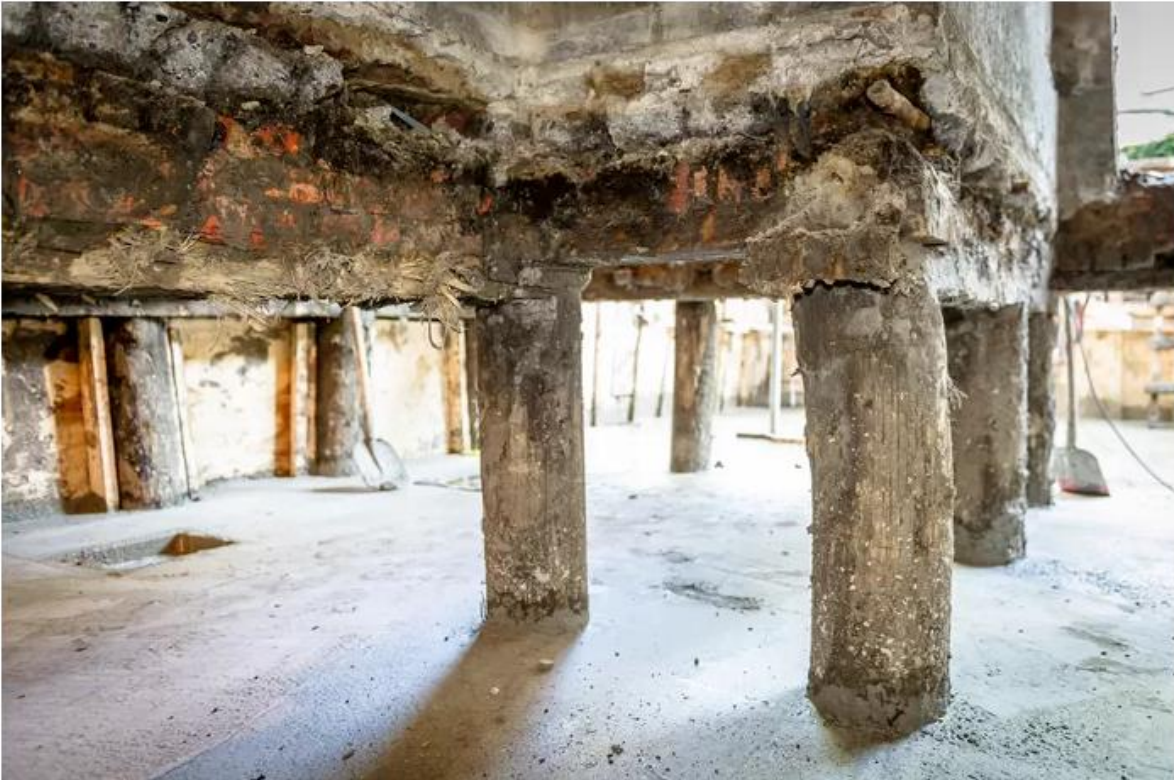
Figure 13 Photo of a rotten exposed wooden foundation in need of repair (Algemeen Dagblad, 2020)

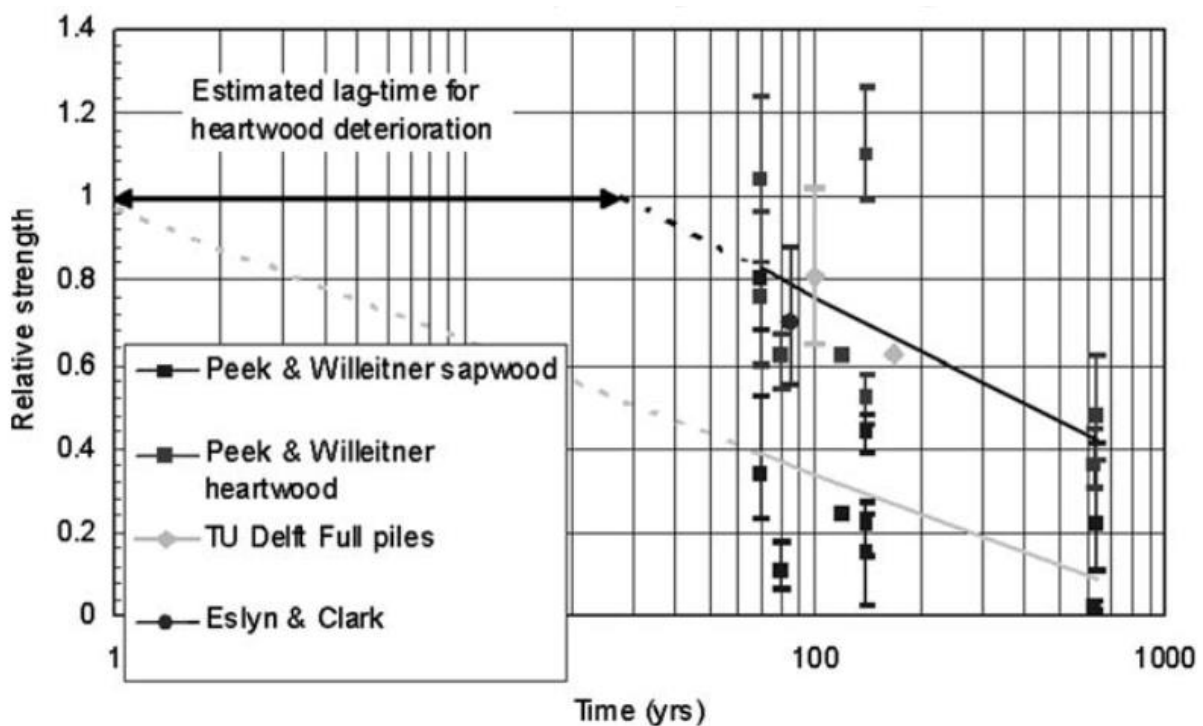
Figure 15 Change of wooden pile strength as a function of time (van de Kuilen, 2007)

its residual strength. Figure 15 indicates the decrease of wooden pile strength over time. The strength at relative strength = 1 is determined from the average strength of new spruce piles in wet conditions, which is 20MPa. The speed of decrease of piles strength over age is assumed to be exponentially decreasing. From the graph, it can be concluded that piles on average have 30% - 40% of their original strength after 100 years of service, while the heartwood can retain about a bit less than 80% of its original strength after 100 years. The whole pile strength half-life¹⁵ can be inferred to be 30 years, while the strength half-life of the heartwood can be as high as 400 years. (van de Kuilen, 2007)

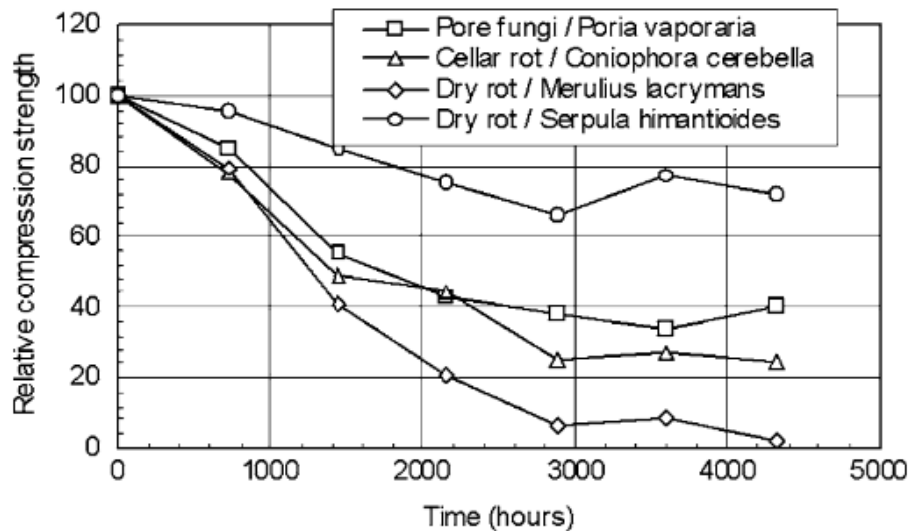
Figure 16 Change of wooden pile strength over time after fungal infection (van de Kuilen, 2007)

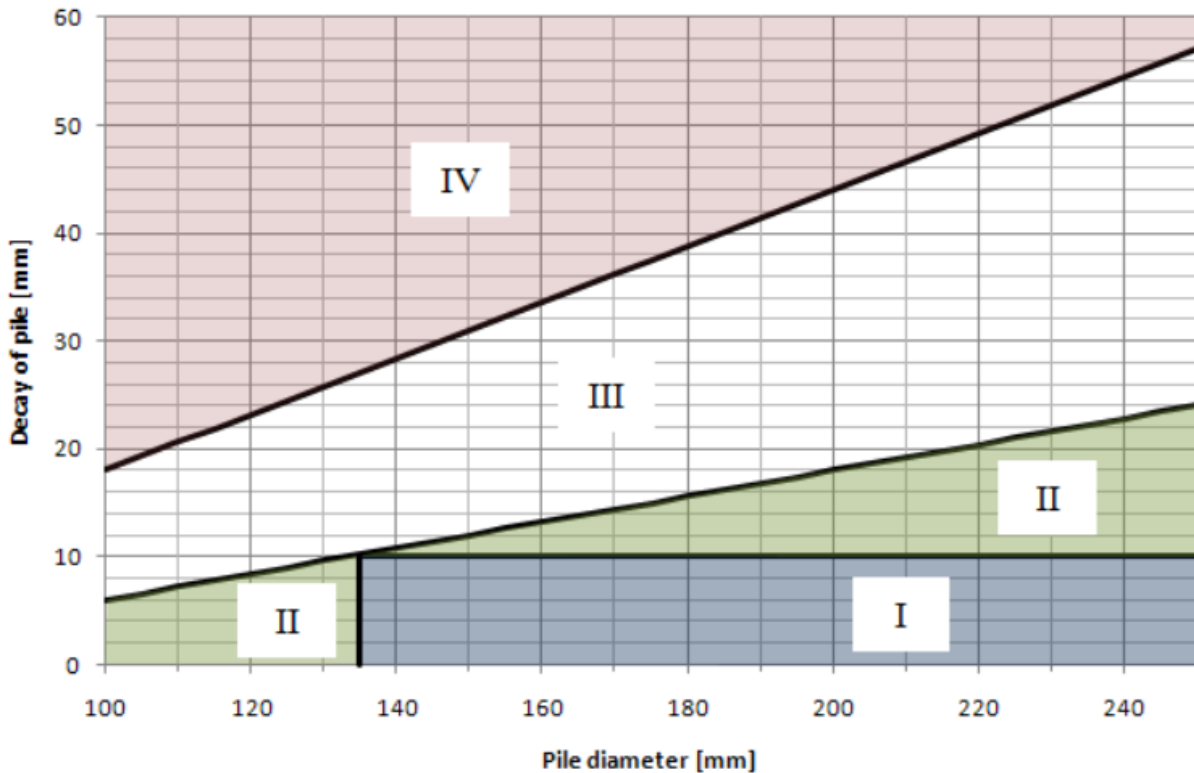
Figure 18 Classification of piles according to extent of decay of pile and pile diameter (Lehtonen et al., 2010; Stichting Platform Fundering, 2006)

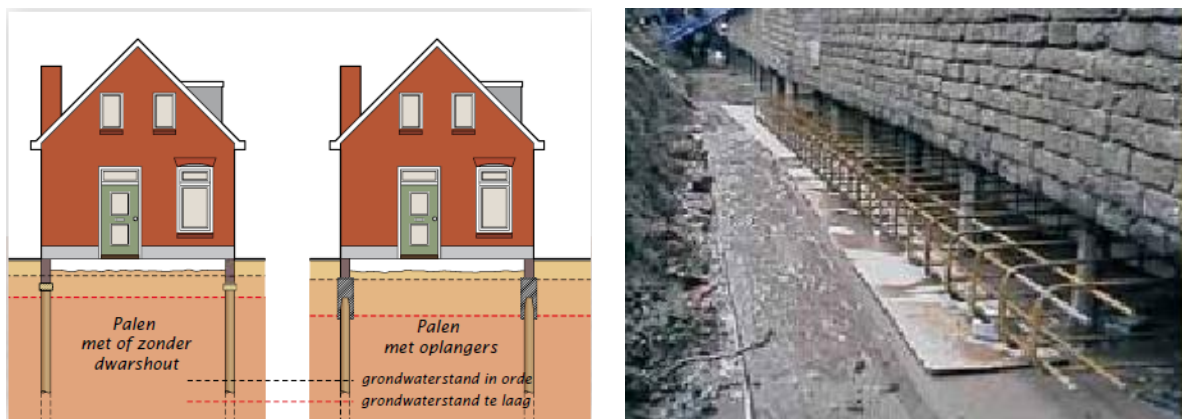
Figure 19 Left: buildings on wooden piles before and after pile head lowering; right: reinforcement of underpinning concrete structure ready to be cast (Photo: CJ Smith) (van Etten et al., 2007; VROM, n.d.)

For this repair method to work there are a few preconditions: 1) the correct pile must be founded on a firm load-bearing sand layer (standing pile); on soft cohesive soil, the foundation would experience unacceptable settlement. 2) Only the top part of the pile is damaged as a result of fungal infection. 3) the infected pile is of spruce and not pine wood, as pinewood piles are also susceptible to bacterial attack even under the pile head. Also, this method does not raise the allowable bearing capacity of the foundation, other methods must be used for that purpose. (van Etten et al., 2007)

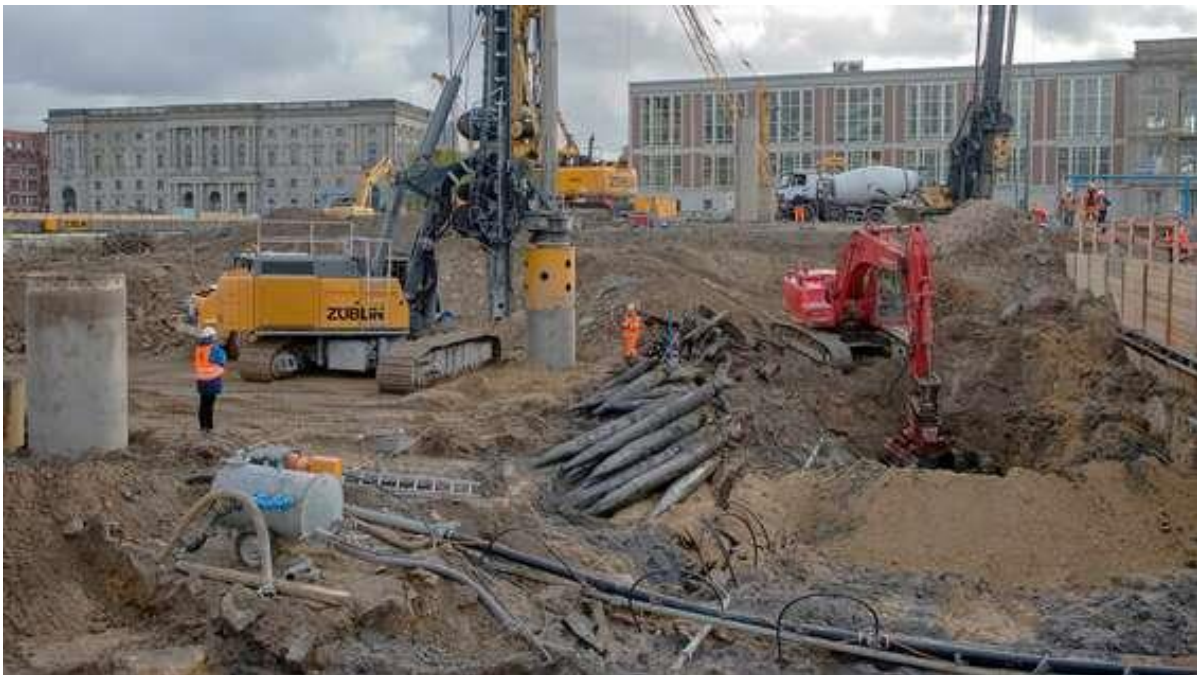
Figure 28 Removal of historical wooden piles in the Berliner Schloss site (Loy, 2012)

Before the foundation of the Humboldt Forum was laid, about 3000 historical pine and oak piles, up to 10 meters long were pulled out and transported away for recycling. According to reports, the piles that were dug up were all well preserved by the groundwater and the anaerobic soil conditions. The piles have been petrified over the years under these conditions. This protects the pile against rotting even better. (Loy, 2012)
