ANALYSIS OF A HYDROPHOBIC COATING AS PASSIVE ANTI-ICE  
SOLUTION FOR WIND TURBINES

Bachelor's thesis 2013

Kymenlaakso University of Applied Sciences,  
RENEWTECH project

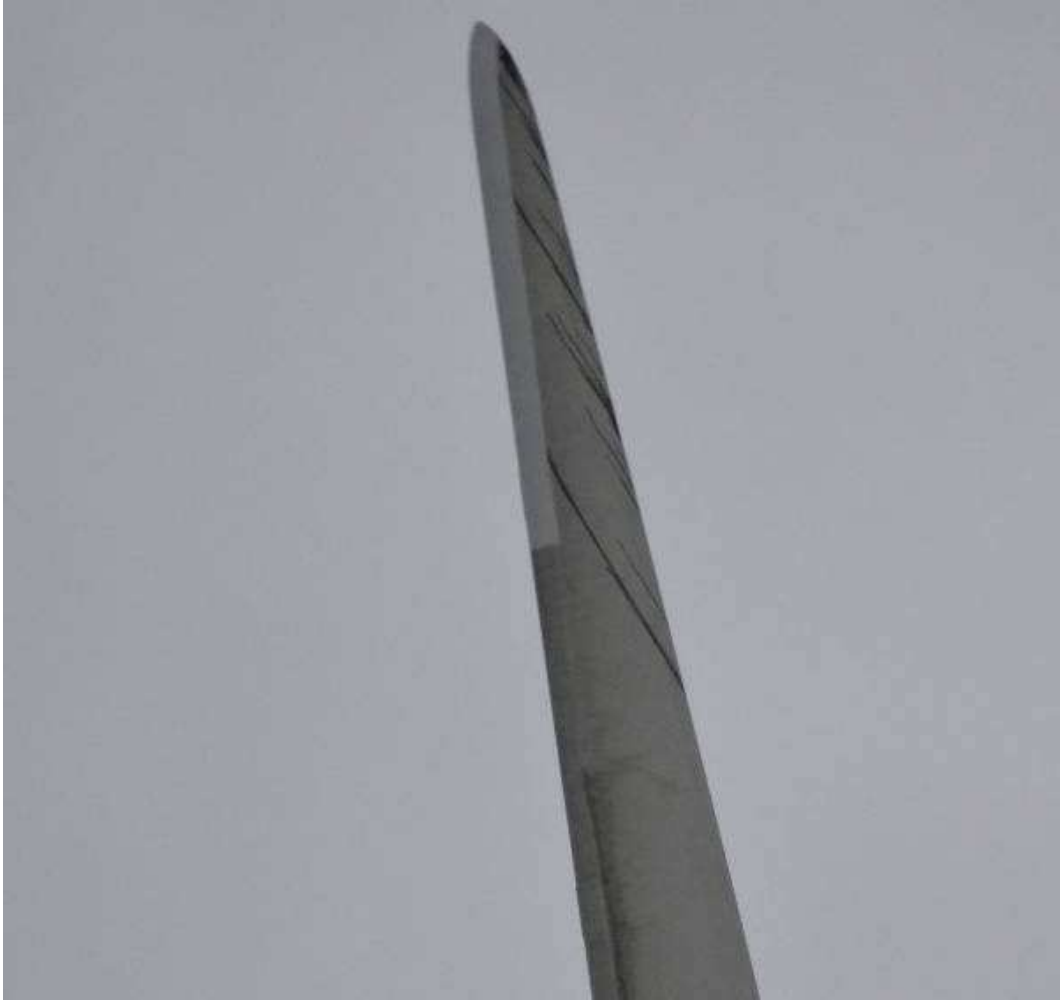
*Picture 1. Newly coated area clearly visible. Note heavy blade pollution.*

The blades were extensively polluted with gear oil leaking from the nacelle and dirt. The gear oil leakage was explained to be caused by gaskets not designed for low viscosity oils suitable for low temperature application.

Preparation of the coating area on blade 1 consisted of thoroughly wiping with acetone drenched cloths, abrasion with an excenter sander using 120-grit sanding paper and then wiping all dust off with xylene wipes. After that, the area was allowed to dry completely before coating.

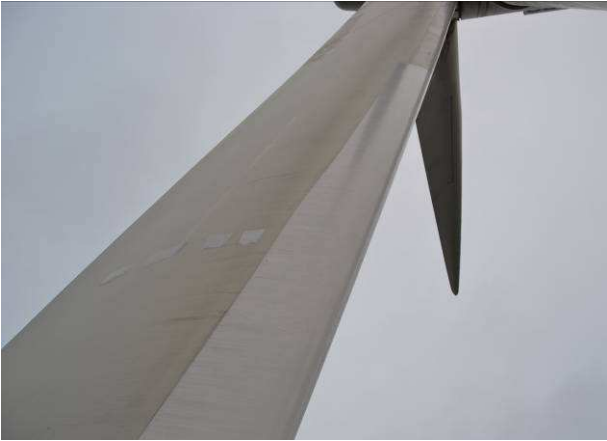
*Picture 2. Test area around leading edge. Semi-gloss surface.*

The finish of the coating showed facile horizontal brush strokes and a slightly mottled surface, where the roller finish had been left. From the brush stroke finish, the thin layer of grime and dust that had accumulated since coating could be wiped away with a dry cloth easily. Concluding from this phenomenon, self-cleaning properties of the coating could be diagnosed. This was in clear contrast to the original gelcoat surface, which would not wipe clean without the use of detergents. Only the unevenness of those parts of the test areas that had a mottled surface from roller distribution made them more difficult to clean.

Furthermore, the finish of the coating could be described as semi-gloss. The hydrophobic properties were obvious, as rainwater running down the blades transformed into beads upon coming up against the newly coated surface, whereas it was forming a film on the original uncoated surface.

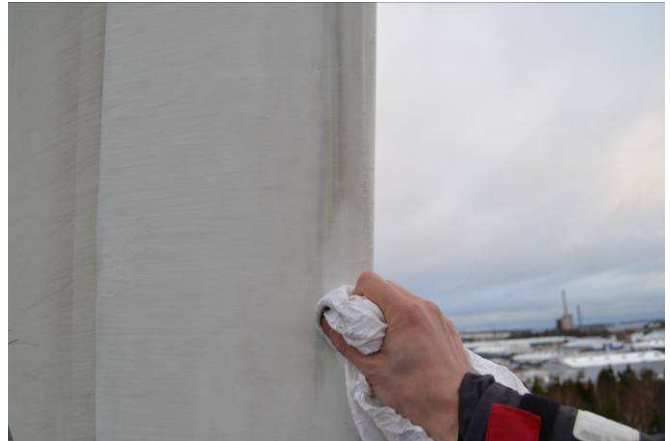
*Picture 3. Good surface cleanability.*

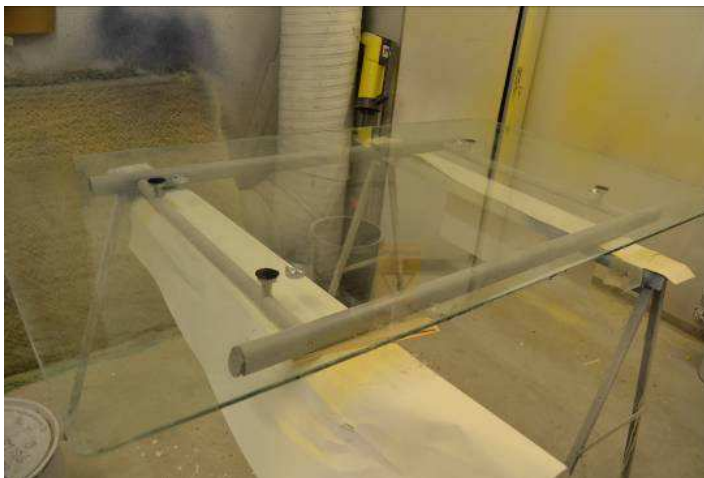
Picture 4. Glass table ready for coating.

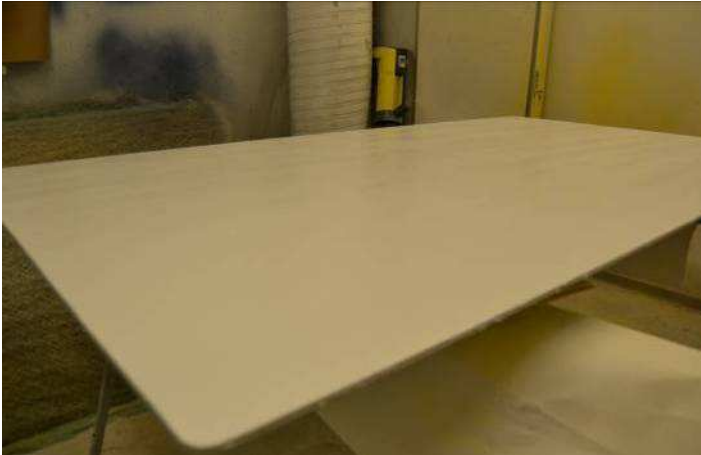
*Picture 5. Gelcoat painted.*

On September 25<sup>th</sup>, 2012, two layers of gelcoat (Crystic 65Pa, a general purpose osmosis resistant isophthalic gelcoat) were applied with a roller to the table surface. Wet layer thickness was 560 microns and an amount of 990 grams of gelcoat had been used, leaving cup residues out of count. After 24 hours of curing, five layers of 650 g/m<sup>2</sup> CSM (Chopped strand mat) glass fibre mats followed in hand lay up, impregnated by 6.2 kg of polyester resin and MEKP -catalyst in total.

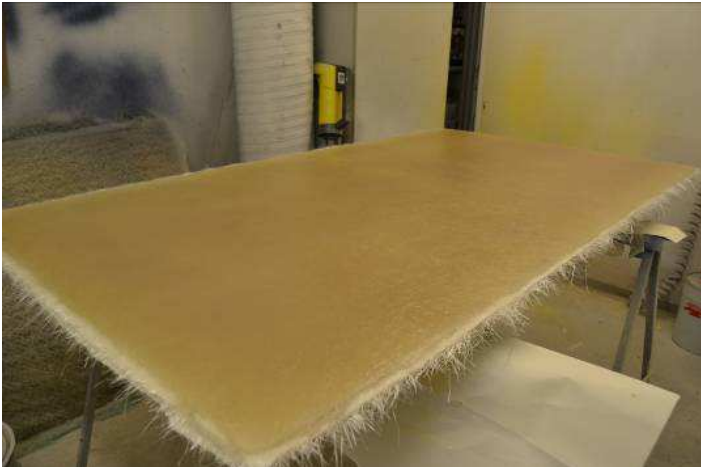
*Picture 6. Test panel laminated.*

The test panel reached a total of 11.9 kg in weight and 5.5 mm in thickness.

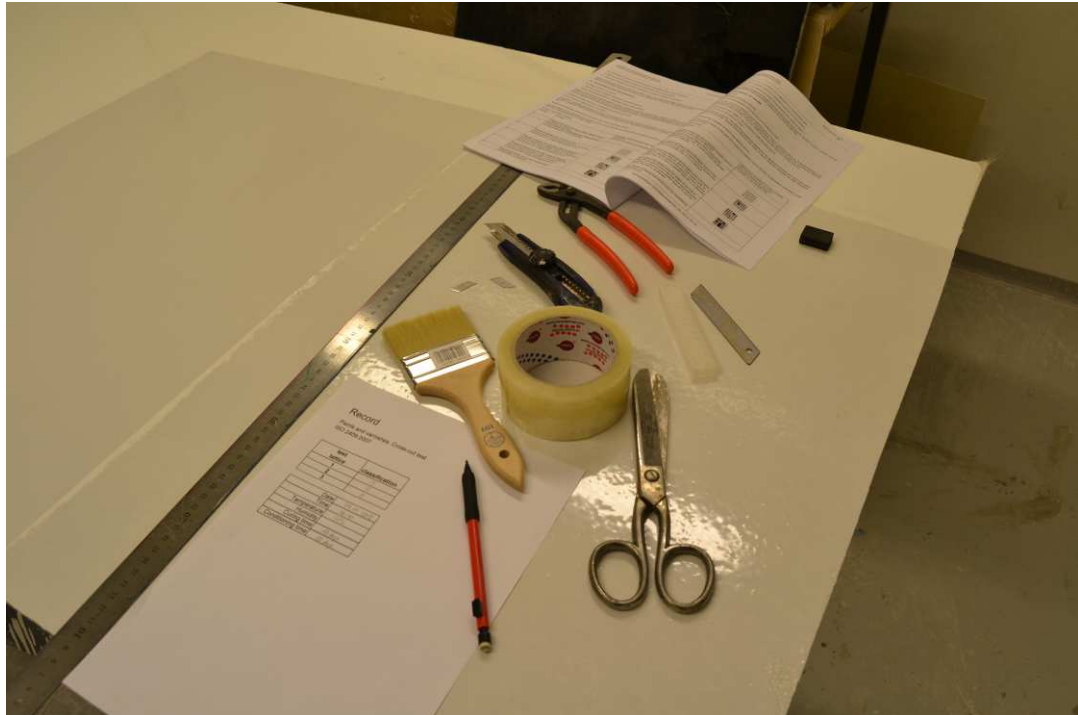
Picture 10. Apparatus and materials used for cross-cut testing.

1. A single-blade cutting tool. In this case a common cutter.
2. A metal ruler for marking distances between cuts and serving as guiding edge.
3. A soft brush.
4. Transparent pressure-sensitive adhesive tape, 50 mm wide. ISO 2409:2007 specifies tape with an adhesive strength between 6 N per 25 mm width and 10 N per 25 mm width. An Eurocel Sicad carton sealing tape was chosen for this test, however no information could be found which tape it was exactly. The adhesive strength of most transparent

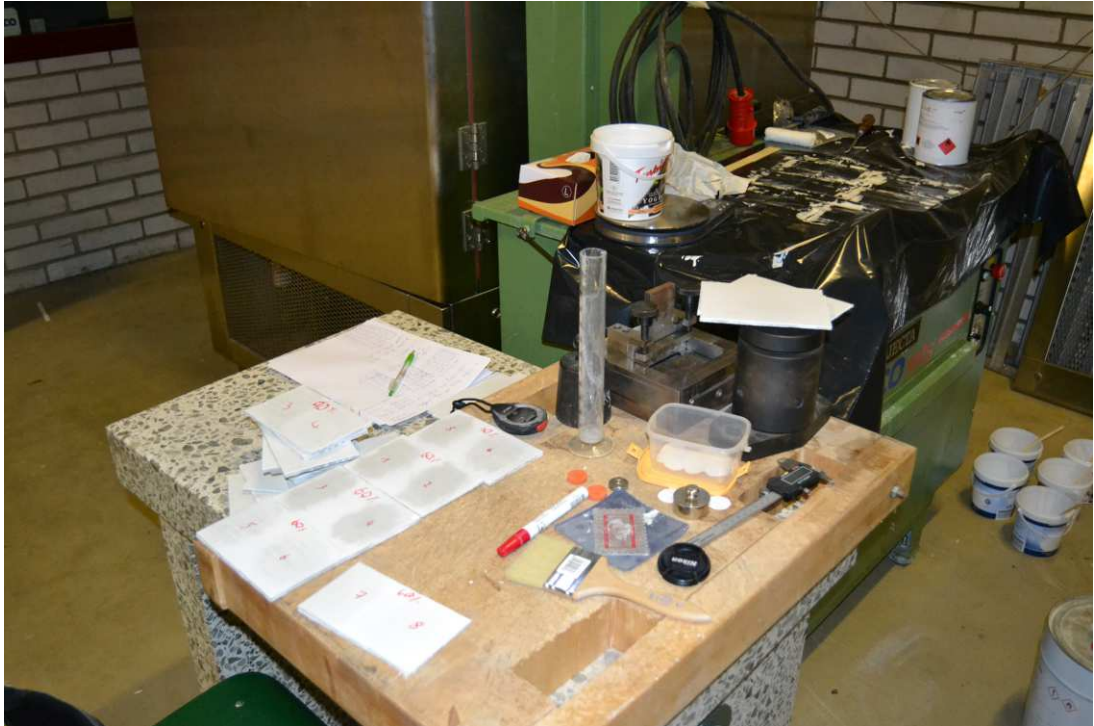
Picture 15. Drying speeds test setup

5. Weights of 20 g, 200 g, 2 kg and 20 kg.
6. A stopwatch.
7. A glass tube.
8. An Arctest ARC-1500 environmental test chamber.

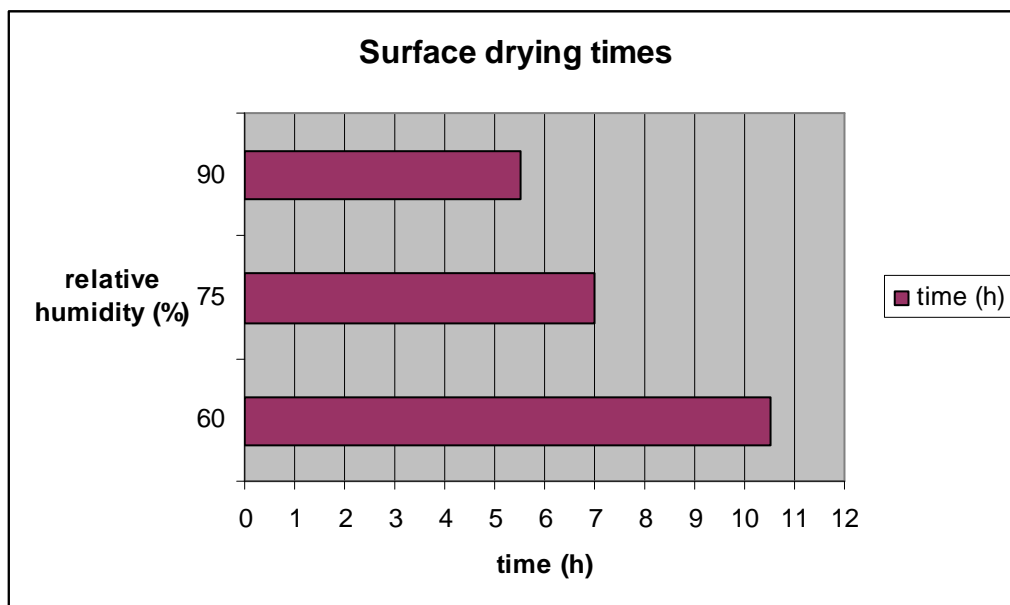
The diagram below shows the surface drying times of NWE SALES Nordic Anti-Friction Silane at a constant temperature of 20° Celsius and relative humidity of 60 %, 75 % and 90 %.

Diagram 7. Surface drying times

Progress of the drying tests had been consistent and the results were plausible.

Surface drying speed tests provided predictable results in terms of the effect of humidity on curing times and furthermore specified concrete drying times of the coating for different percentages of humidity at a constant temperature.
