# Environmental Sustainability of Water Supply Systems Implemented at RWSSP-WN

Helsinki Metropolia University of Applied Sciences

Degree : Bachelor of Engineering (B Eng.)

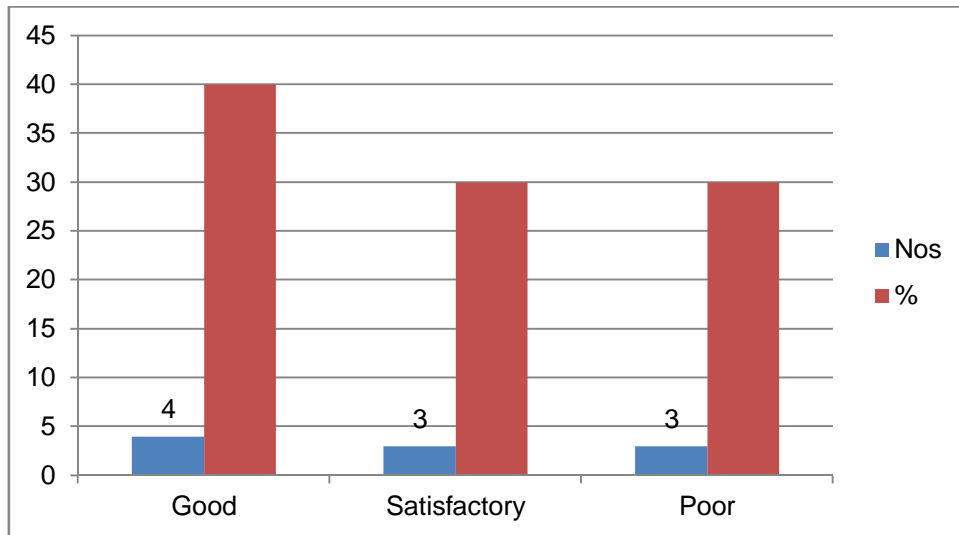
The sanitary conditions surrounding the water source of 10 selected scheme was evaluated and it was found that four schemes had good sanitary conditions,3 schemes had

satisfactory sanitary conditions and 3 schemes had poor sanitary conditions surrounding the source(Figure 3).

**Figure 3. Sanitary conditions of the selected schemes**

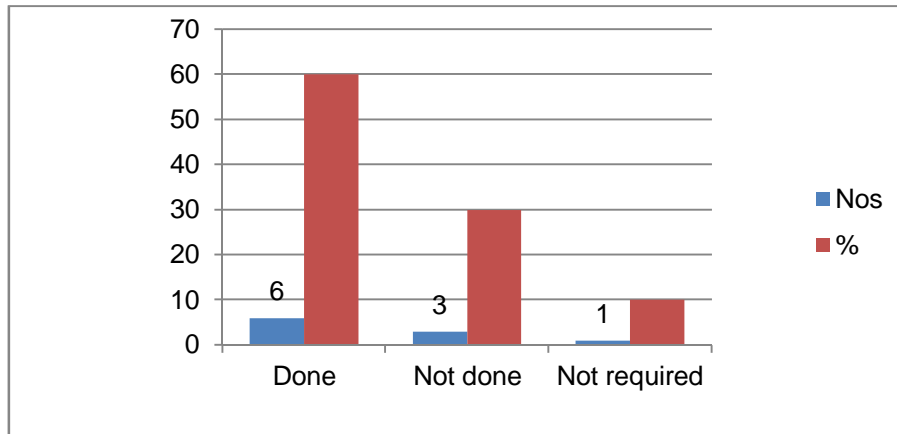
During the thesis project, it was found that source protection had been done properly in six schemes and that source protection had not been properly carried out in three schemes. It was also reported that such protection work was not required in one of the scheme. This means there was no possibility of environmental threats in that scheme. Figure 4 shows the source protection measure taken around the source.

**Figure 4. Source protection measure taken of the selected scheme**

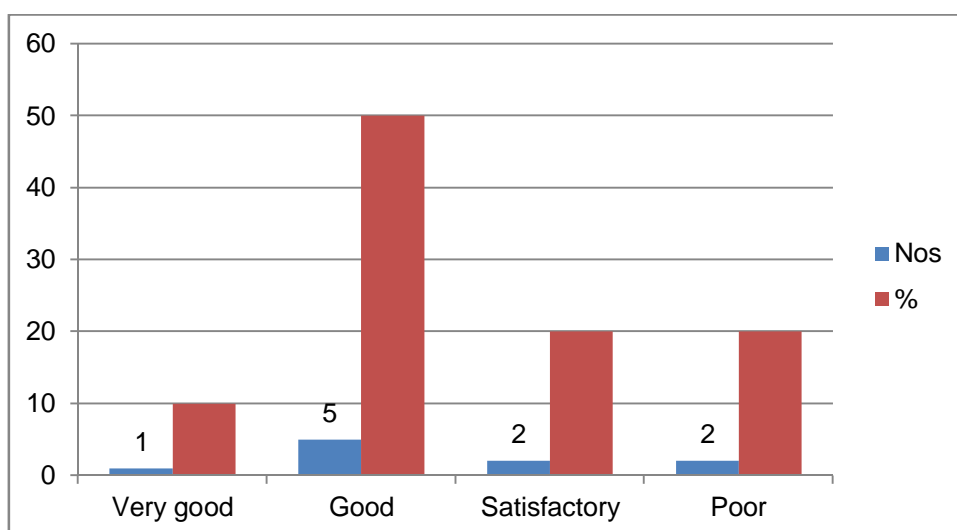
The technology used in most of the scheme was appropriate for the scheme area. However, there were some complaints from people of scheme area with respect to selection of technology. For example, Intake design for those schemes which were affected by lime should have been done in a different way, which could increase the sustainability of the schemes. It was also found that, after the construction of the schemes, many people in the community had become more knowledgeable about the technical options and the operation of the scheme. Figure 5 explains the quality of construction of selected schemes.

**Figure 5. Quality of the constructions of selected schemes**

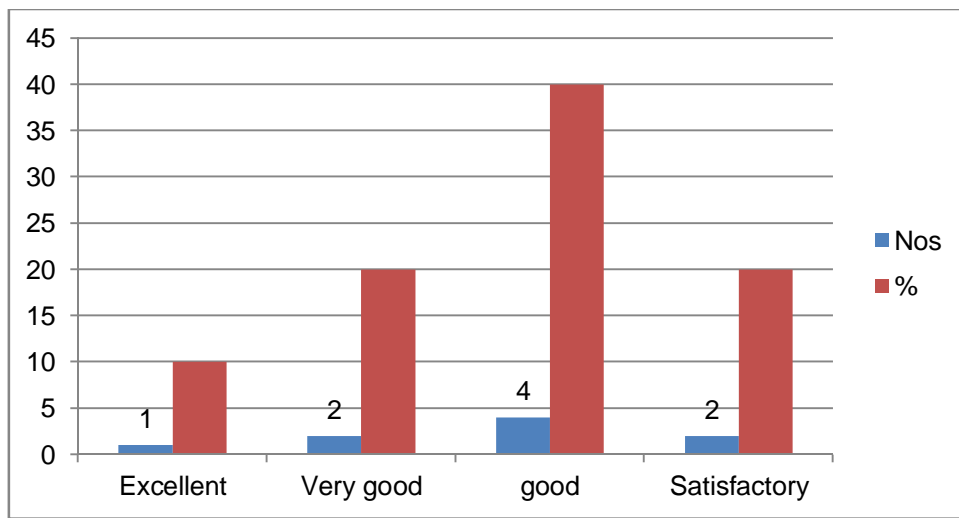
During the study, it was found that in two schemes, there was excellent operational status, two schemes had very good operational status and four schemes had good operational status. And it was also noted that two schemes had satisfactory operational status. See further information on appendices. Figure 6 shows the operational status of the water systems.

**Figure 6. Operational status of the water supply system**

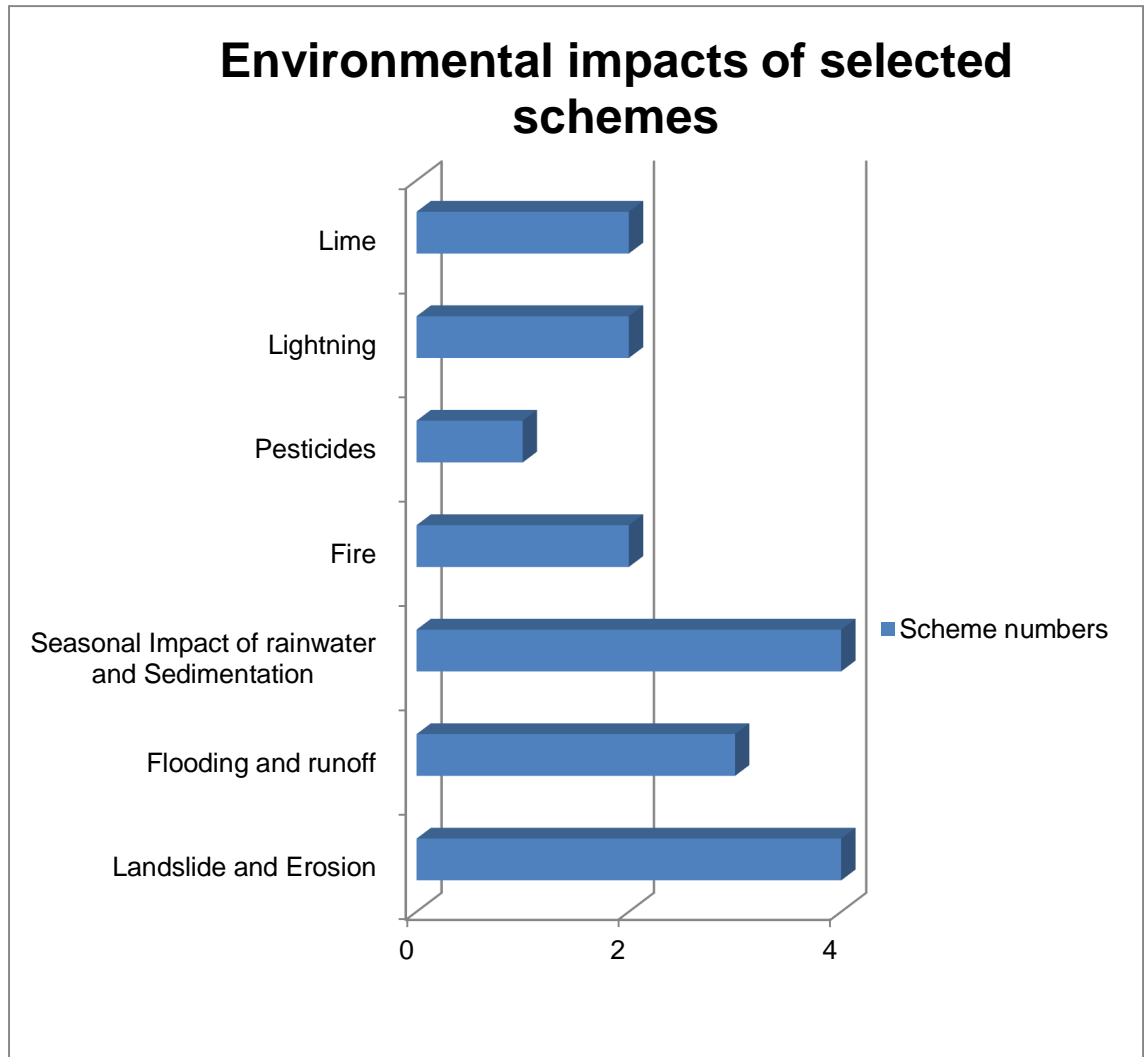
As it is explained in earlier chapter 4.2, Figure 9 illustrates the environmental impacts in sample scheme. During the field visit, it is noted that in two schemes have possible lime, fire and lightening problems. Similarly one scheme had pesticides problems. And four schemes have possible landslide and erosion and seasonal impacts of rainwater and sedimentation.

**Figure 9. Chart showing the environmental impacts of selected schemes**

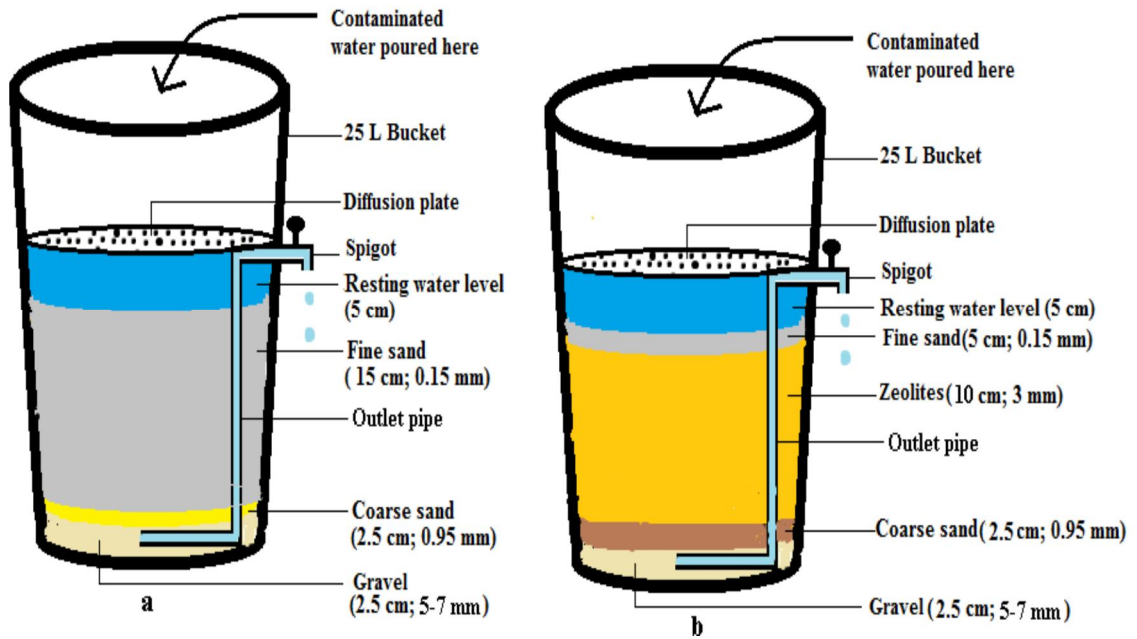
Figure 11 shows the typical structure of Biosand Filters. In Figure b, zeolite has been used, and in Figure a, fine sand has been used.

Figure 11. Biosandfilters. (Socelyre et al, 2012)

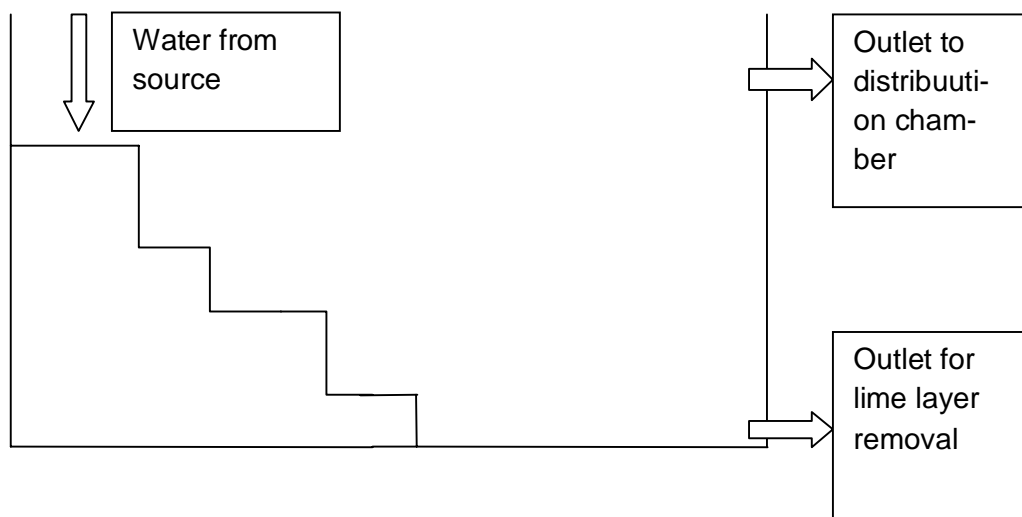
In aeration method, lime is reacted with oxygen, and the resulting layer will be sediment in a tank (Lindedahl, 2013). Then lime will be removed by cleaning the intake every month depending upon the lime quantity. Figure 12 shows the typical method of removing lime from the water supply.

Figure 12. Typical method to remove lime from water supply systems

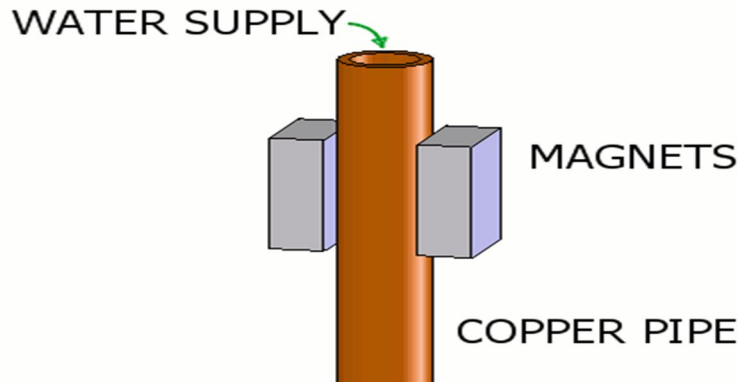
Another method to remove the lime is by using a magnet. In this method water is passed through a magnetic field. With this method Lime scale will be reduced. Typical method of this technology has been shown in figure bellow. (Gabielli et al, 2001)

Figure 13. Typical method to remove the lime using magnet. (K&J Magnetics, n.d.)

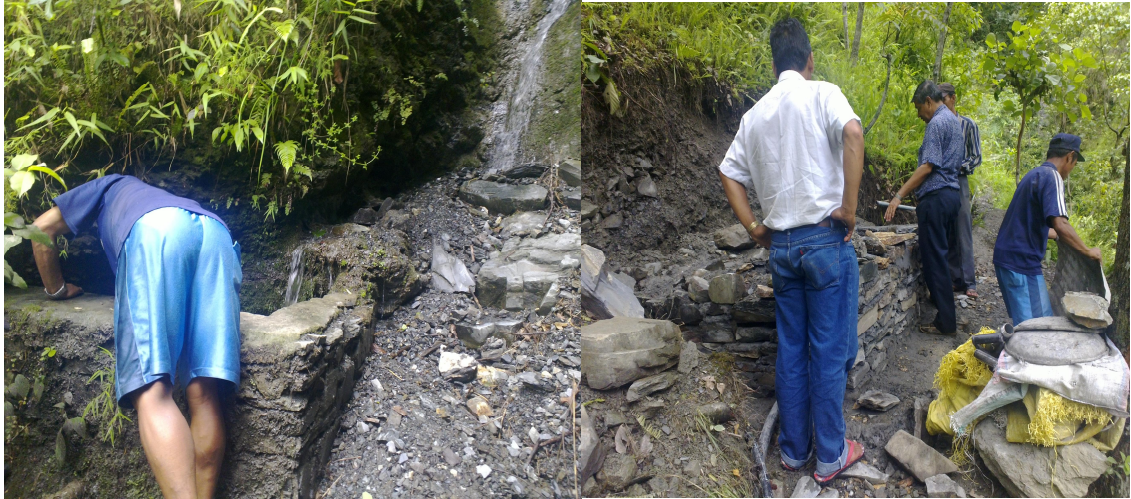
**Photo 1:** Source Tapping Point near landslide area  
construction, sliding area observed

**Photo 2:** Intake under

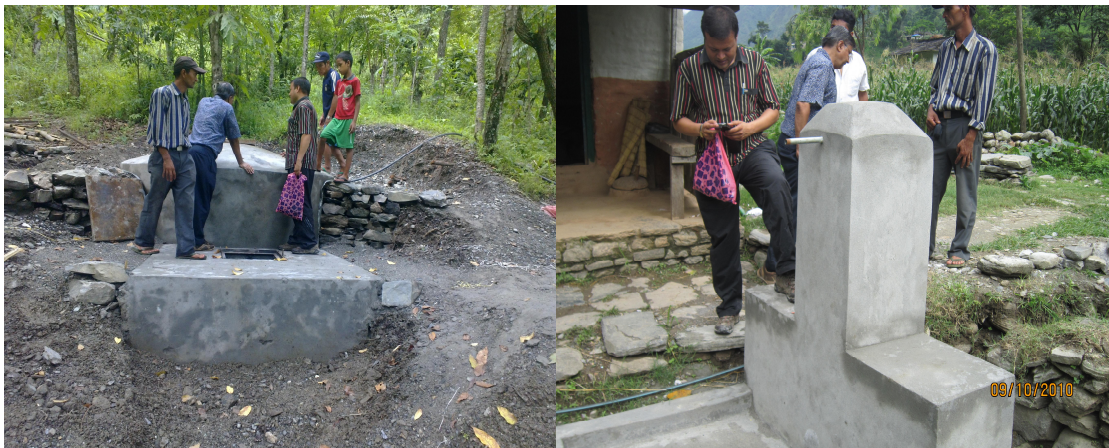
**Photo 3:** View of RVT, Fencing to be completed  
connection to be provided

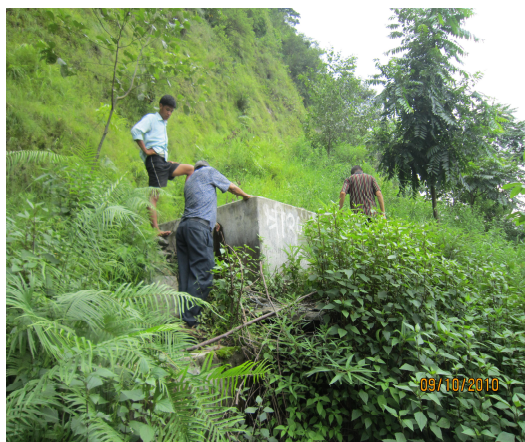
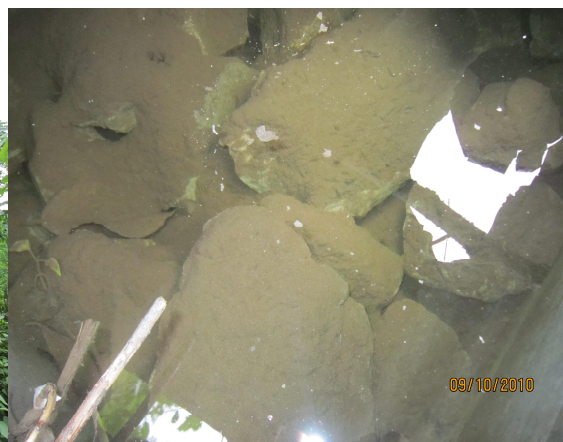
**Photo 1:** View of Intake and catchment Area  
take; cleaning work needed

**Photo 2:** View inside In-

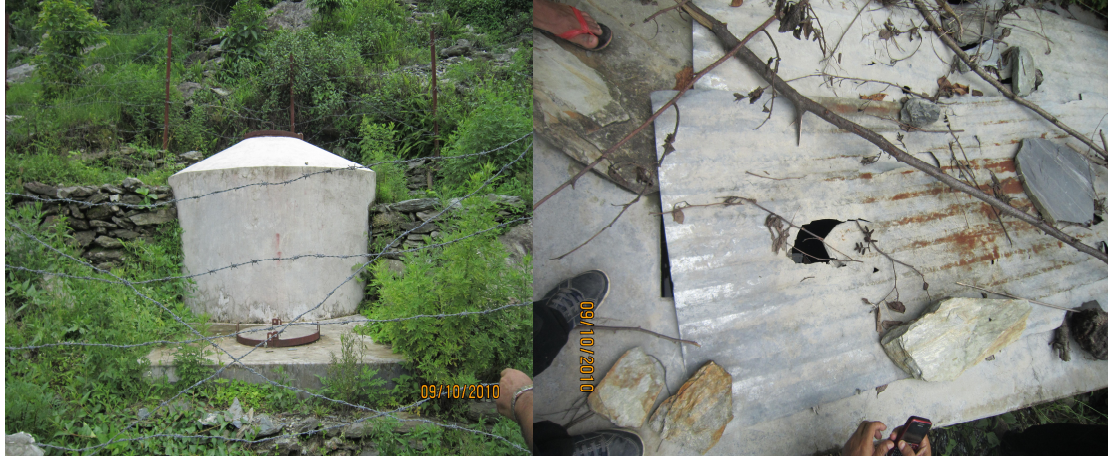
**Photo 3:** View of RVT; regular cleaning needed  
cover; need to be changed

**Photo 4:** View of Intake

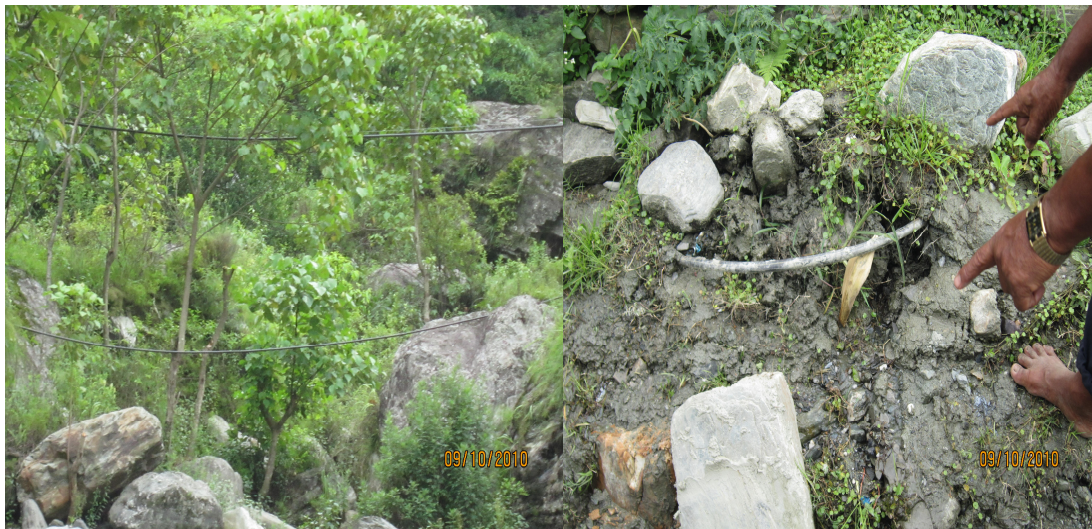
**Photo 5:** HDP pipe at crossing, needs proper support  
village road; to be properly covered

**Photo 6:** Exposed pipe at

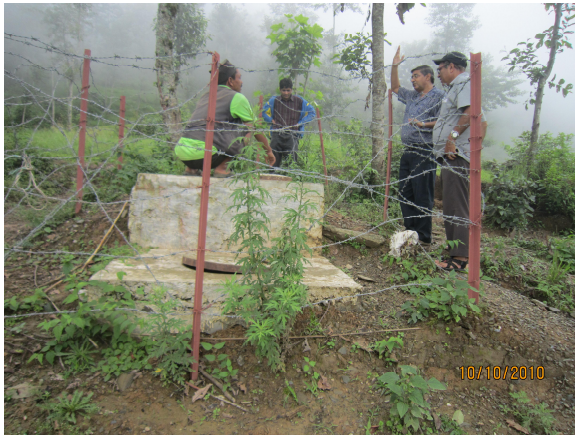
**Photo 3:** View of DC; Manhole cover properly fixed  
RVT; cleaning work needed

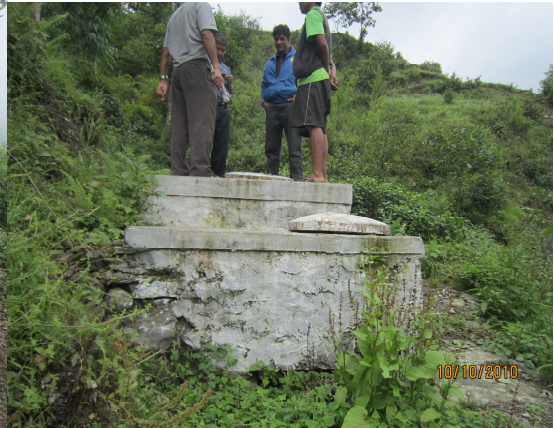
**Photo 4:** View of RVT; cleaning work needed

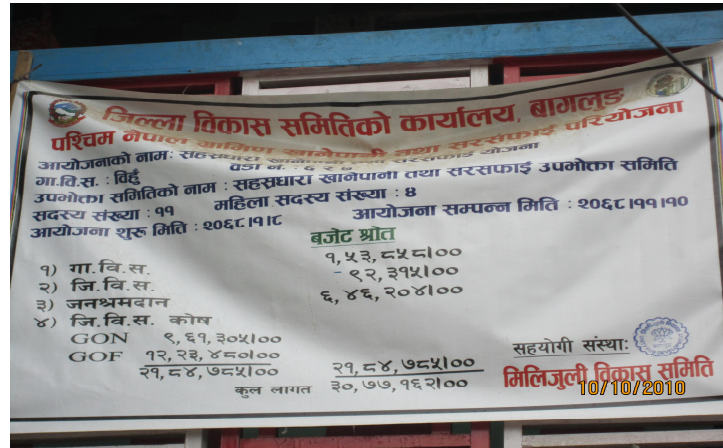
**Photo 5:** Display Board in flex; Need to be prepared in GI sheet for durability

And Information on Technical Details should also be included.

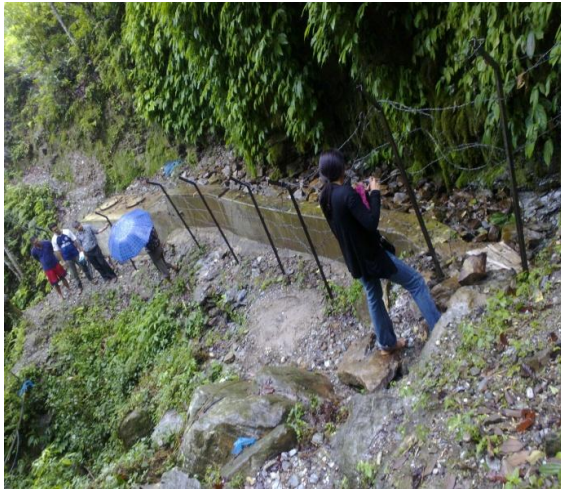
Photo 1: Intake/CC; source to be protected from possible contamination needs proper support/backfilling and cleaning around it

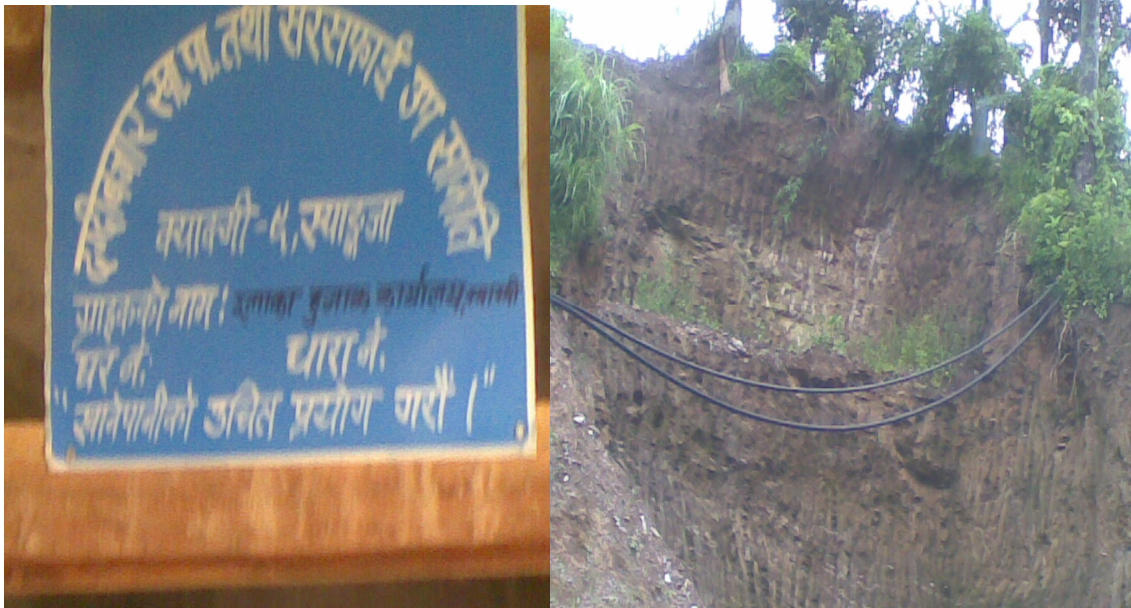
**Photo 5:- Household ID No. (Blue Plate) provided to each HH      Photo 6: Pipe exposed and hang ing at distribution line due to land**

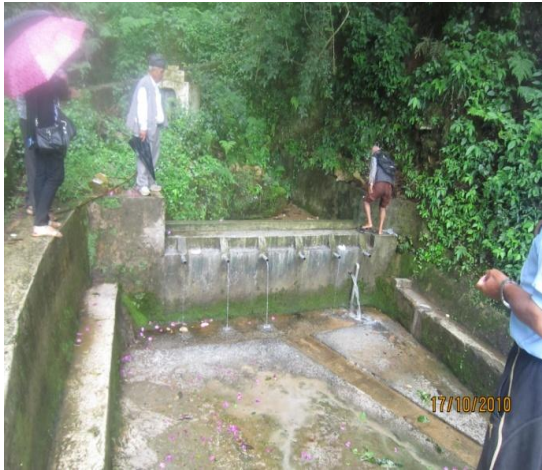
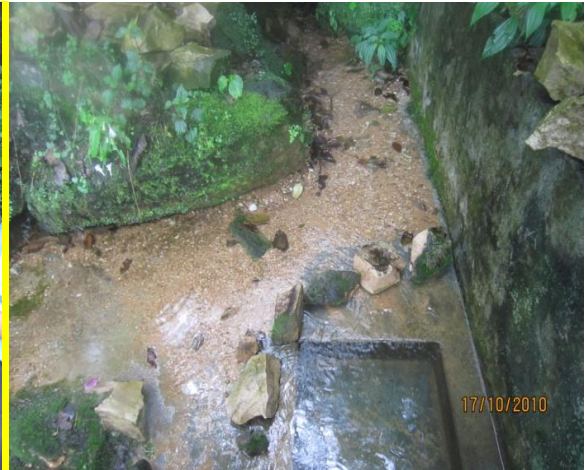
Photo 1: Source/catchment; boulder packing needed at intake

Boulder packing needed area at intake

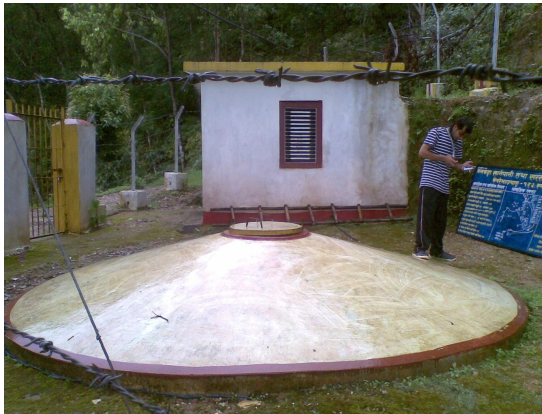
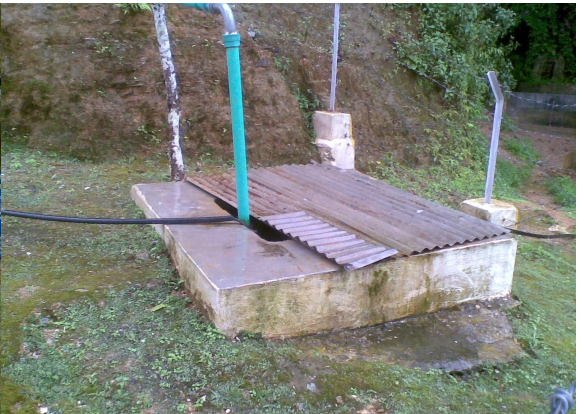
Photo 3: View of 1<sup>st</sup> RVT and Pump House; proper fencing done

Pumping Chamber which needs concrete slab cover for water safety.

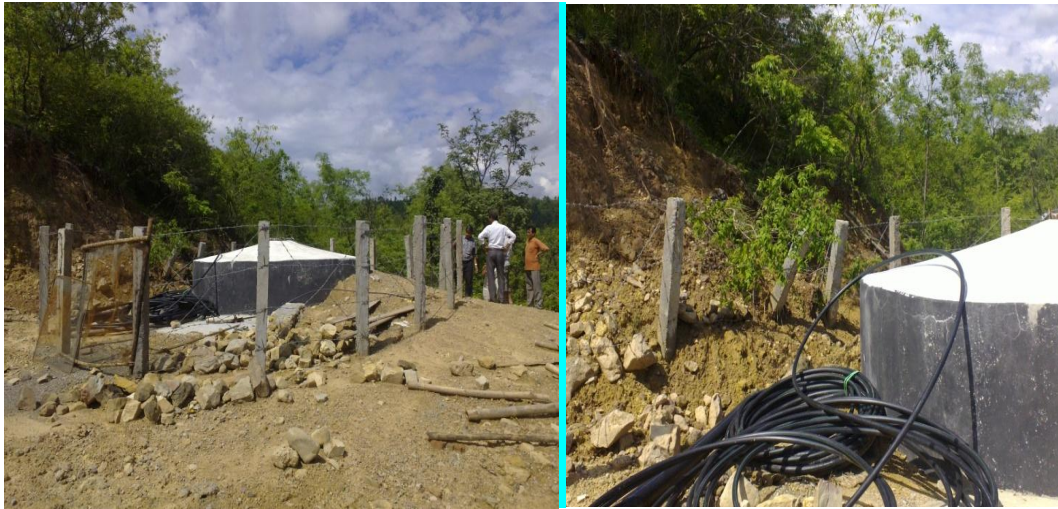
Photo 3:- RVT good workmanship; site clearance and backfilling left      Photo 4: Fencing improvement at north part with protection work (masonry wall) needed to stop sliding.

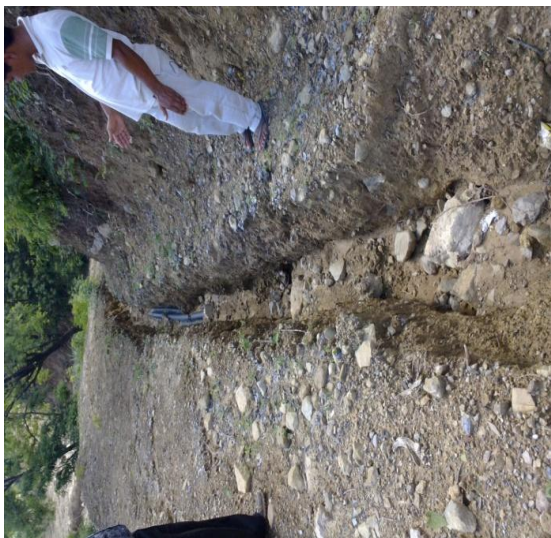
Photo 5: Erosion due to runoff water from hill/drain to be constructed.      Photo 6: Interaction with WUSC Chairperson/users

– Saharsadhara	Intake	Heavy flooding in river may cause the landslide at intake.	Supporting wall has been provided around the source tank.	WUSC has to construct drainage to divert the runoff water from the hill near RVT.

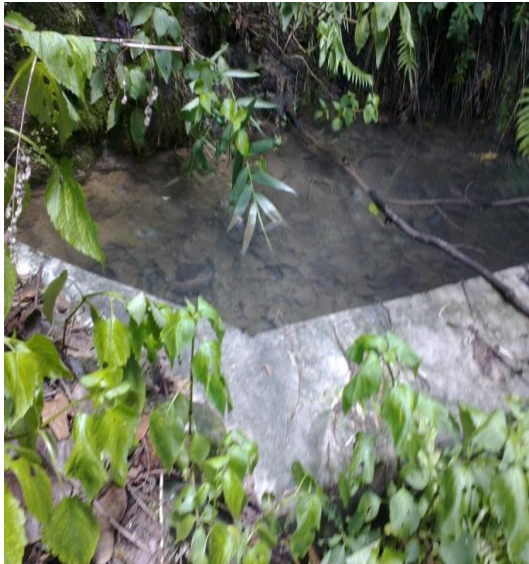
**Photo 1: - Intake structure; needs proper cleaning cleaning and fencing**

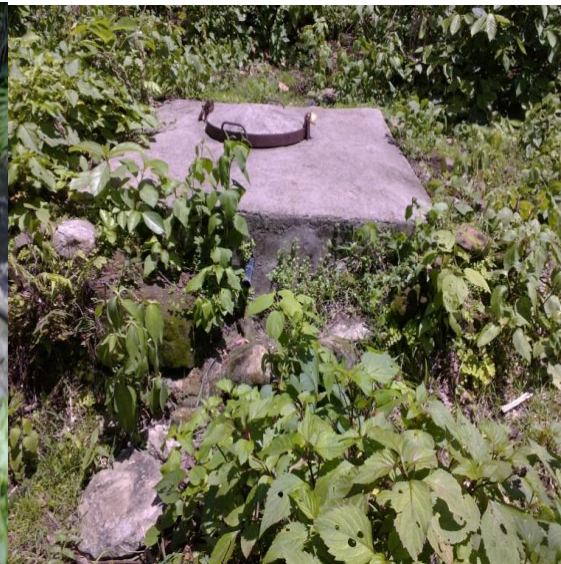
**Photo 2: - collection chamber needs proper**

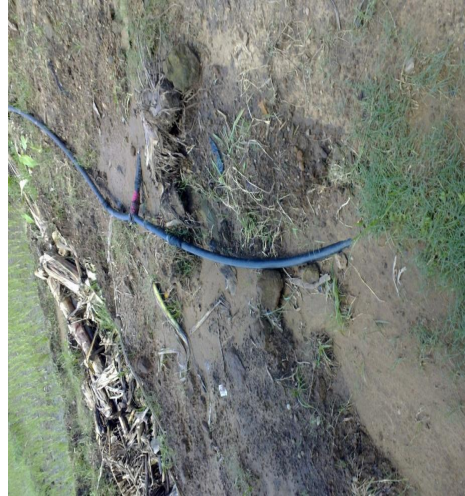
**Photo 5 and 6: Pipelines not buried properly as the users cut and thrash it from time to time to remove lime;**

**Possibility of water contamination observed**

Table 9 shows the schemes where a lime problem was observed. It was also noted that because of lime, the pipelined blocked and schemes almost failed. So it is strongly recommended to use proper technology to get rid of this of problem

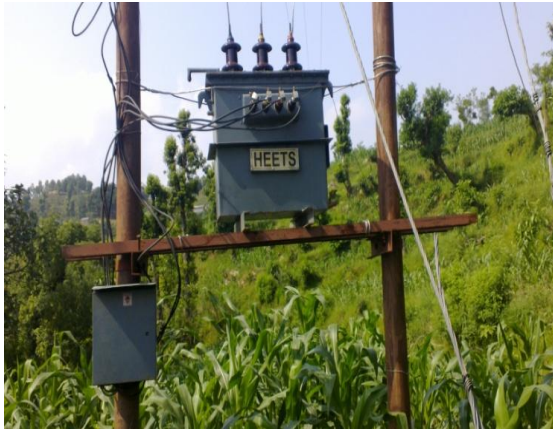
**Photo 1: view of transformer fencing needed**

Nabarjung Water Scheme & Hariyali wa- ter scheme	Transformer	Lightning could damage the transformer which could lead to a failure of the scheme.	Earthing has been done in all possible threat schemes.	Strong lightening arresters need to be connected.
---	-------------	---	--	---

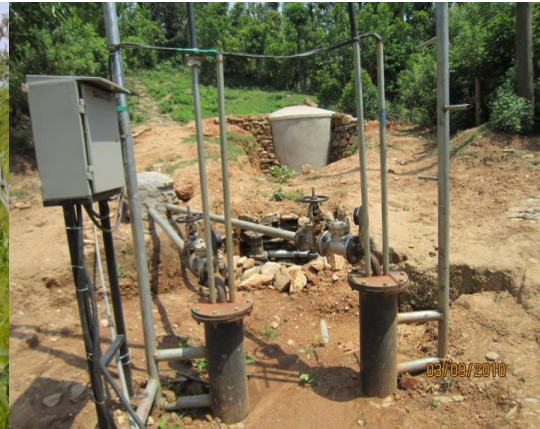
**Photo 2: 2<sup>nd</sup> pumping station, backfilling &**

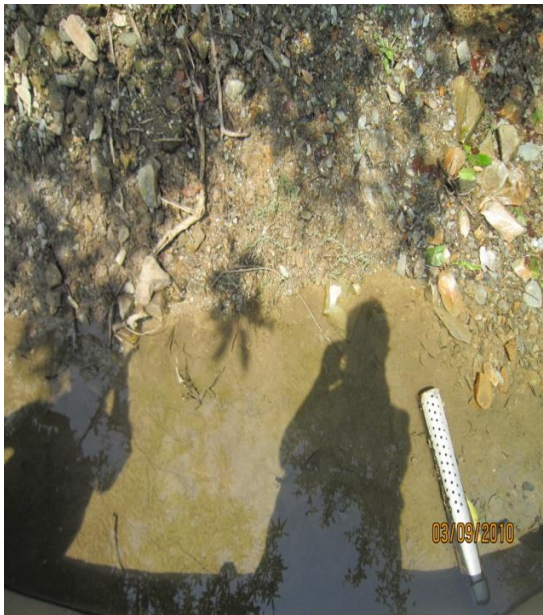
**Photo3: Debris inside intake, cleaning and slab needed changed**

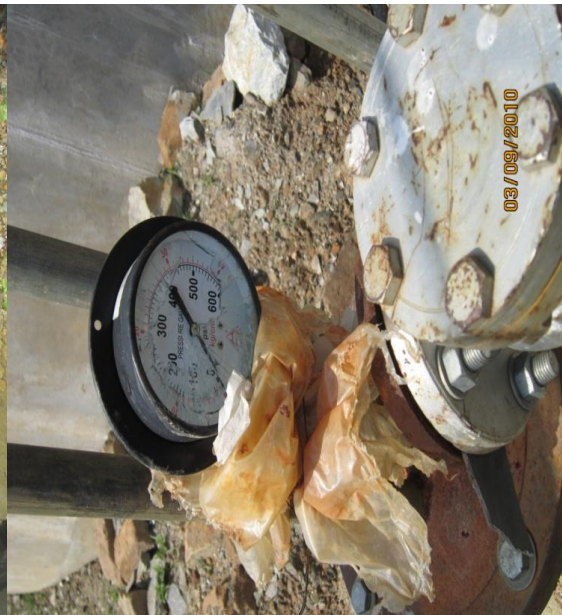
**Photo 4: Broken meter need to be changed**

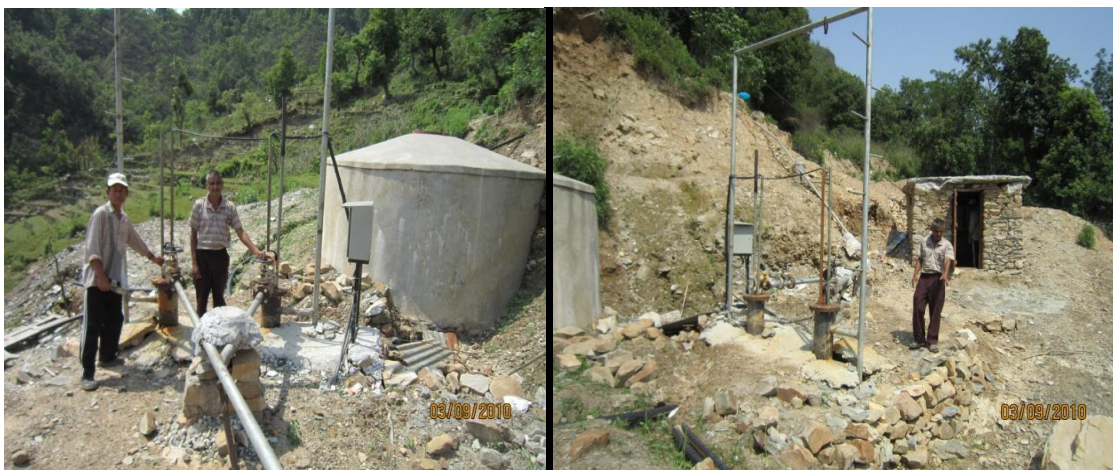
Photo 5: 1<sup>st</sup> pumping station, site clearance and fencing needed due to road construction; protection measure needed.

Photo 6: Sliding near 1<sup>st</sup> pumping station

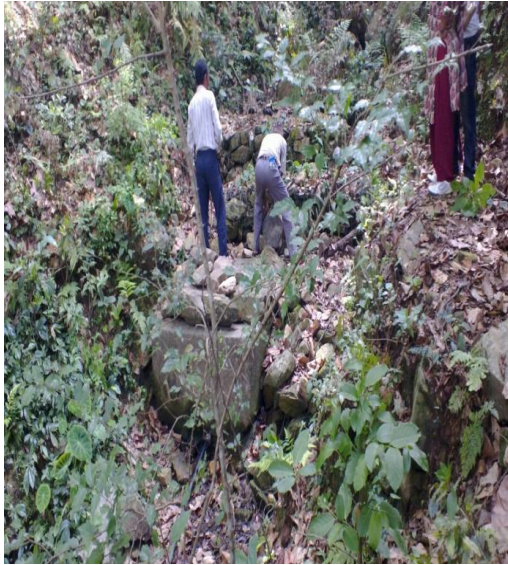
**Photo 1: View of Intake/catchment; fencing needed pipe to be replaced**

**Exposed HDP Pipe at rocky area below Intake**

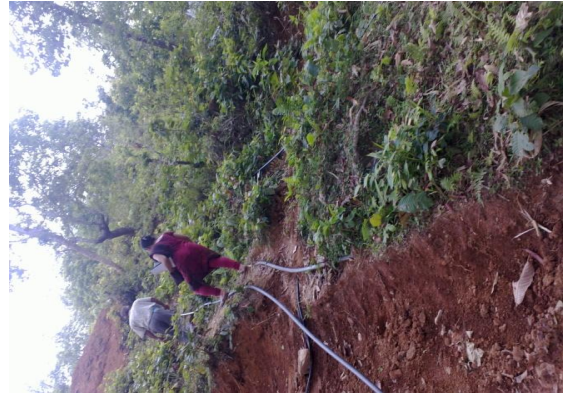
**Photo 5 and 6: Open pipelines at different stretches in distribution system need to be buried at proper depth**
