Leak Detection Systems in Finnish District Heating Net- work

BACHELOR'S THESIS
November 2024

Degree Programme in Building Services Engineering
HVAC Systems

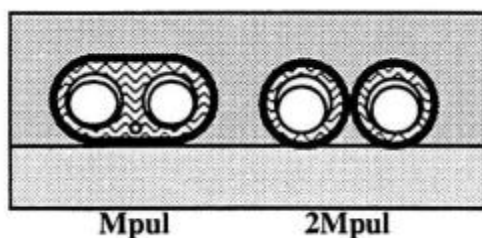
Freely moving plastic-cased district heating pipes, referred to as Mpul pipes, were extensively implemented in Finland's district heating networks from the 1960s until the early 1980s. Mpul pipes typically comprise an insulation element, which may either consist of a casing for two flow pipes or two separate casings, each intended for one flow pipe. The casing is made of plastic and includes polyurethane insulation, with the flow pipes installed freely within the insulated casing as shown in Picture 1. This design allows for improved flexibility and adaptation in varying operational conditions. (Kaukolämpöverkon suunnitelmanllinen perusparantaminen L7/2016)

Picture 1. Freely moving plastic-cased district heating pipes

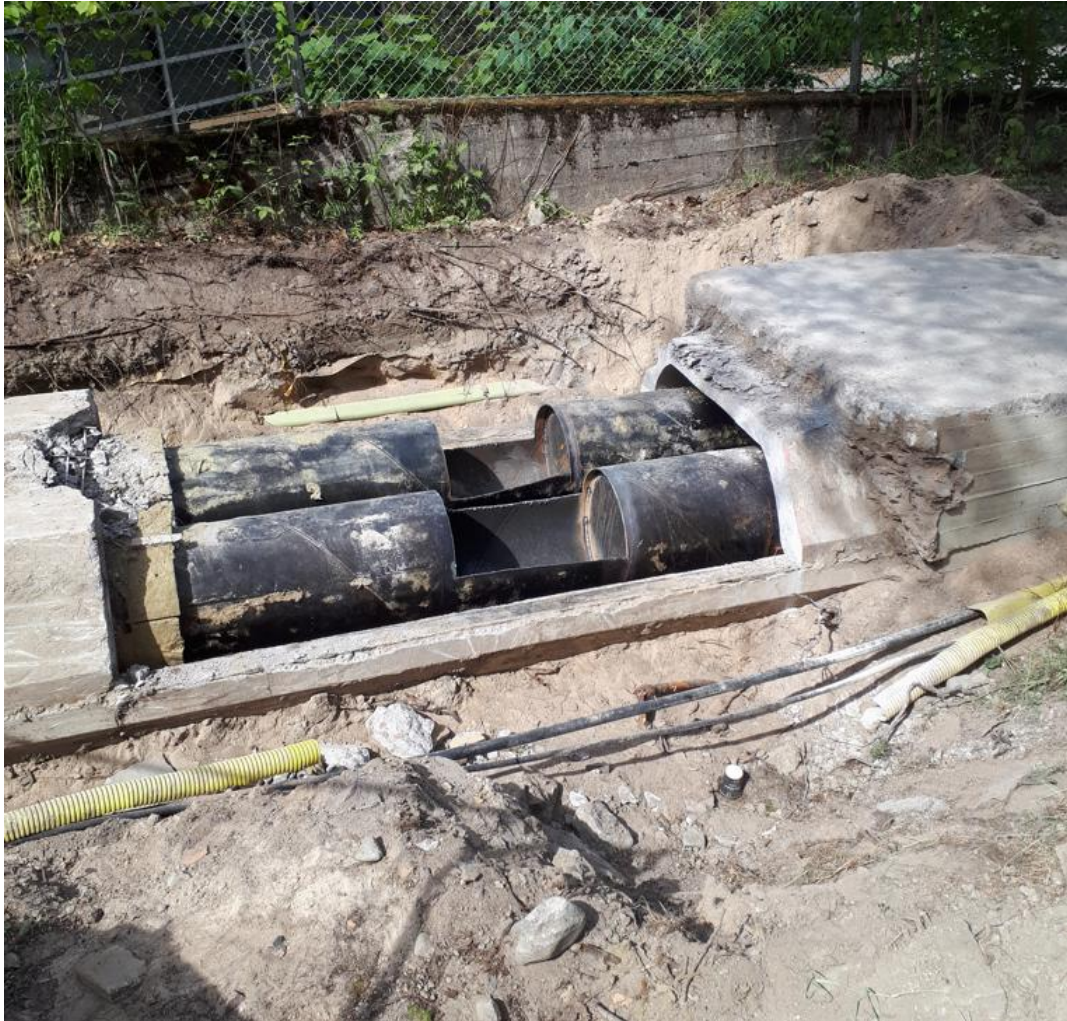
Concrete prefabricated channel systems are commonly used for large-scale, high-priority transmission pipelines within district heating networks. In these systems, steel pipes acting as flow pipes are encased within a concrete shell and supported on brackets. The steel pipes are secured to the concrete walls and base through embedded steel supports to accommodate movement and thermal expansion as shown in Picture 2. The walls of the concrete shell are thick enough to allow for adequate insulation between the flow pipes and the outer casing. (Koskelainen 2006, 144)

PICTURE 2. Concrete duct district heating line (Jari Randell)

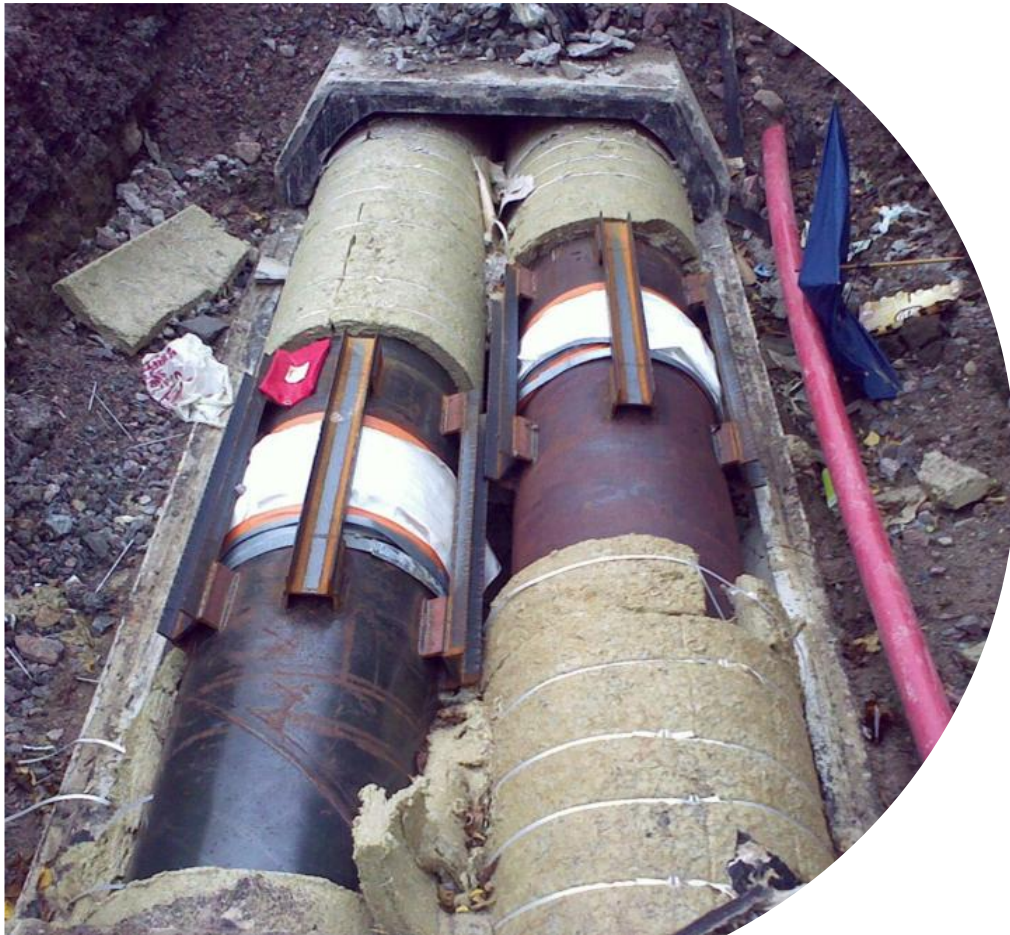
In Picture 3 the insulation used in these ducts is typically made of mineral wool or polyurethane foam channels.

PICTURE 3. Concrete duct district heating line (Henrikki Nuutinen, Helen Oy)

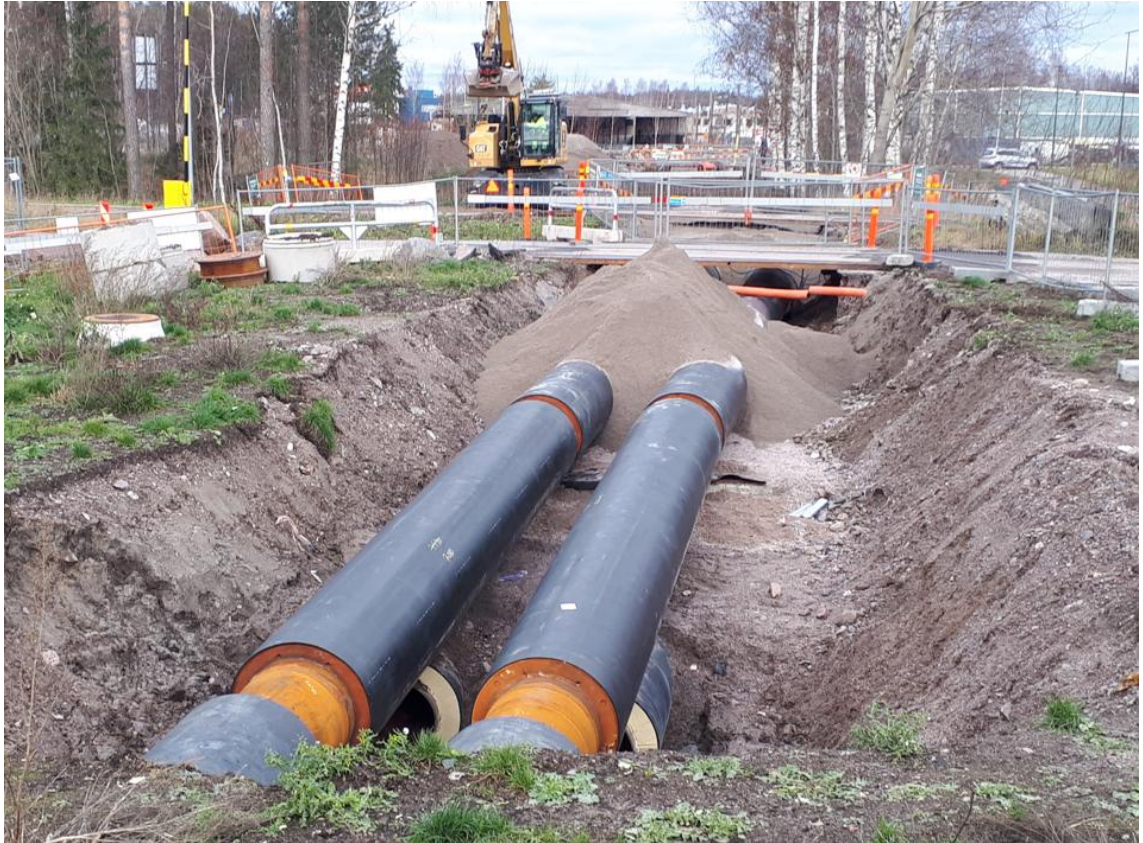
Bonded pipes generally come in two configurations: a single casing that houses two flow pipes or separate casings, each designed for an individual flow pipe. These pre-insulated pipe elements feature a durable plastic casing, polyurethane insulation, and flow pipes that are securely bonded to the casing with polyurethane foam, ensuring structural integrity and effective thermal insulation. (Kaukolämpöverkon suunnitelmallinen perusparantaminen L7/2016)

PICTURE 4. Bonded pipes (Jari Randell)

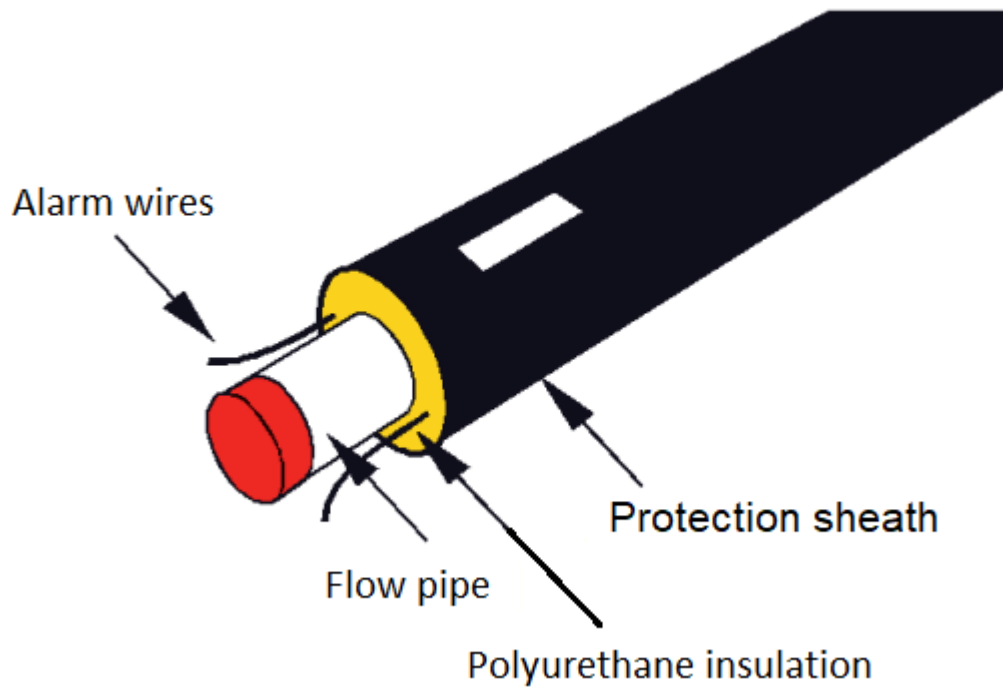
Pre-insulated district heating pipes can be equipped with built-in moisture alarm cables, allowing continuous monitoring of the pipe's condition and detecting any moisture ingress into the insulation as shown in Picture 5. (Koskelainen 2006, 142)

PICTURE 5. Parts of pre-insulated district heating pipe (Logstor Kaukolämpökäsikirja-2015)

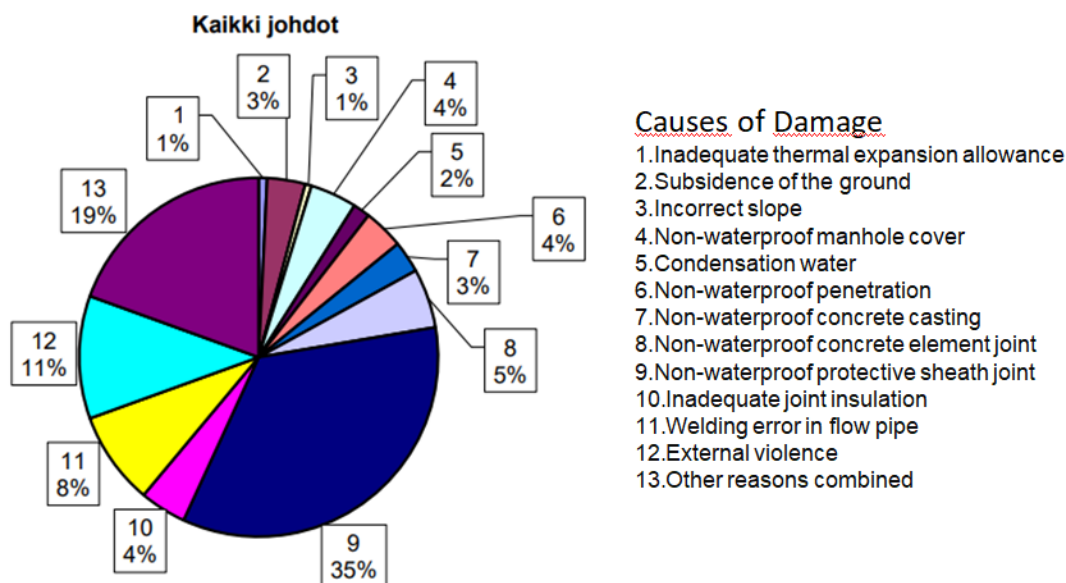
The causes of pipeline damage can vary, but the most frequent cause is an "improperly sealed protective sheath joint," as shown in Picture 6, regardless of the type of pipelines (Energiateollisuus ry. Stastics on district heating 2019). An improperly sealed protective sheath joint allows outside water to penetrate the protective sheath and polyurethane insulation, gradually over time leading to corrosion of the steel pipe and resulting in perforations.

Picture 6. Distribution of damage causes for year 2019 (District heating network damage statistics 2019)

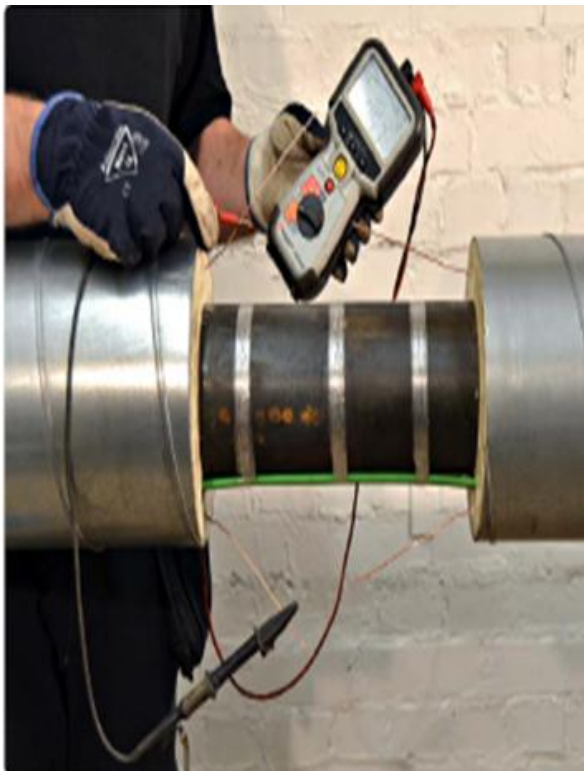
After calculating the expected resistance, it should be measured by using a multimeter, and a comparison chart should be constructed using these values. If a discrepancy exists between the calculated and the measured resistance, the nature of this discrepancy could indicate one of three potential issues. For instance, if the measured resistance is significantly lower than expected, this may suggest a short circuit. Conversely, if the resistance is higher than anticipated, it could point to a poor wire connection. Moreover, if the measured resistance is infinitely large, it likely indicates a broken wire, signifying an absence of conductive material to carry the current. In Picture 7, the resistance is measured using a multimeter.

PICTURE 7. Resistance measurement of alarm wire loop (Jari Randell)

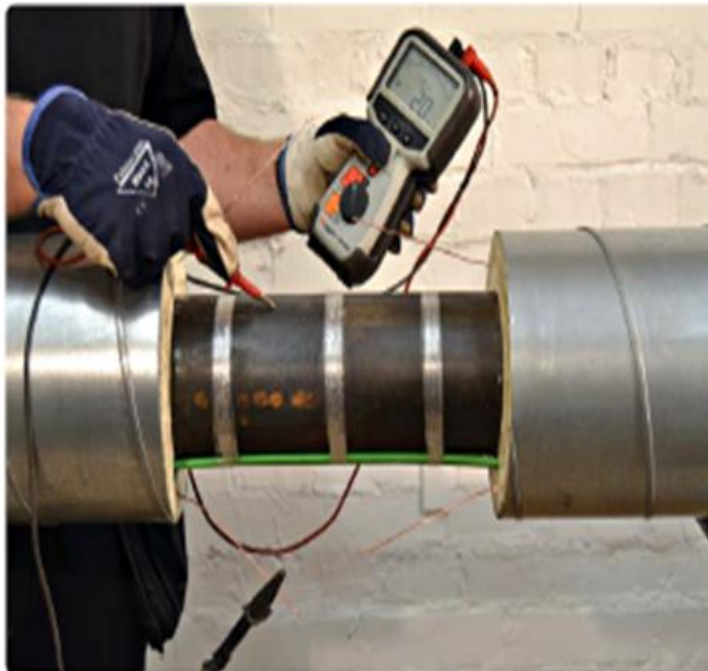
After confirming the continuity of the alarm loop, the next step is to measure the resistance between the wire and the flow pipe. This measurement determines the dryness of the polyurethane insulation and whether the alarm wire is in contact with the flow pipe. In Picture 8, a worker is shown using a multimeter to measure the resistance between the alarm wire and the flow pipe. In insulation resistance measurement, a test voltage of 1000 V is used, and the resistance value must exceed 0.5 mega ohms.

PICTURE 8. Resistance measurement between alarm wire and flow pipe (Jari Randell)

When the insulation is dry, no current flows between the alarm wire and the flow pipe, as dry polyurethane insulation does not conduct electricity. According to Ohm's Law, when the current approaches zero, the resistance becomes infinitely large.

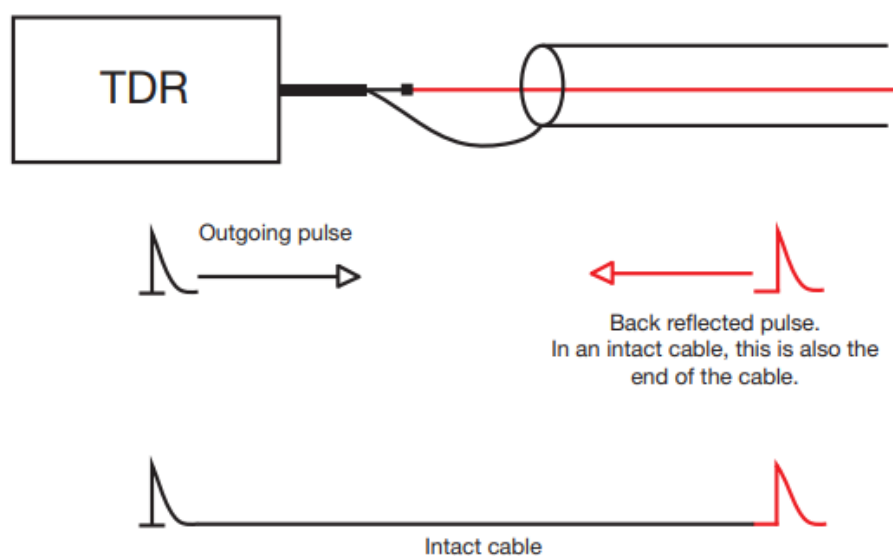
Time Domain Reflectometry (TDR) is a technology employed to identify faults within metal cables. In district heating systems, these metal cables are typically two pieces of copper wire, each with a cross-sectional area of 1.5 mm² and length of 1-3 kilometer, functioning as alarm cables. The process initiates with the generation of a traveling wave, produced by a low voltage pulse generator. As this wave propagates through the conductor, it encounters varying types of wave impedances—a metric that quantifies the resistance faced by the wave within the cable. (Megger n.d.) The pulse of intact cable is shown in the Picture 9.

PICTURE 9. TDR – Pulse measuring (Megger)

At any point where there is a change in wave impedance, due to variations in the cable's physical or electrical properties, part of the wave's energy is reflected back towards the source while the rest continues to propagate along the cable. These points of change can be natural terminations, like the end of a cable, or irregular such as joints, breaks, bifurcations, or areas where additional resistance is introduced, for instance by moisture.

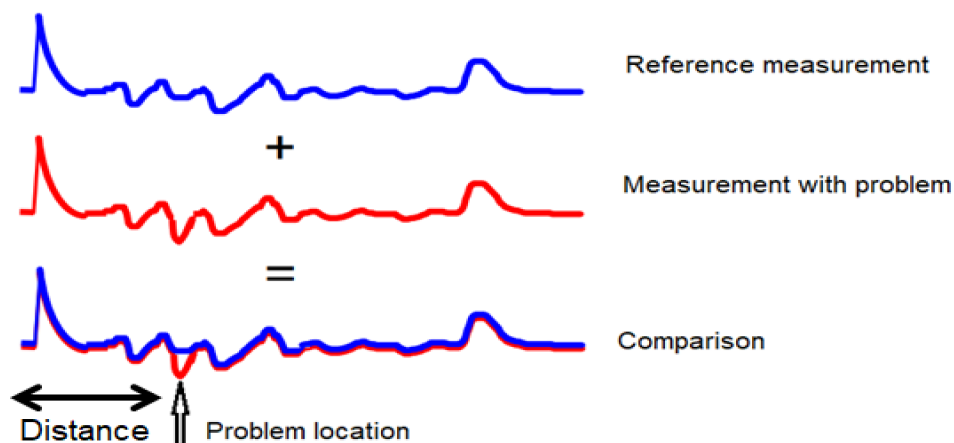
Before beginning measurements, this system must undergo an inspection to evaluate two key aspects: the continuity of the alarm loop and the condition of the foam insulation. The methods employed are the same as those used in resistance measurement. After confirming the continuity of the alarm loop and the dryness of the insulation layer, initiate the first pulse test to obtain a reference measurement. If there is a problem in the cable, the measurement will differ. By comparing these measurements, we can accurately determine the location of the problem. In Picture 10, there are pulses of reference pulse of alarm loop and pulse of the same alarm loop but with a problem. In the lower of the picture, is the combination of these two pulses and location of the problem can be found easily.

PICTURE 10. Comparison of measurements and location of the problem (Megger)

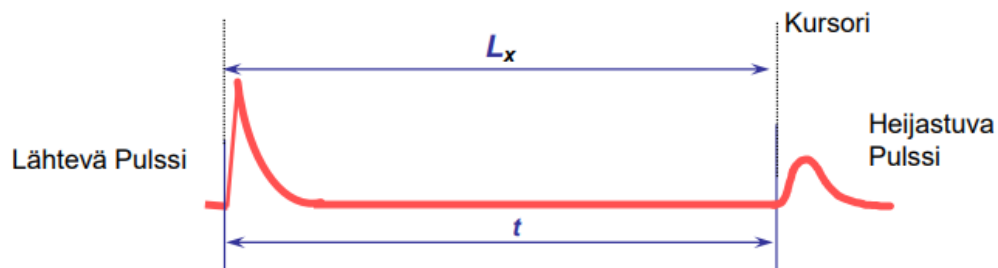
The calculation method relies on the corrected speed of the transmitted pulse and the time it takes to return. By measuring these parameters, we can determine the distance to the fault location from the starting point of the wire. In Picture 12, the scenario is illustrated, showing the initial outgoing pulse (lähtevä pulssi) and the resulting reflected pulse (heijastuva pulssi), along with their respective distances and the time taken for the pulse to travel divided by 2. (Megger n.d.)

PICTURE 12. Calculating the distance of initial pulse and reflected pulse (Megger)

$$L = \frac{1}{2}tv \quad (2)$$

L is the distance and t is the time for the pulse to travel back and forth, v is the correct speed of the pulse. A reflected pulse is an electrical signal that bounces back along the wire when it encounters a change in impedance. In an intact cable, this reflection generally happens only at the end of the cable, where the signal reaches the cable's termination. However, if there are branching points, changes in wire geometry, or a break in the wire, the pulse will instead reflect back from these locations. The specific cause of the reflected pulse can be determined by comparing it to the pipeline wiring diagram.

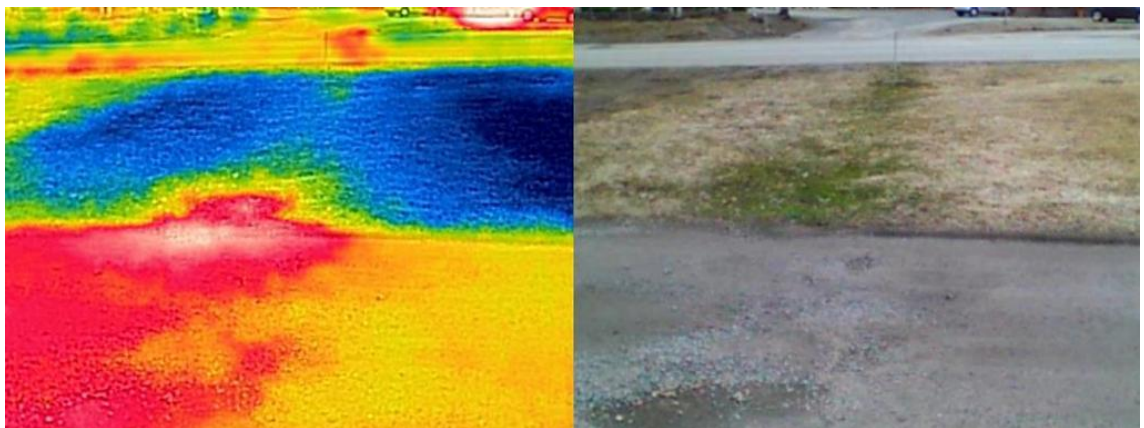
For district heating pipelines, a leak involving hot water can raise the temperature of the surrounding soil, making this area warmer than its surroundings. This temperature difference causes the soil to appear in different colors when viewed through a thermal camera. Thermal camera is used to detect leaks via aerial surveys, often conducted using helicopters or nowadays drones. These inspections are typically carried out once or twice a year to ensure the integrity of the heating system. In Picture 13, the right side shows no indication of leaking pipes. However, on the left side, a thermal camera image reveals an unusually high temperature in a specific area of the ground.

PICTURE 13. Thermal camera for leak detection (Jari Randell)

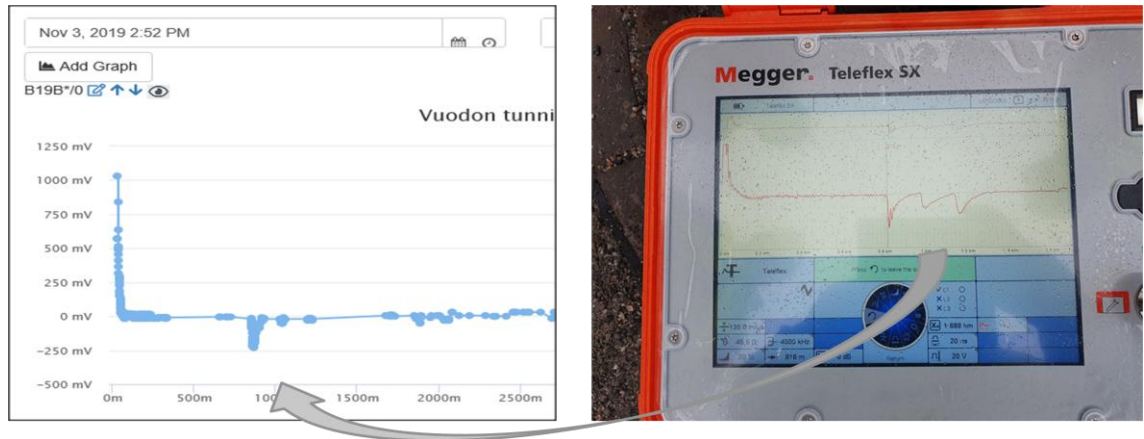
On the following day, three different points showed deviations from the reference line. All of these deviations were measured at over 50 mV, indicating the presence of water within the insulation layer, not just moisture. Given that it had rained during the pipeline installation, the insulation was likely moist in certain areas. In Picture 14 on the left part of the figure, the computer interface displays the measurement, with the y-axis showing millivolts and the x-axis indicating the distance from the device. On the right side, there is an image of the handheld device used for on-site measurements.

PICTURE 14. View of pulse in iSENSE interfaand handheld device (Jari Randell)

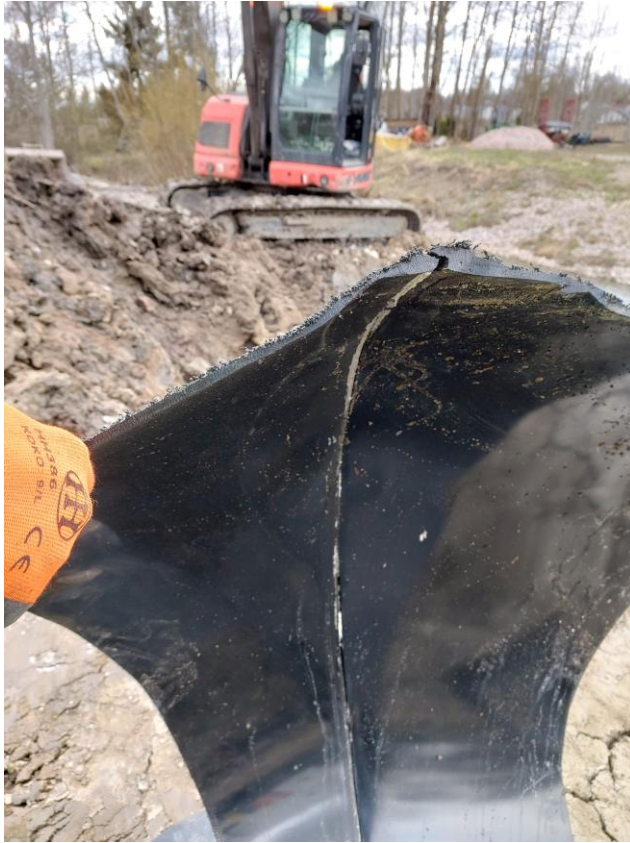
Upon observing these deviations, Vexve notified the Fortum workers and dispatched personnel to inspect the first identified leak site. Vexve personnel accounted for the fact that the distance displayed on the handheld device corresponds to the length of the copper wire, not the pipeline itself, as the copper wire is not tightly positioned within the insulation or at connection points. After identifying these additional meters, Vexve personnel successfully located the leak at a nearby pipe seam. The first leak site was located beneath a riverbed. Due to the soft, muddy soil, the pipeline had settled, leading to a rupture in the protective sheath at a joint. In the Picture 15 and 16, one shows the damaged protective sheath joint, while the other reveals the corroded flow pipe after the insulation was removed.

PICTURE 15. Broken protective sheath joint (Jari Randell)

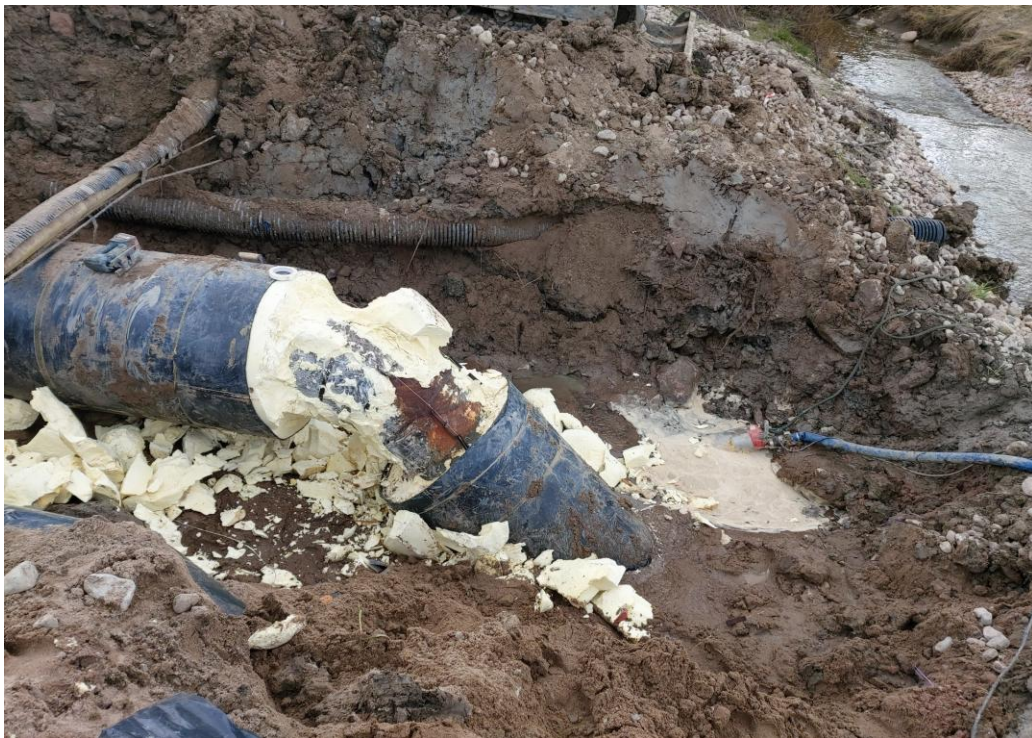
PICTURE 16. Corroded flow pipe (Jari Randell)

Worker from Fortum noted that the pipeline's is located near to a road, where salt is used during winter, which accelerate corrosion through the damaged insulation, finally causing perforation to the flow pipe within three years. Seven workers were involved in this repair, with labor costs estimated at around 20,000€. Additionally, a material cost of treated water about 5,000€. This DN 500 line, with a length of 1.9 km, costs approximately 13€ per cubic meter.
