Performing the Rolls Royce Trent XWB Non-Modification Service Bulletin 72-AL055 at Finnair Technical Services

LAB University of Applied Sciences
Bachelor of Engineering, Mechanical Engineering
2024
Henri Mikkonen

Keywords		
72-AL055, Trent XWB, service bulletin, aircraft, borescope, Excel, Power Query

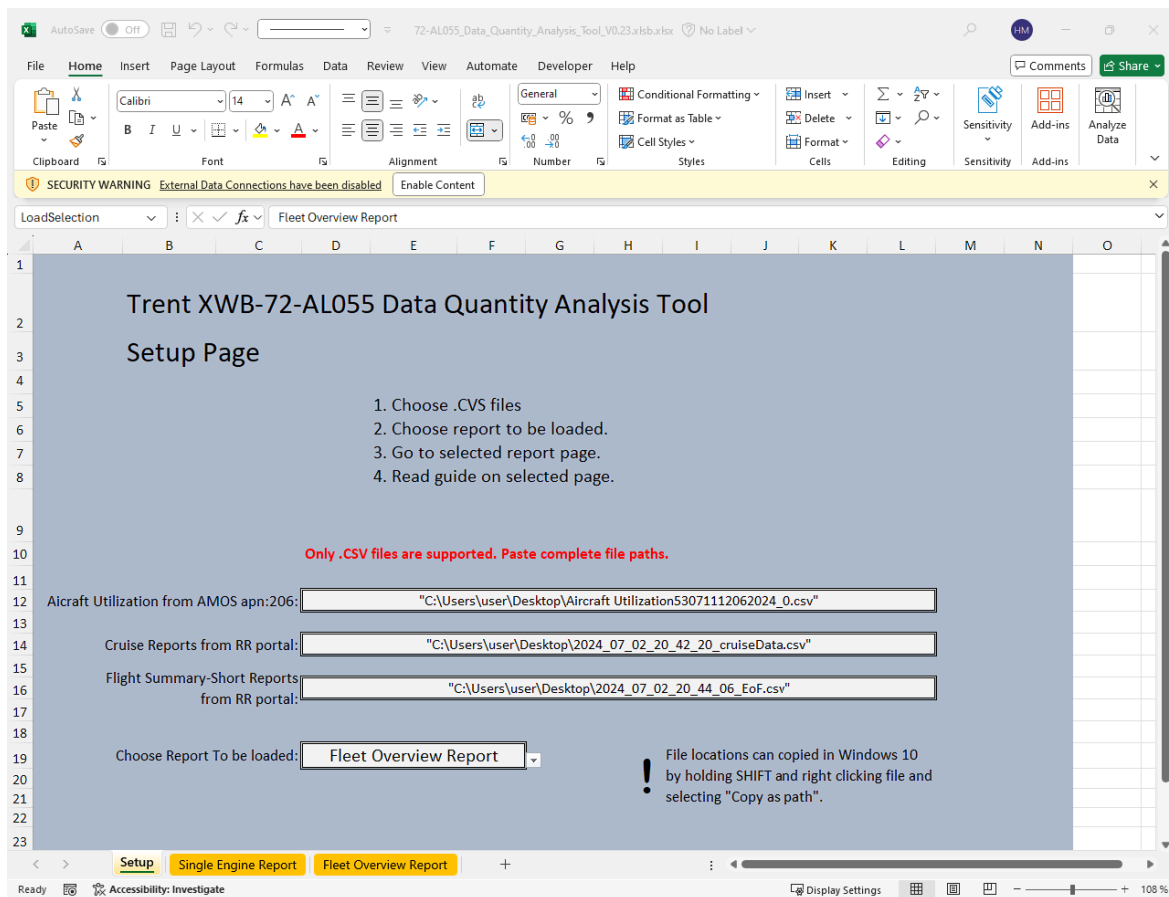
Figure 5. Setup Page

When making the tool, the validity of the results and the ability to verify them by the user were taken as the most important aspects. Automation was added when platform features allowed it. The tool included Excel macros to make selecting files and using Excel easier, but it was later found out that Finnair's computers would not allow to use them for security reasons, so those features were removed. When the tool is opened, on the Setup page user must first select the data files in CSV format (Figure 5). It was decided to support only CSV format since it seemed to be handled more reliably by the Power Query than XLS files. Also, the usage of only one file type is a better option when the validity of the results is crucial since variables that might occur from the usage of multiple file types are eliminated.

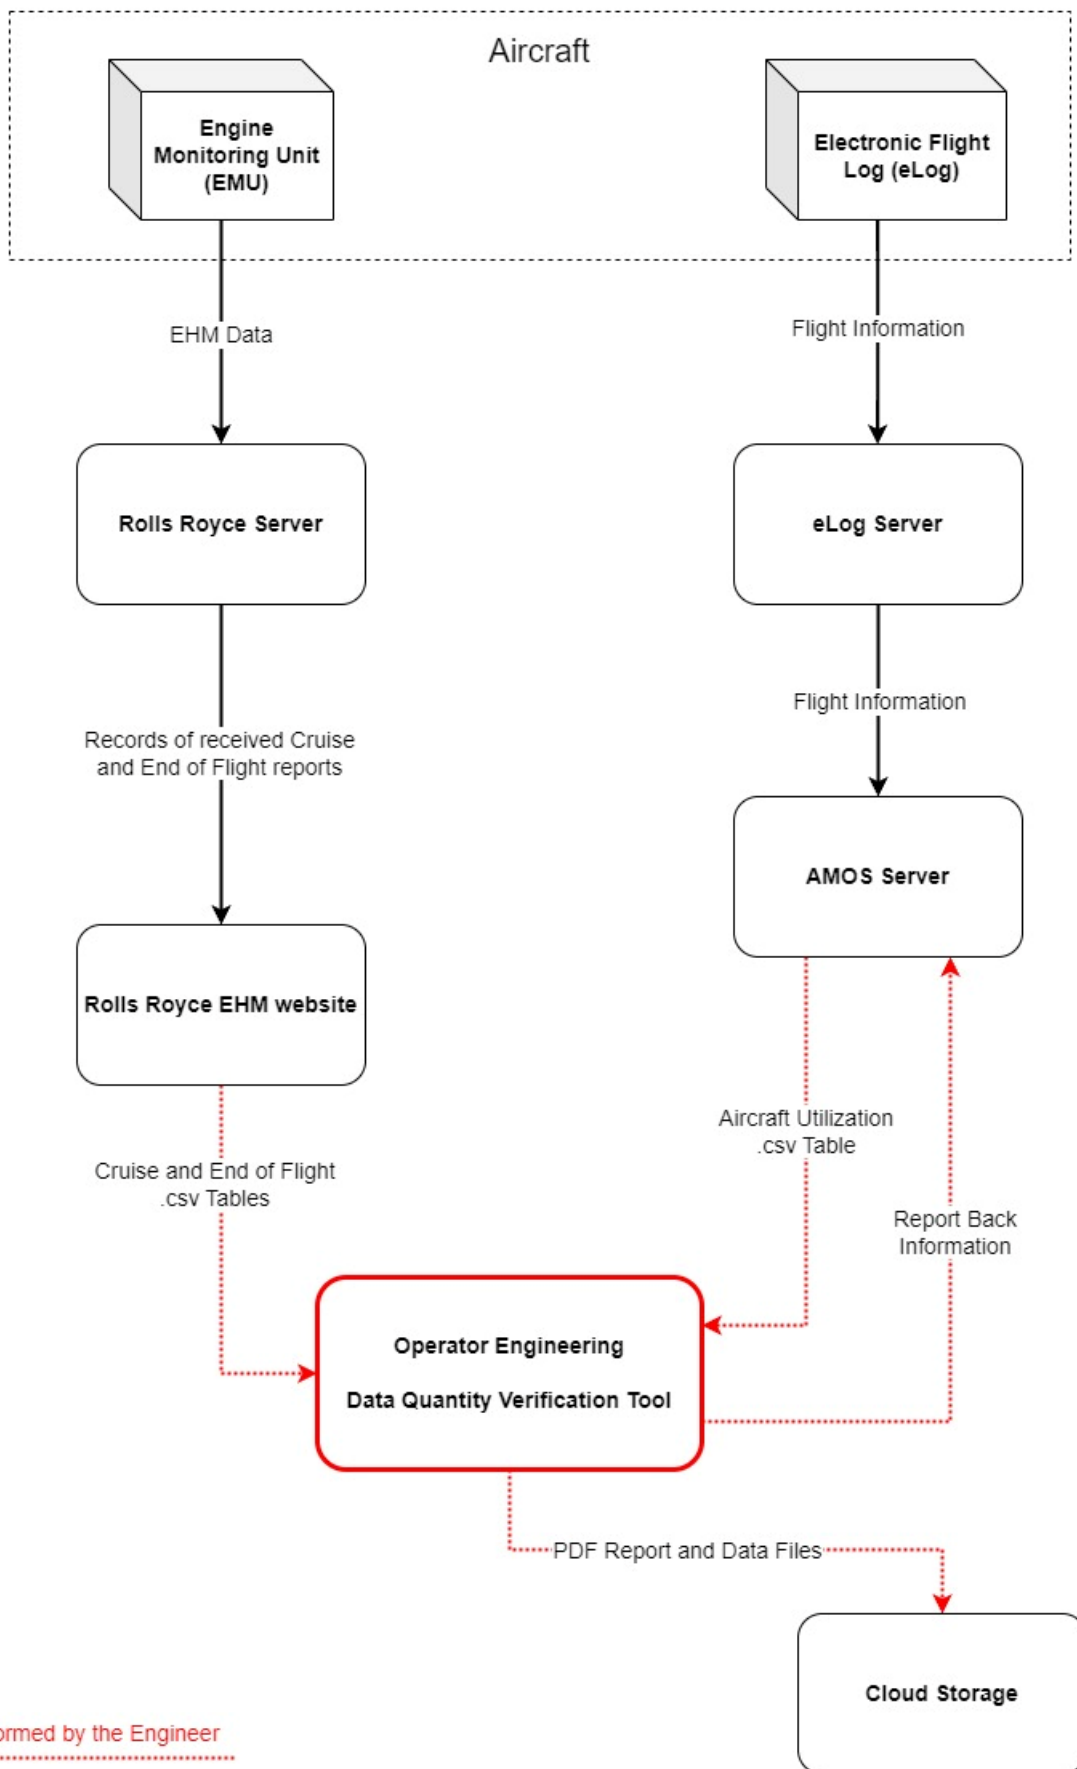
Figure 8. Method B Information Flow

As there is plenty of data required for the NMSB to be completed according to the method B, a flowchart was created to show the data flow from the aircraft, all the way to the engineer (Figure 8). It also shows the data movement after the engineer has performed the initial analysis, which exists for archiving purposes. All the data handled by the engineer is displayed in red in the flowchart.

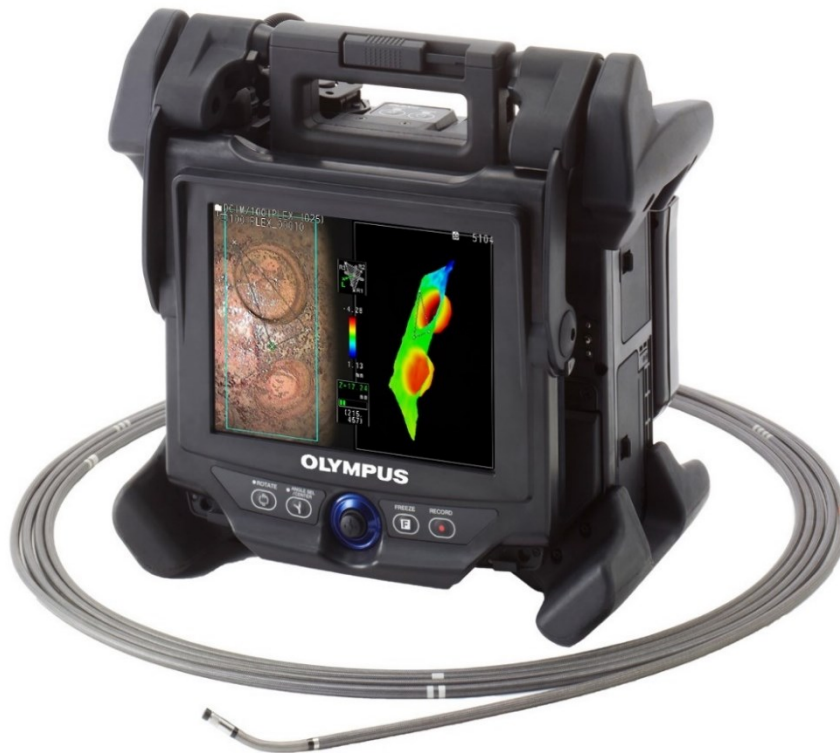
Figure 9. Olympus Borescope (Evident)

NMSB instructs to use a 4mm borescope with image or video capture capability, without specifically stating the model or manufacturer (Rolls Royce plc 2024a). In the Rolls Royce Power Point presentation about the NMSB it is also mentioned that the borescope should be at least 3 m long (Roll Royce plc 2024b). The borescope used for the trial was an Olympus IV9000N with a 4 mm thick and 3,5 m long insertion tube and AT120D/NF-IV94N optical adaptor, which Finnair already had in the tool store (Figure 9). IV9000N base unit includes functions for distance and surface area measurements. It is also possible to create colour 3D models of the examined objects, which can be rotated around in the display. These features are however not necessary for inspection, since only the presence of the anti-rotation plates must be confirmed. A wide view of the optical adaptor was found to be beneficial during the trial since it helps to get a view of anti-rotation plates after the last bend. Therefore at least a 120-degree view angle will be recommended.

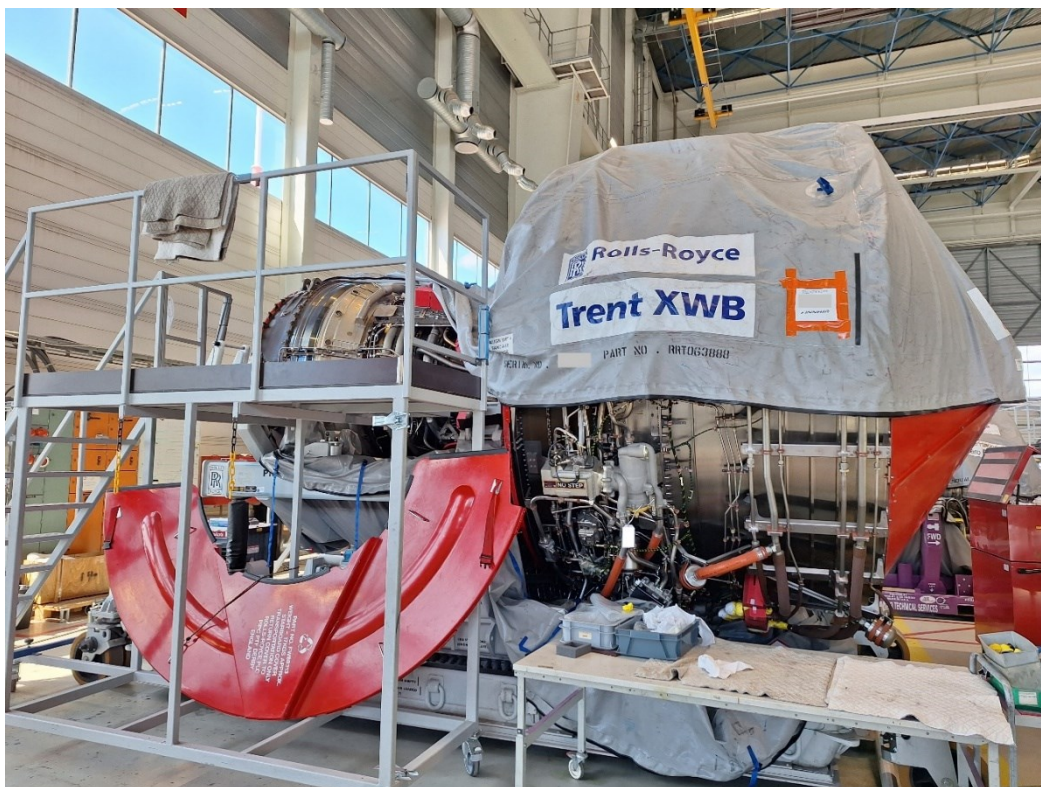
Figure 10. Trial Engine

A trial of borescope inspection was performed on an engine, that was already removed from the aircraft to be sent for a shop visit (Figure 10). This made sure that if damage would be caused to an engine during the trial it would not affect flight operations. The engine was already covered with the transportation cover, which was opened just enough to get access to the required location. A work stand made for widebody engine maintenance was placed on the right side of the engine for safe access to the borescope insertion location. Access was also required for the turning tool installation location and the bottom of the fan case, where the installation hole is located at the auxiliary gearbox.

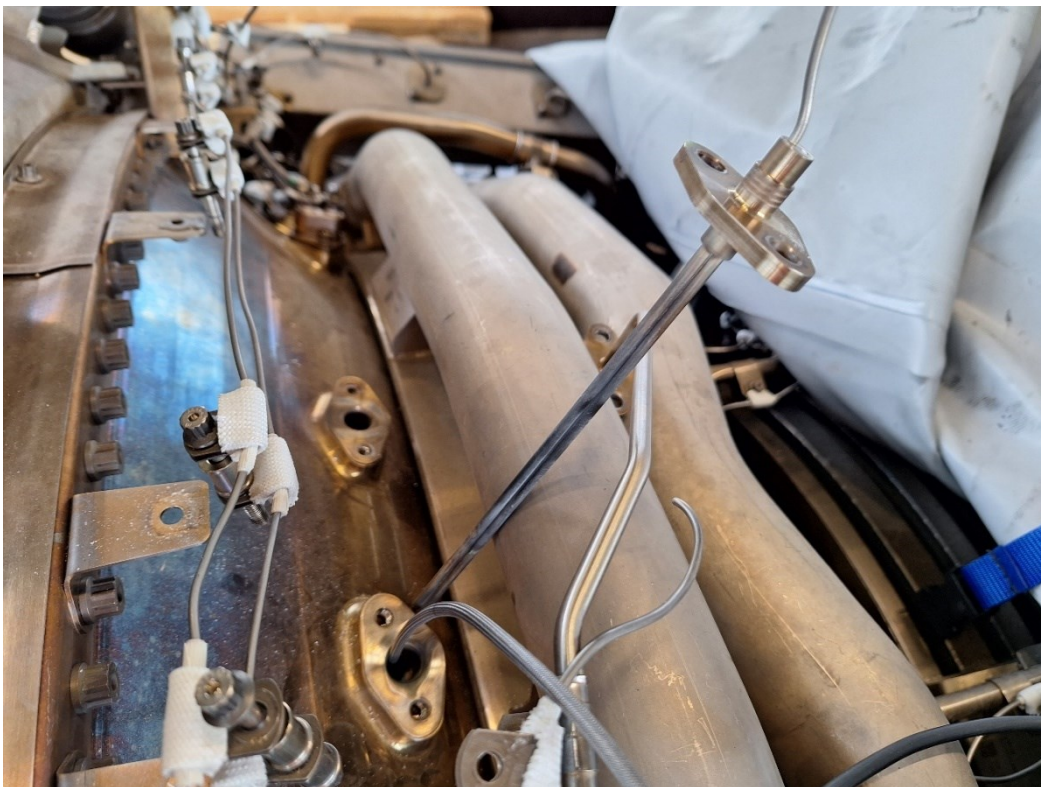
Figure 11. Borescope Insertion Location

BSI was started by removing a rear IP turbine overheat temperature thermocouple. Work instructions called to use protector RRT116239 on the thermocouple (Rolls Royce plc 2024c). The purpose of it is to protect the leads to the thermocouple connection joint from getting bent during removal and installation. Protector was not available for use at the time of the BSI trial, so the procedure was attempted without it. At first, the engineer removed the thermocouple attaching screws and started removing the clamps holding the thermocouple leads one by one to see how much disassembly was required for getting the thermocouple out of its hole since complete removal was not necessary for BSI inspection (Figure 11). During this procedure, one lead broke off from the thermocouple and made the thermocouple unserviceable. Before beginning the disassembly, it was noticed that the broken-off lead had white insulation visible from the connection joint which may indicate it being weakened before the trial started. The conclusion was made from this that it is best to remove the thermocouple and its leads completely from the engine and to use the protector stated in the manual to avoid bending the leads.

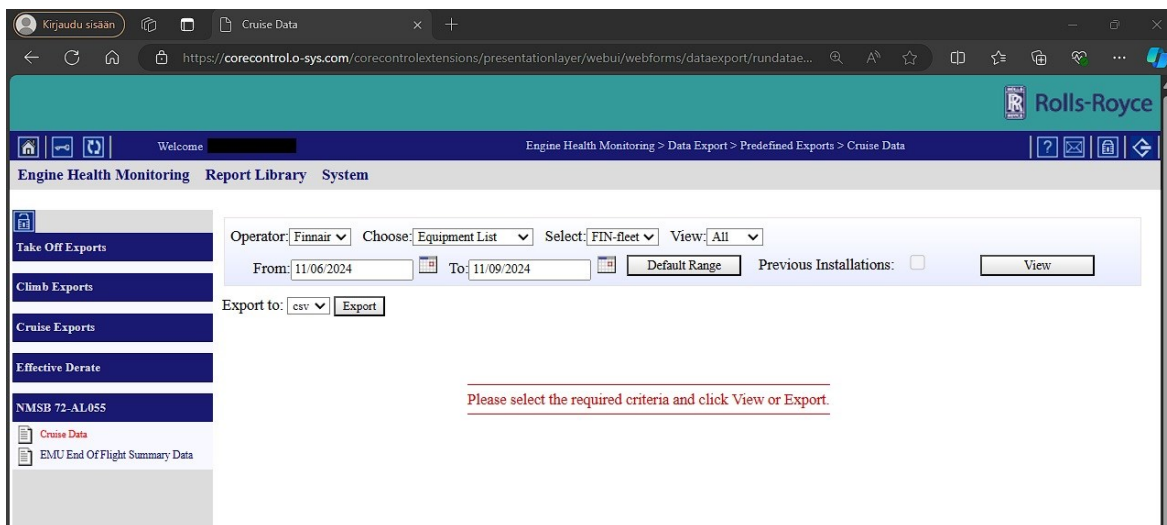
Figure 3. RR Engine Health Monitoring Site, Cruise Data Download Page

- c. Click **Export** and wait for the file to download.
