# STORMWATER FLOATING ISLANDS

Case study INNOHULE

LAHTI UNIVERSITY OF APPLIED  
SCIENCES  
Master in Engineering  
Urban Sustainability  
Autumn 2018  
Waseem Sukkari

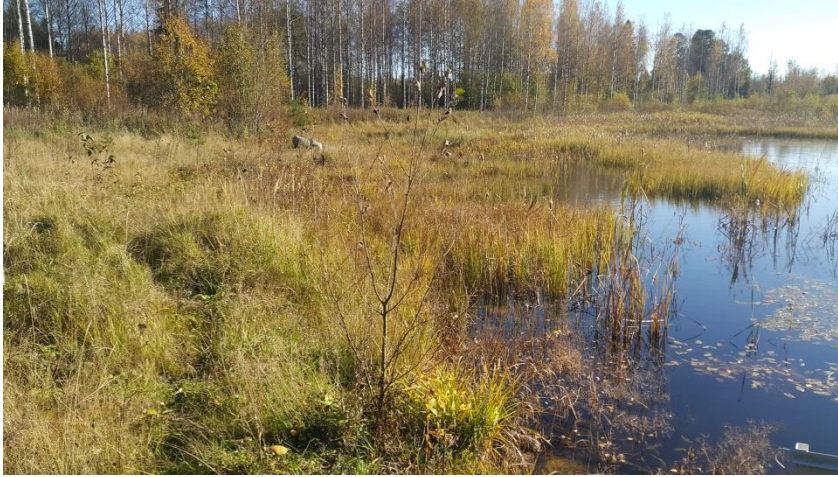
PICTURE 1 Kivipuro wetland in Karisto

In high-density urban areas close to discharge outfall, a swale is not able to deal with the large quantity of stormwater. To deal with this problem, the City of Lahti constructed wetlands such as Kivipuro wetland in Karisto ( picture1). A wetland helps to reduce the runoff speed, increase the percentage of water infiltrated into the ground, and reduce the negative impacts of the pollution in stormwater, by the help of natural aquatic plants (Aryal et al. 2010; Malaviya and Singh 2012; Mallin et al. 2002; Stanley 1996).

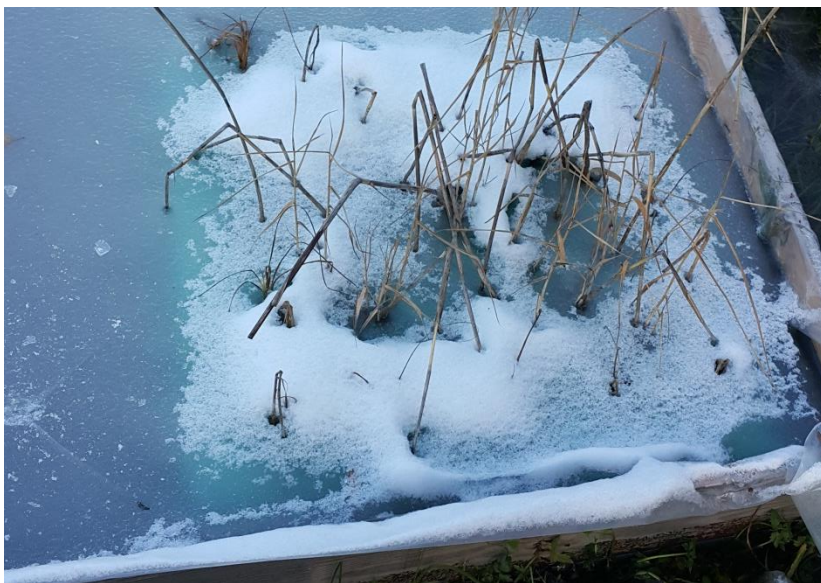
PICTURE 2. Sudden frost of the growing ponds after the summer experiment

- A Delay of 11 days in October 2017 due to the weather conditions.
- Heavy rainy days in October 2017 during fixing the greenhouse, which caused difficulties such as muddy ground (picture 3) and the inability to cast concrete in days when the temperature was below 5 degrees C.
- Sudden frost occurrence (-12 degrees Celsius) delay pumping water to the growing ponds in the greenhouse (picture 2).
- Due to the death of some plants during the early warm spring, and for more variety plants investigation; it was estimated that the thesis draft would be ready in September 2018.
- Early sunny spring caused the ice to melt and evaporate from around the roots leaving a loss of 5 cm in thickness (picture 4).
- Also, it caused dehydration of some plants' leaves due to the warm air and lack of water supply from roots as the water was frozen (picture 5).

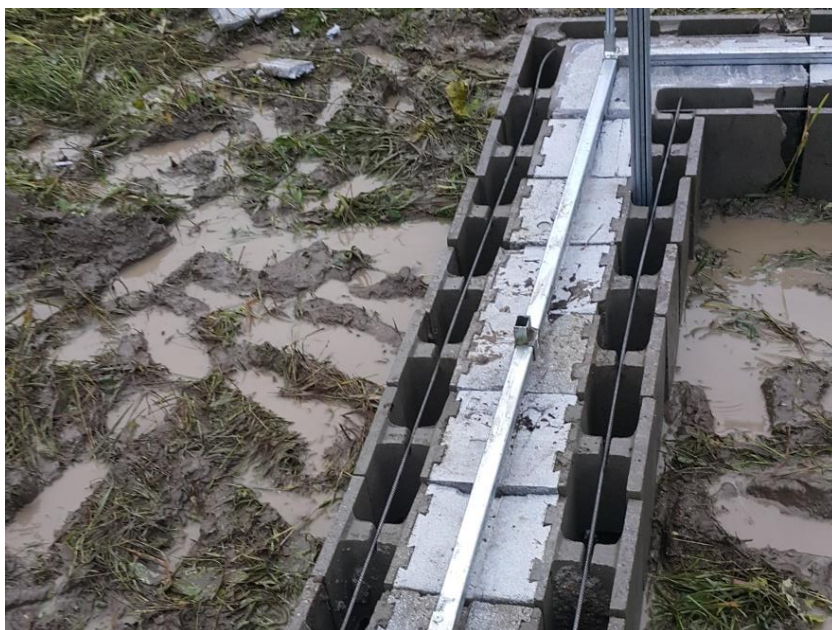
PICTURE 3. Heavy rain caused very muddy conditions in which to work

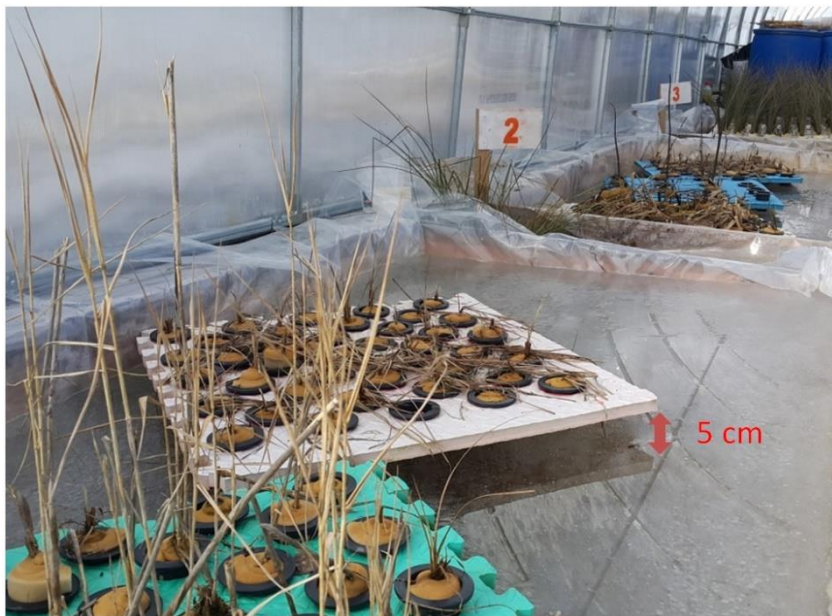
PICTURE 4. Ice loss around the roots

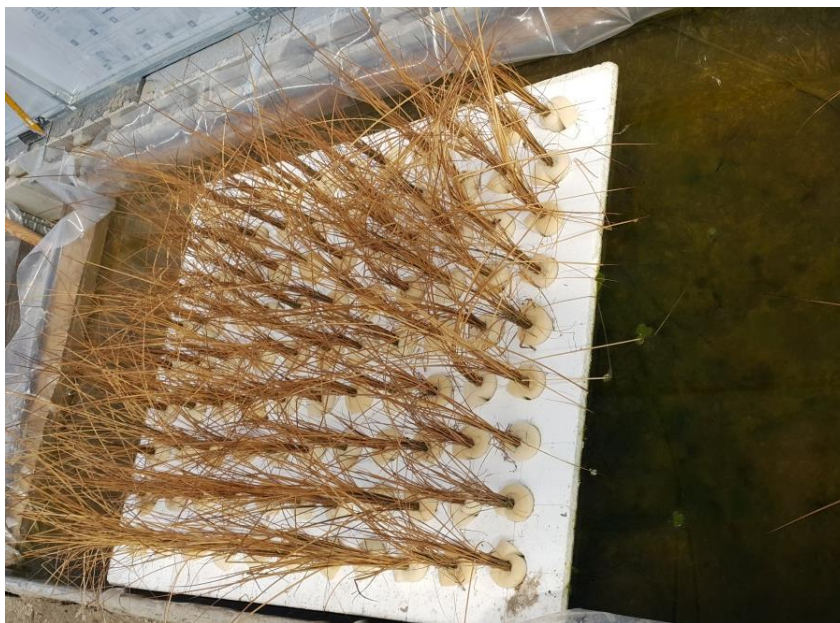
PICTURE 5. Plants are dehydrated at early spring 2018

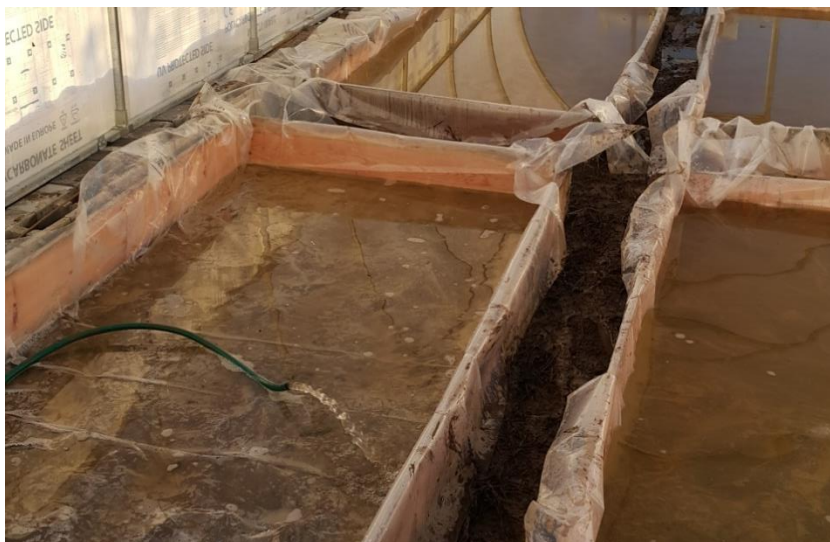
Twelve growing ponds were installed in two rows along the greenhouse. The growing ponds were made out of garden grow boxes of rectangular prism shape (114 cm x 228 cm x 22 cm). Construction plastic sheets (0.2 mm thick) were used for the liner (picture 6). A gap of 40 cm was left between the growing ponds for easy access during the installation of the floating islands, monitoring, and testing, for example when taking a reading of the water depth of each growing pond corner during the water testing procedure.

PICTURE 6. Growing ponds installed and water filling process ongoing

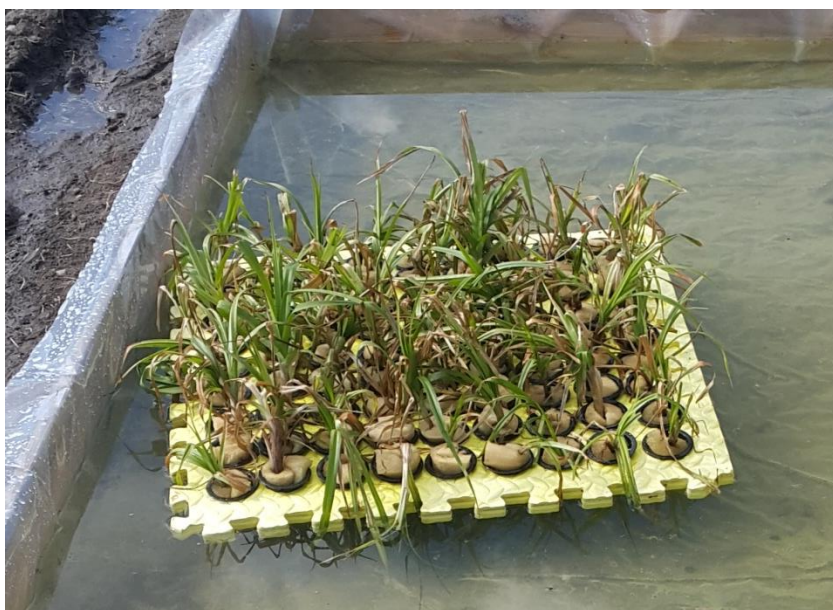
- 1) The first design was made out of a gym mat and by drilling suitable holes to fit the hydroponic net pots where the plants stem surrounded by a sponge strip to keep it in position and allowing the roots to grow in direct contact with the water body. This design was very stable, durable and the floating island can be easily enlarged and shaped as required by matching the gym mat with another one or by cutting it into another design shape. However, it is having some difficulties during the installation of the plants in the hydroponic net pots as the root of the plants might be larger than the hydroponic net pots holes. (picture 7 &8).

PICTURE 8. Plants installed in hydroponic net pots and surrounded by a sponge.

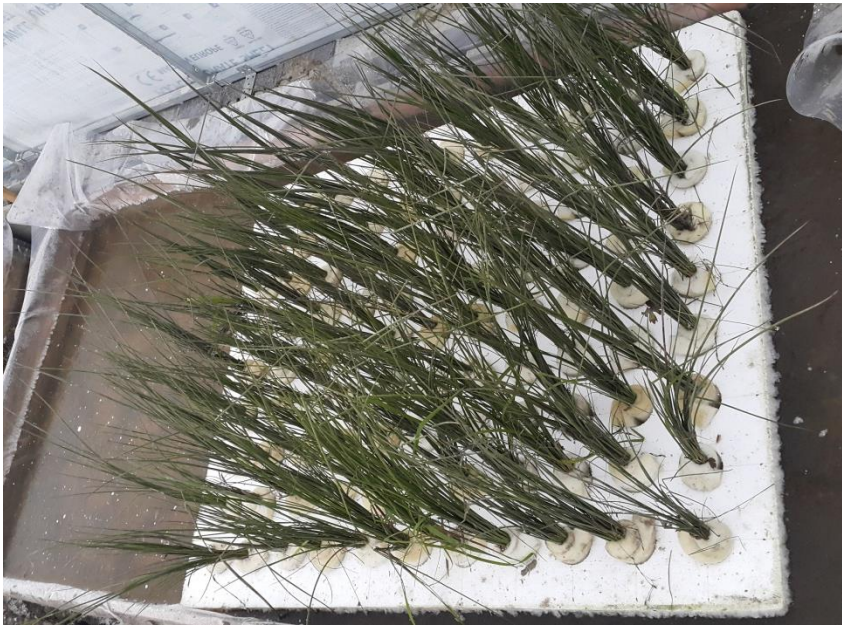
- 2) The second design was made out of Styrofoam board by drilling suitable holes, in this design, hydroponic net pots were not used. Instead, a long stripe of sponge was used surrounding part of the roots and the stem to hold the plants in position within the hole in the floating island. This design showed acceptable stability and durability. Moreover, it is made out of 100% recycled materials (picture 9).

PICTURE 9. Plants installed over Styrofoam board.

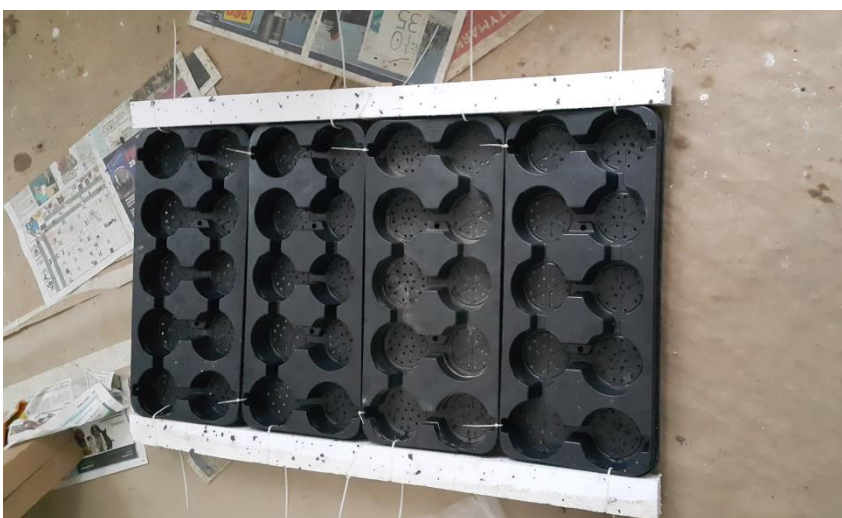
- 3) The third design was made out of flower baskets trays that are usually disposed of as trash. It was managed to connect three pieces and support it with Styrofoam beam around, this allows to this design to float, carrying the expanded clay aggregate (ECA) and the plants. At the bottom of these trays, 6mm holes were drilled in order to let the plants' roots to grow freely in the water body (picture 10). The reason behind this design is that to find out if there is an opportunity to start the plants from seeds.

PICTURE 10. Setup a design of SFI out of flower basket trays

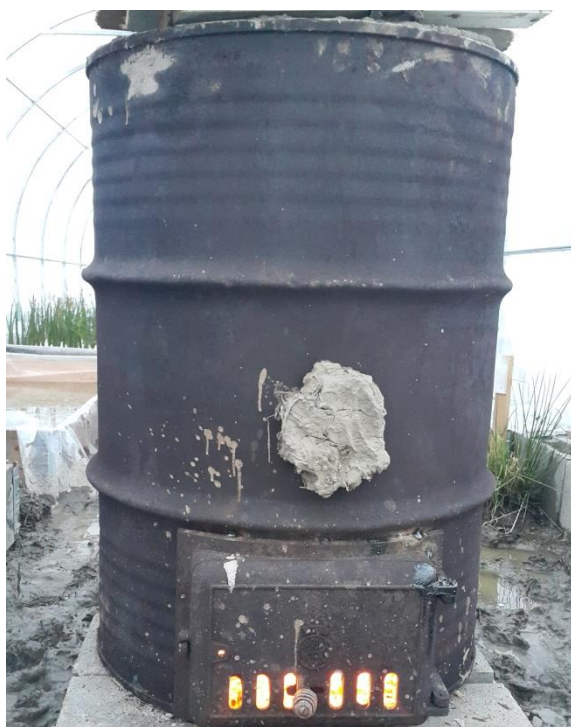
The other heating system was a stove burning wood. The stove was built from recycled material, and the firewood were reclaimed wood (i.e., rotten wood, building leftover pieces). About 15 kg on average was used daily to heat the greenhouse and keep it above freezing temperature (picture 11). The temperature within the greenhouse was between +2 to +24 degree Celsius, while the outside temperature was between -12 and +4 degrees Celsius. This system worked until the end of December 2017 when it was challenging to maintain the greenhouse above zero Celsius; therefore, the heating process was turned off. It should be mentioned that there were additional water mass in barrels (5 barrels of 200 liters each) inside the greenhouse, to supply the growing ponds with water if needed, and as a mass that stores heat during the day and the heating hours.

PICTURE 11. Stove in action in the greenhouse

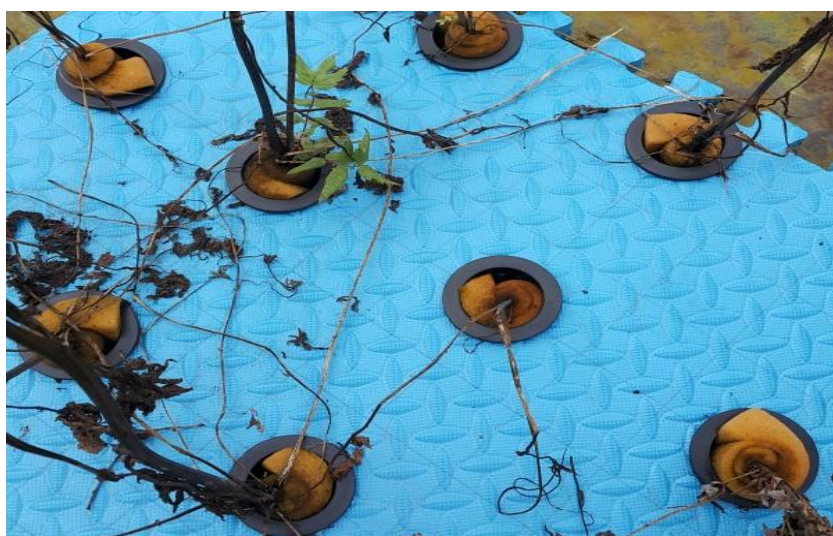
PICTURE 12. Many plants were unable to survive the aquatic condition

Collecting of the plants started from June 2017, from Päijät-Häme region, focusing on Nastola, where the greenhouse is located. The search of the plants was focused on ditches, low lands, and marshes. The plants were then studied and classified. Non-native and invasive species were excluded (i.e., *Fallopia japonica*). The collected plants were installed on floating mats (summer growing ponds) in order to find out which could survive the SFI system. Some plants were unable to survive the aquatic environment (picture 12). The plants showed varying adaptation shock periods, such as a slow growth period, as is the case with *Carex rhynchophylla* that returns to normal growth after 15 days (picture 13). On the other hand, *Phragmites australis* appeared to be severely affected, as it appeared to have completely died. However, *Phragmites australis* started to grow up again after 70 days (picture 14).

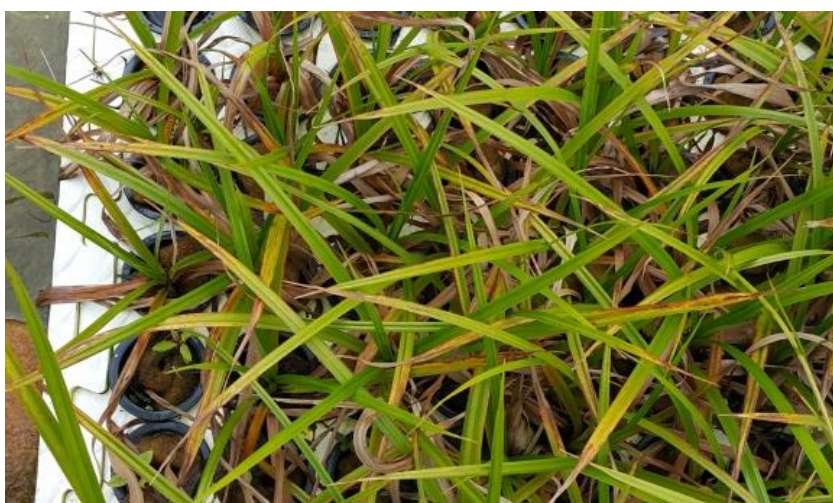
PICTURE 13. *Carex rhynchophylla* was able to survive on the SFI.

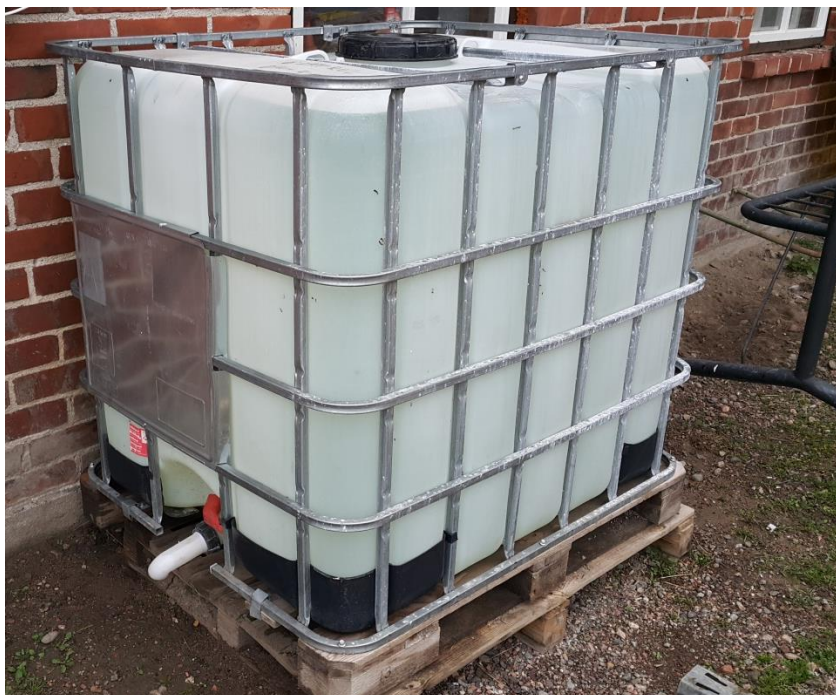
PICTURE 16. A container full of water with nutrients before discharge it to the growing pond

contained water with low nutrients. The nutrients including phosphorus and ammonia were added well mixed and dissolved before the water was discharged into the target growing ponds (picture 16).

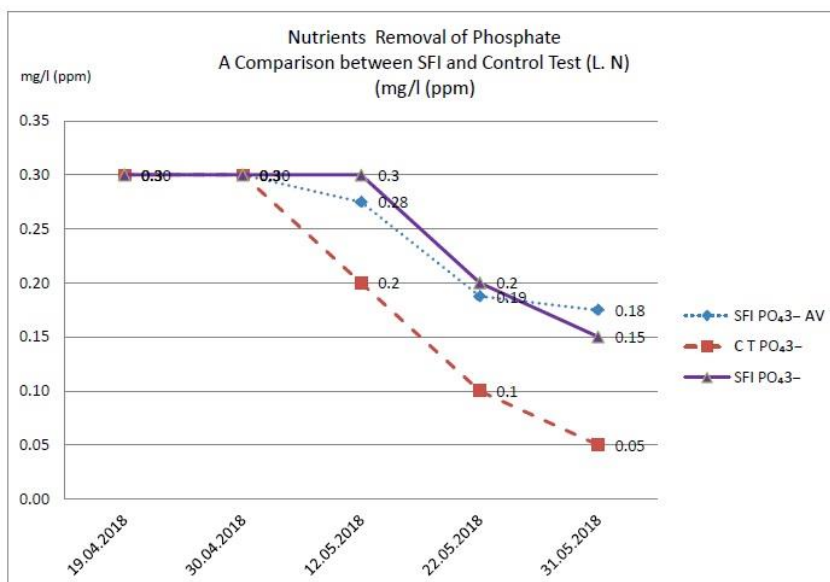
At low nutrients concentration, phosphate level started to reduce from April 30<sup>th</sup> from the control growing pond, unlike the one that was equipped with a SFI, including growing pond 1, 2 and 5 (figures 6, 7, 10 respectively), the phosphate started to reduce on May 12<sup>th</sup>. Moreover, the final phosphate test at the control growing pond was lower than the one equipped with SFI, so in growing pond 1 phosphate level at the final test was higher than the control growing pond by 0.1mg/l, and at growing pond 2 and 5 was higher by 0.15 mg/l.

FIGURE 6. Phosphate removal chart from growing pond 1

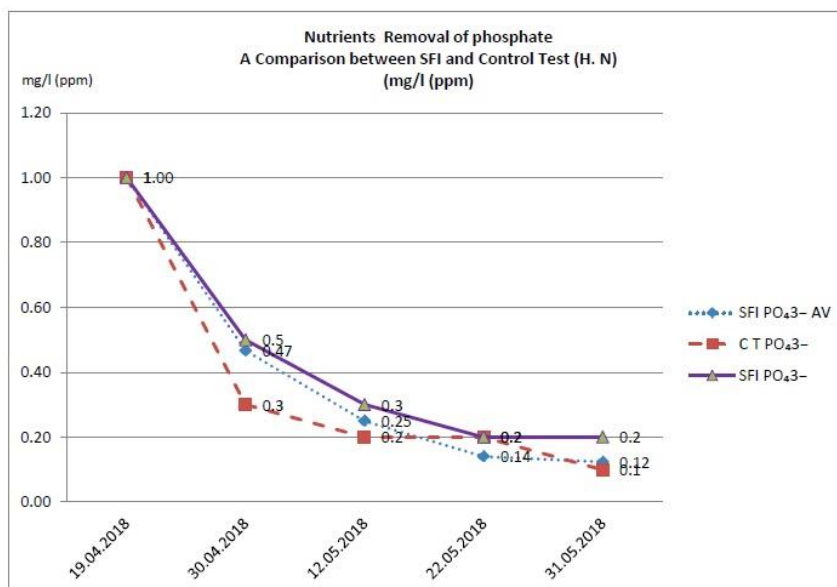
In high nutrient concentration, the phosphate level in both control growing pond and the one equipped with SFI shows close results in the whole experiment (figures 19, 20, 23).

FIGURE 8. Phosphate removal chart from growing pond 3

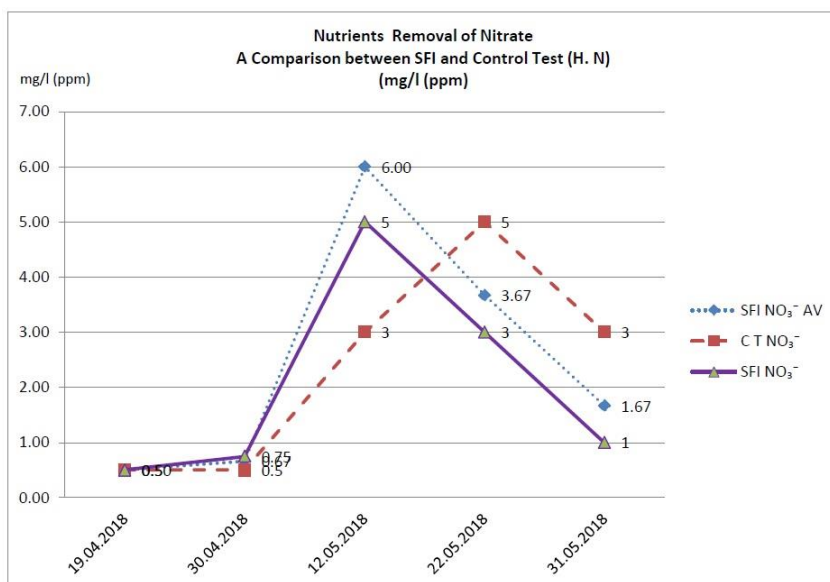
FIGURE 15. Nitrate removal chart from growing pond 3

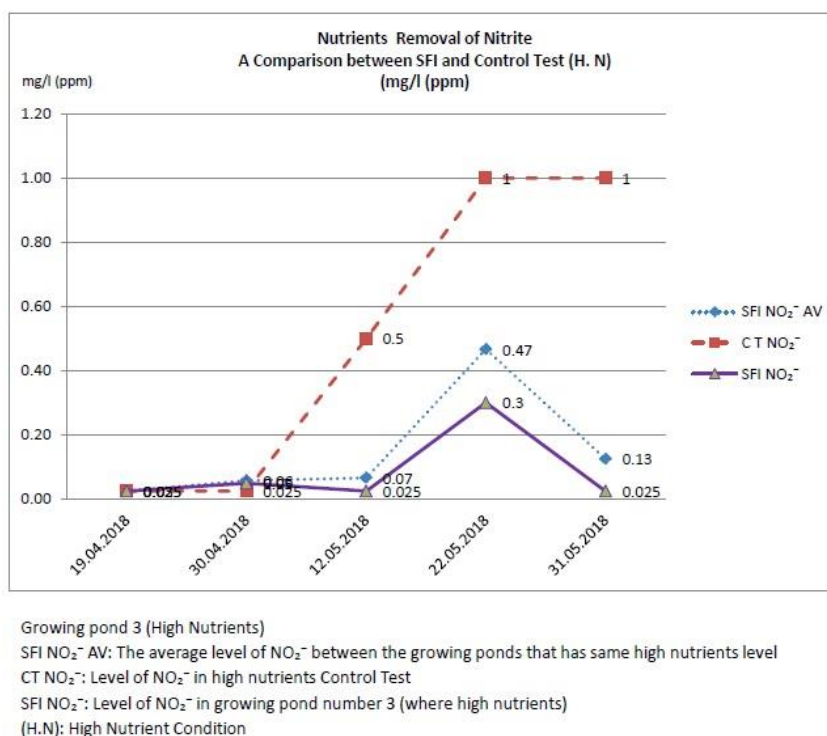
FIGURE 22. Nitrite removal chart from growing pond3

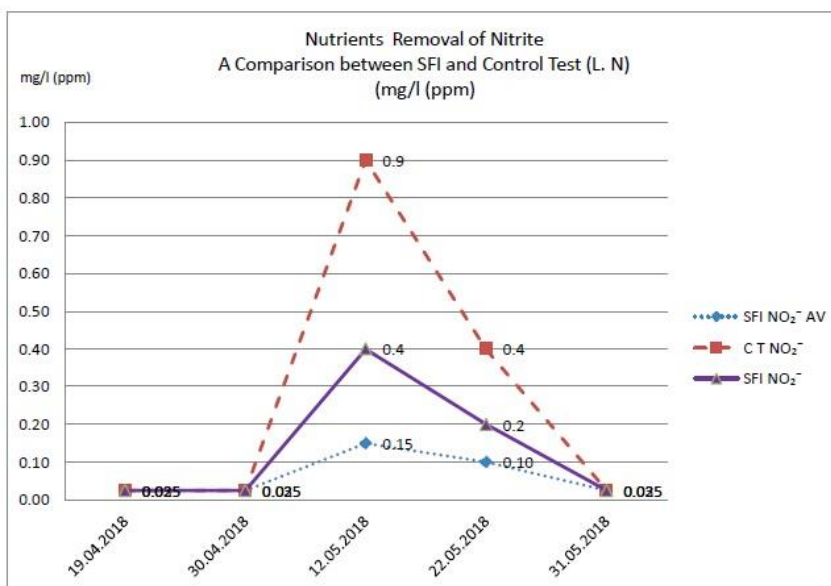
At the growing pond 11 the high nitrite peak was on May 12th but was lower than the control growing pond by 0.5 mg/l, but there was an identical final test with control growing pond at the end of the experiment (figure 25).

FIGURE 25. Nitrite removal chart from growing pond 11

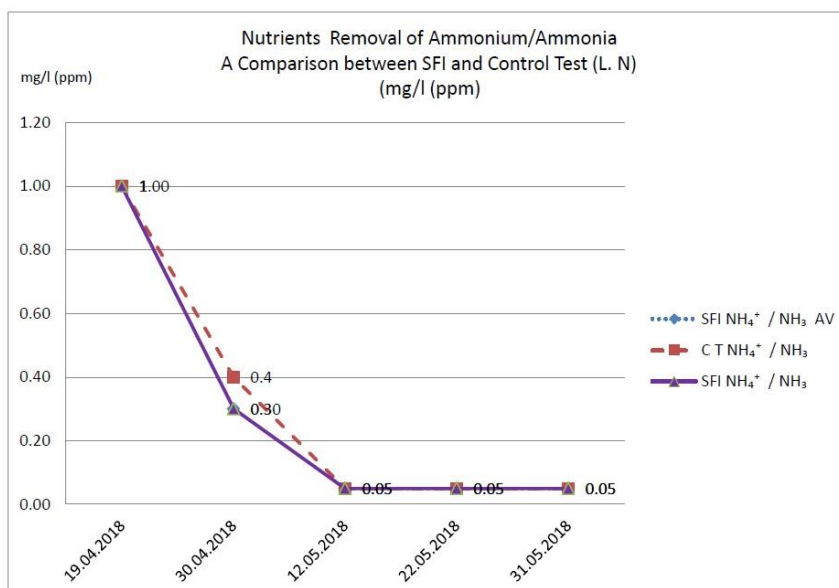
In growing pond 1 where the nutrient concentration is low, the final result of Ammonium/Ammonia on May 31<sup>st</sup> was equal to that of the control growing pond at the same date. It is also observed that on April 30<sup>th</sup> the test results of Ammonium/Ammonia are lower than the control growing pond by 0.1 mg/l as seen in (figure 27) and then there were matching test results between the growing pond and the control growing pond. A similar result is also observed at low nutrient concentration growing ponds number 2, 5 and 11 seen in (figures 27, 31,32) respectively.

FIGURE 27. Ammonium/Ammonia removal chart from growing pond 1

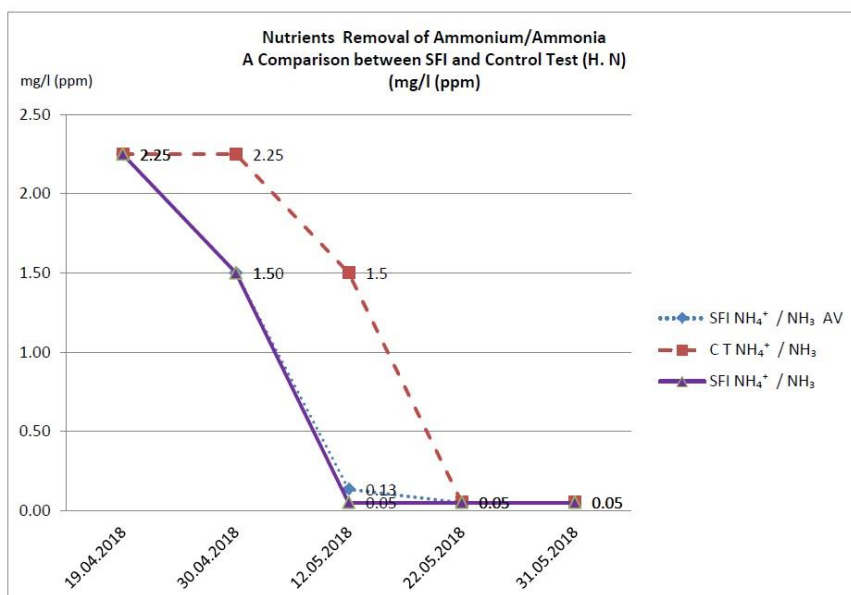
FIGURE 30. Ammonium/Ammonia removal chart from growing pond 4

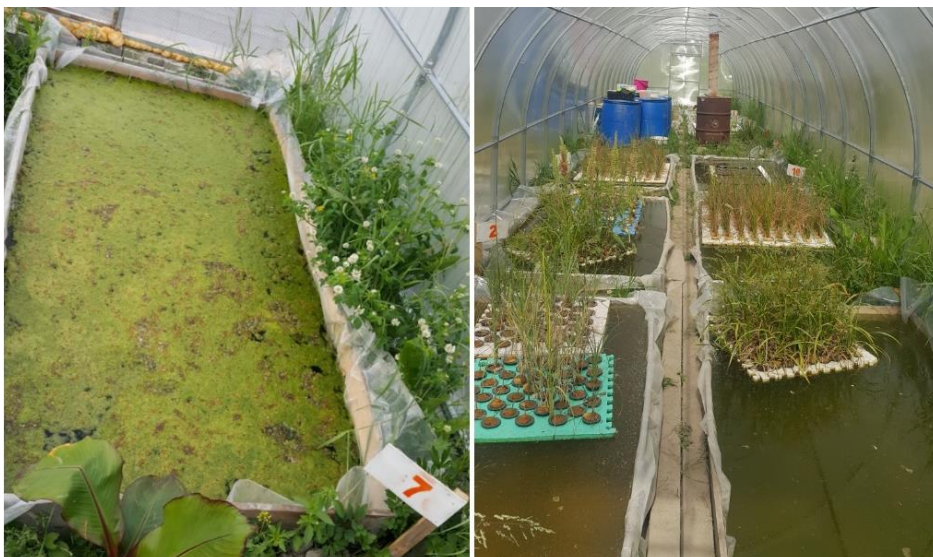
The algae growth was inhibited at the growing ponds equipped with SFI compared to the control growing ponds with no SFI (picture 17).

PICTURE 17. Algae growth; on the left is the control growing pond and on right growing ponds equipped with SFI

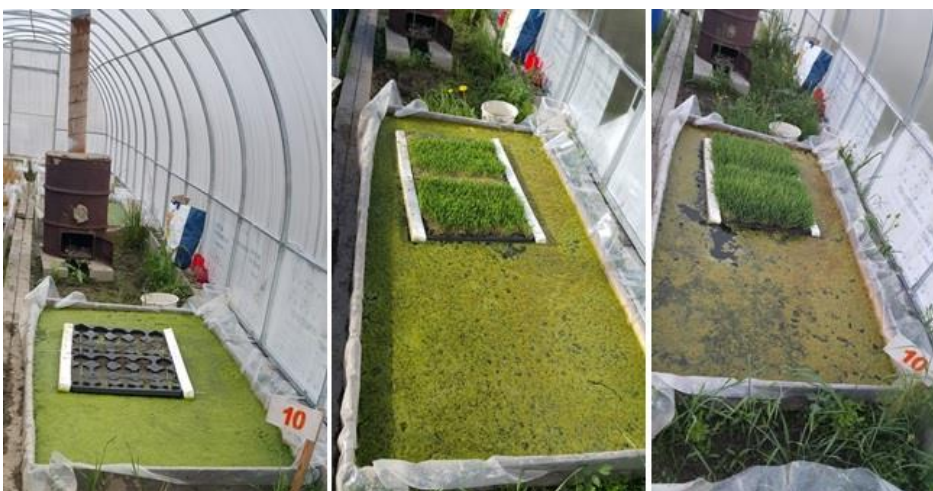
Moreover, in growing pond10 (picture 18) shows the three stages of *Avena sativa* growth along with the algae that cover the rest of the surface area.

PICTURE 18. Stages of the growth of *Avena sativa* and algae in 15 days (from left to right)

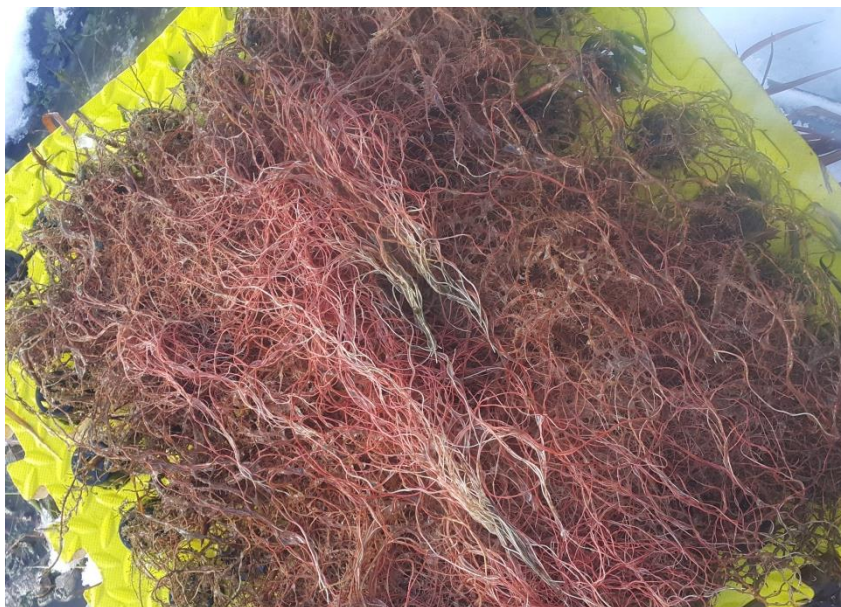
The plants that succeeded in the new aquatic condition showed good root growth although the growth varied between the types of plants. The largest root growth was observed in *Scirpus sylvaticus* (picture 19).

PICTURE 19. Roots growth of *Scirpus sylvaticus* under SFI
