INFLUENCE OF NATURAL AND
MECHANICAL VENTILATION ON
THE INDOOR CLIMATE

Bachelor's thesis
Building Services Engineering

February 2012

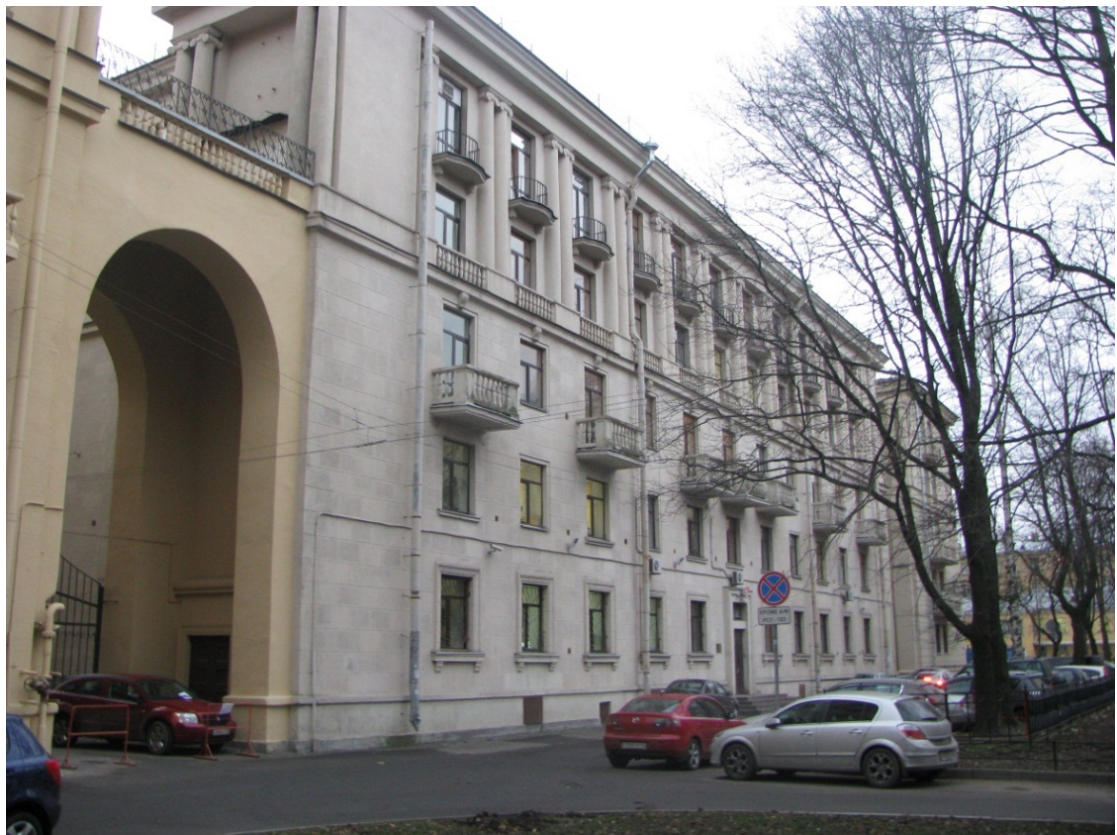
This office building is situated in Kirovsky area of Saint-Petersburg and it was built around 1938 (shown in Figure 4). It is made of concrete blocks and has five floors. The height of each stage is about 3,5m. The walls between the rooms are made of gypsum plasterboard. It has two stairs in the opposite ends of the building. In the center of each stage along the bigger side of the building there is a corridor. All rooms are connected to these 5 corridors. Toilets are in the left end of the building, near the stairs. Close to them there is a ventilating shaft. On the second floor there is a café with kitchen.

Figure 4. Outside view of case 1 (office building with natural ventilation in Saint-Petersburg)

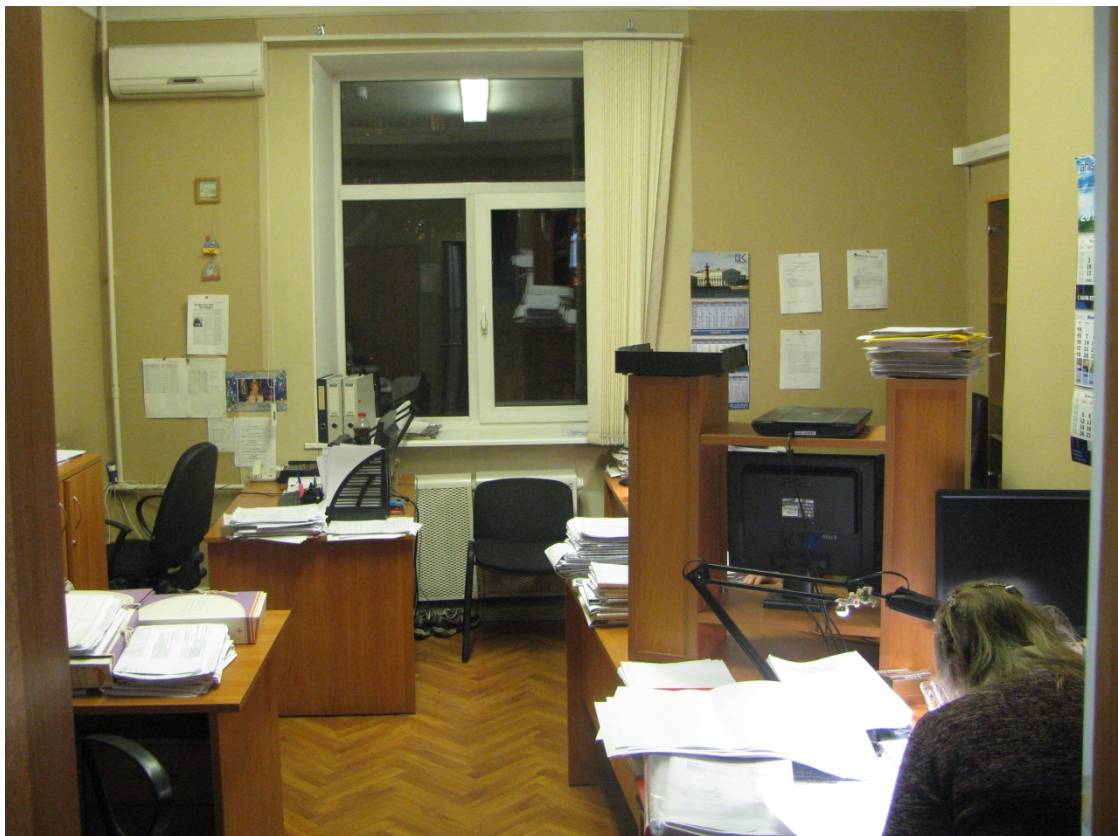
Figure 5. Typical room of model 1 with air-conditioner.

The building has natural ventilation. Ducts from rooms with exhaust air are going to the ventilating shaft. Unfortunately, some of ventilation diffusion cells are completely plugged up by the gypsum plasterboard. The reason for it is replanning of the building many times without any attention to ventilation. Supply air gets to the rooms from windows and leakages. In the toilets there are exhaust fans, which move dirty air to the ventilating shaft. There is also an exhaust fan in the kitchen. Some office rooms (but less than a half of the whole number) are equipped with separate air-conditioner units. Each room with it is equipped by two blocks – one inside and one outside. Other rooms in summer time often use fans that just move air inside the room. The typical room with an air-conditioner is shown in Figure 5 and room without air-conditioner is in Figure 6.

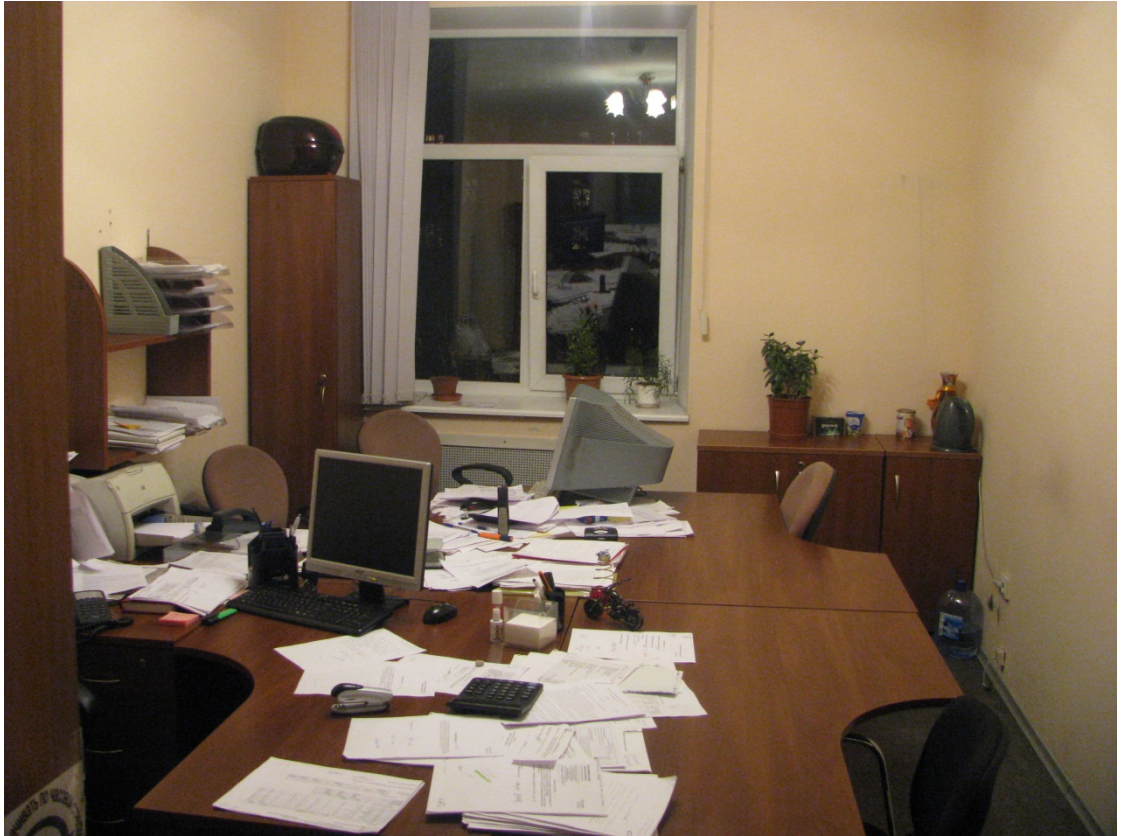
Figure 6. Typical room without air-conditioner.

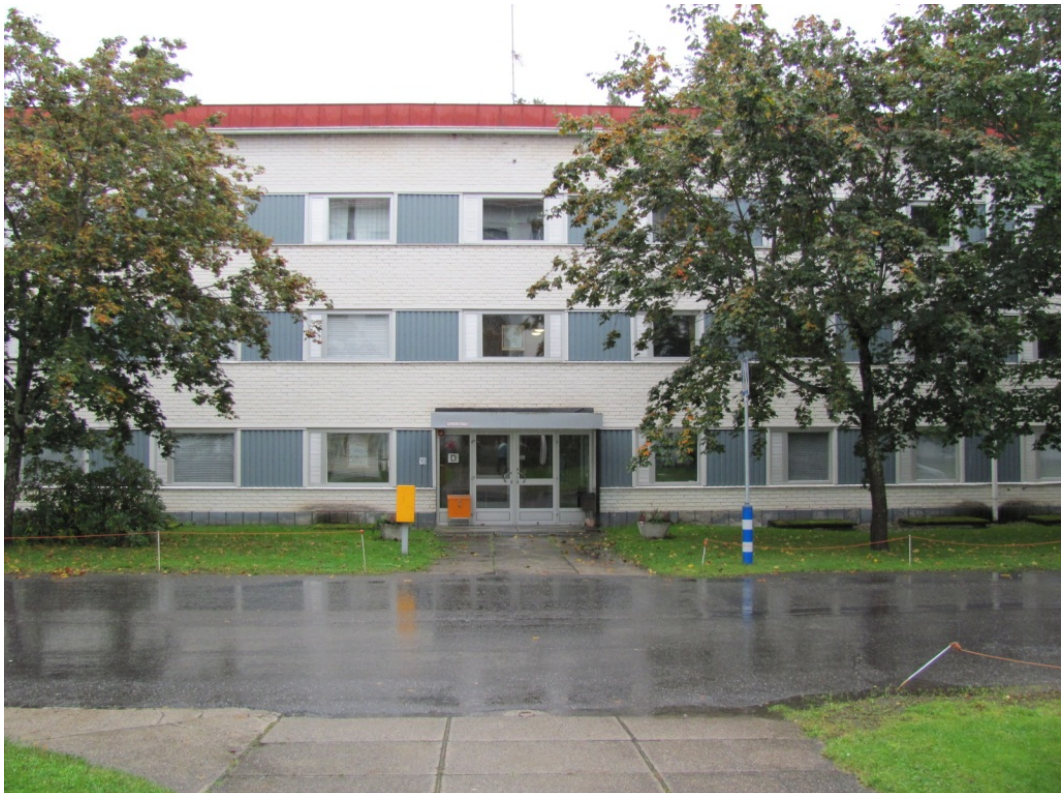
The second case is a hospital administrative building in Mikkeli (shown in Figure 15). In this building there are some administrative offices for example accounts department, a few rooms for patients and doctors. There are also some rooms on the 3rd floor, where the some of the staff live. This building is situated in south Mikkeli. It was built in the 1962. It is made of concrete and has 3 floors. The height of each stage is 2,55m. The walls between the rooms are also made of concrete. The corridors are situated in the center of floors and rooms are on the both sides of them.

Figure 15. Hospital administrative building.

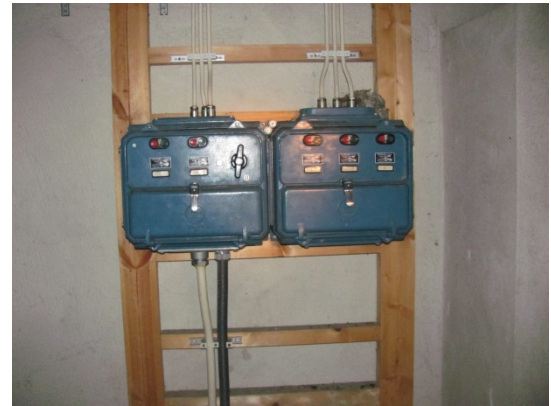
Figure 16. Fan on the attic.

In the past the building had mechanical supply and exhaust ventilation on the first floor and mechanical exhaust ventilation in all other rooms. The fan, which provides ventilation, is located on the attic (Figure 16). In the past it was controlled distantly, but nowadays this system (Figures 17 and 18) does not work.

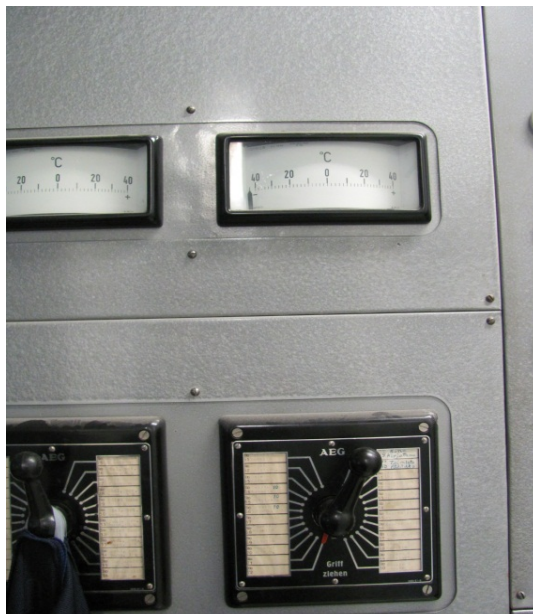
Figure 17. Distantly controlling system.

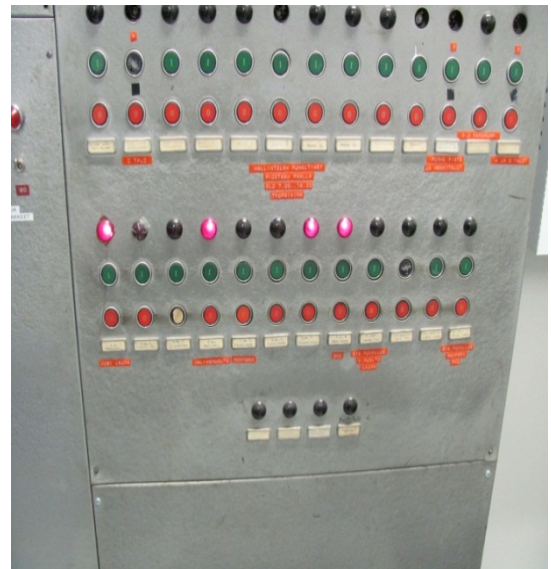
Figure 18. Distantly controlling system.

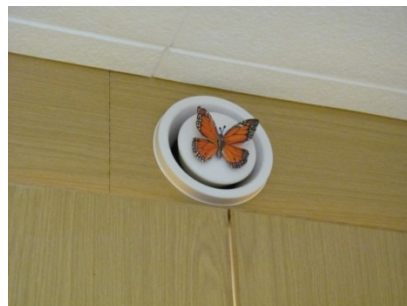
Figures 19 and 20. Ventilation devices on the 2nd and 1st floors.

There are 4 exhaust and 2 supply main ducts moving air from this unit to the building. However, it is not used at all for some reasons. Supply ventilation does not work in correct way (it is shown in the results) and exhaust ventilation is switched off because of complaints of staff. The problem is low temperature and draughts, caused by mechanical exhaust ventilation.

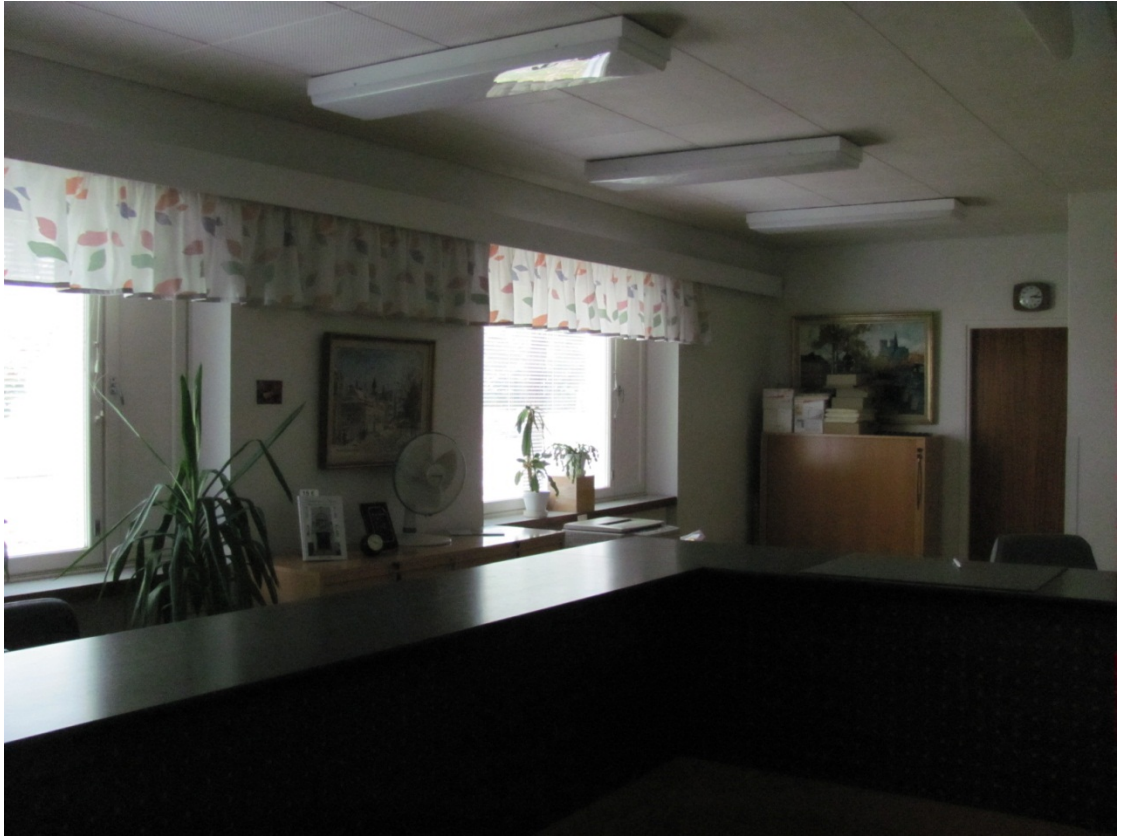
Figure 21. Room 1.

The temperature, humidity and CO₂ level monitoring were performed from 11.30 27.09.2011 till 11.10 04.10.2011 (fan switched off) and from 11.10 04.10.2011 till 11.30 13.10.2011 (fan switched on). Values of temperature and relative humidity were measured in two rooms and outside. Rooms were situated on the first floor (room 1) and on the second floor (room 2). The room 1 is on the Figure 21 and the room 2 is on the Figure 22. The first one was the room for customers with area about 30 m² and 3 workplaces and the second one was an office room with area about 10 m² and one workplace. The room 1 has both supply and exhaust ducts and the room 2 has only exhaust ducts. Outside measurements were done on the balcony near the stair. CO₂ level monitoring was performed only in room 2 on the second floor. Air flow rate and draft rate were measured on the 13.10.2011 in the same rooms.

Temperature and humidity were measured by data loggers (Ebro). Loggers were put at the work tables. The limits of measuring conditions for this type of devices are: from -30°C to +60°C and from 0 to 100% rH. The accuracy is $\pm 0,5$ °C and $\pm 0,5\%$ rh. CO₂ level was measured by TSI instruments HP12 3RT. The accuracy is 5 ppm. It was installed at the height of 1,7 m. Draft rate and air flow rate was measured by Swema air 300. Draft rate was measured at the level of 1,7 m. Air flow rate measurement in room 1 is shown in the Figure 23.

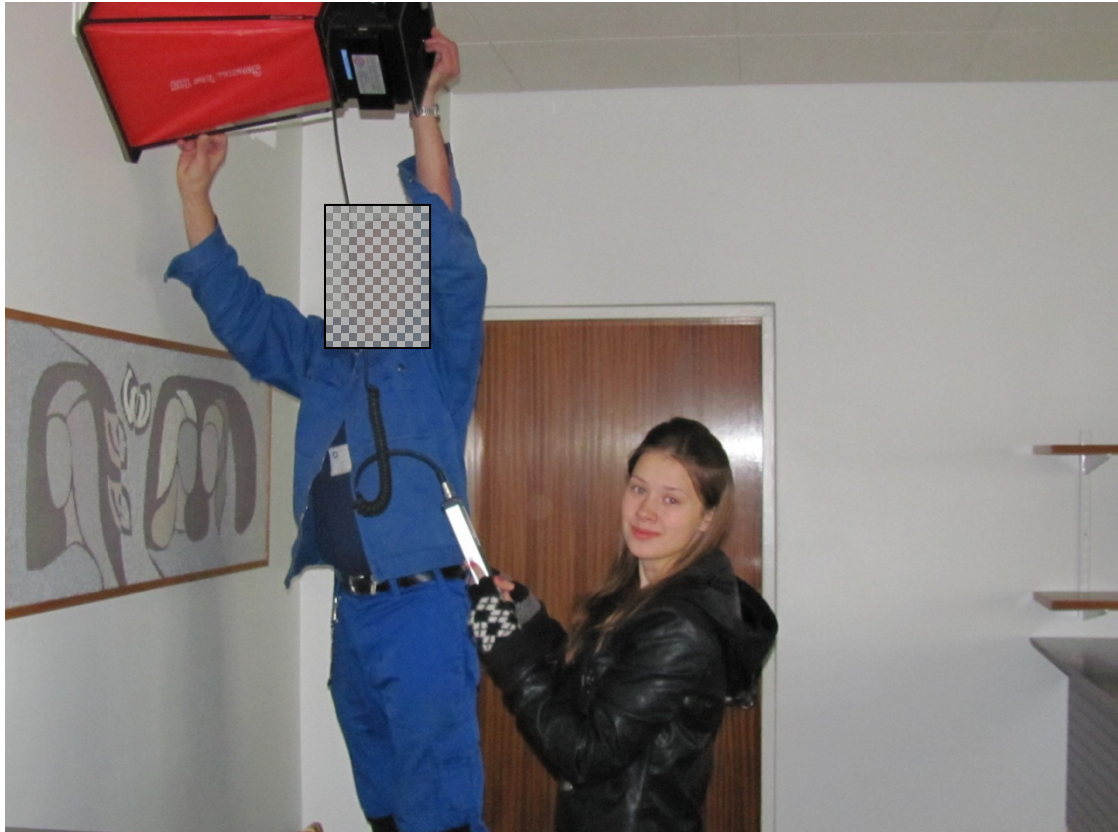
Figure 23. Air flow rate measurement in the room 1.

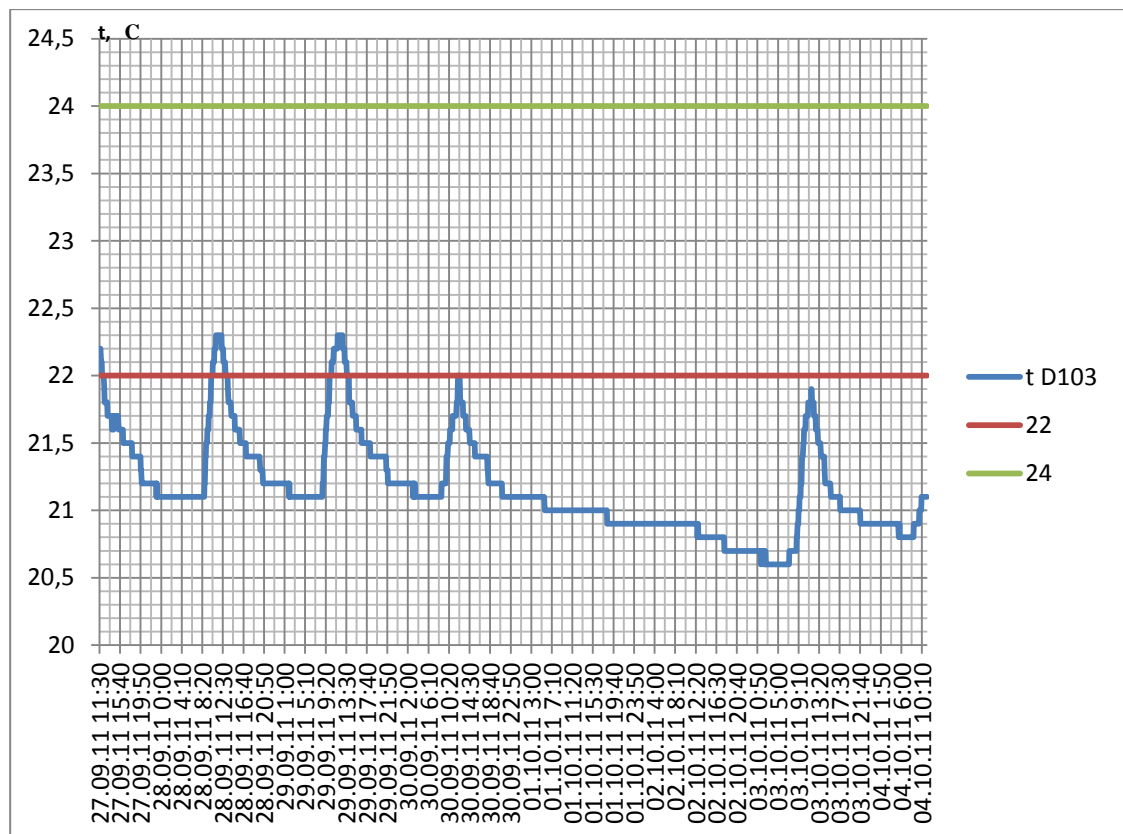
Inside temperature during this period varied between 20.6 and 22.3 °C, which is mostly under the lowest limit of comfortable temperature (22 °C). During the day long temperature graphic has a form of hill. The reason for it not only rising outside temperature (illustrated by Figure 25, more detailed in Appendix 9), but also heat from people and devices inside the room. (Extremely hot outside temperatures on the picture are not actual. They are accounted by direct sun light at the location, where the instrument was.) The top of «hill» corresponds to the middle of the work time between 11:00 and 13:00 and has values of temperature between 21.8 and 22.3 °C. There are no “hills” on the 1st and 2nd of November, because it was holidays and there was nobody inside the room. You can find a more detailed in Appendix 3.

Figure 24. Inside temperature in room 1 from 11.30 27.09.2011 till 11.10 04.10.2011 (fan switched off).

The temperature measurements (Figure 24), were made from 11.30 27.09.2011 till 11.10 04.10.2011 in room 1 which is situated on the first floor. The fan (and so the mechanical ventilation) was switched off during this period. Figure 24 has several lines: temperature line and limits: at 22°C and at 24°C. These limits are based on the calculating percent of dissatisfied persons in several conditions. When the temperature changes between 22°C and at 24°C there will be 10% of dissatisfied persons, if the metabolic efficiency is about 1-1,2 met = 105 - 125 W (office working) and insulation

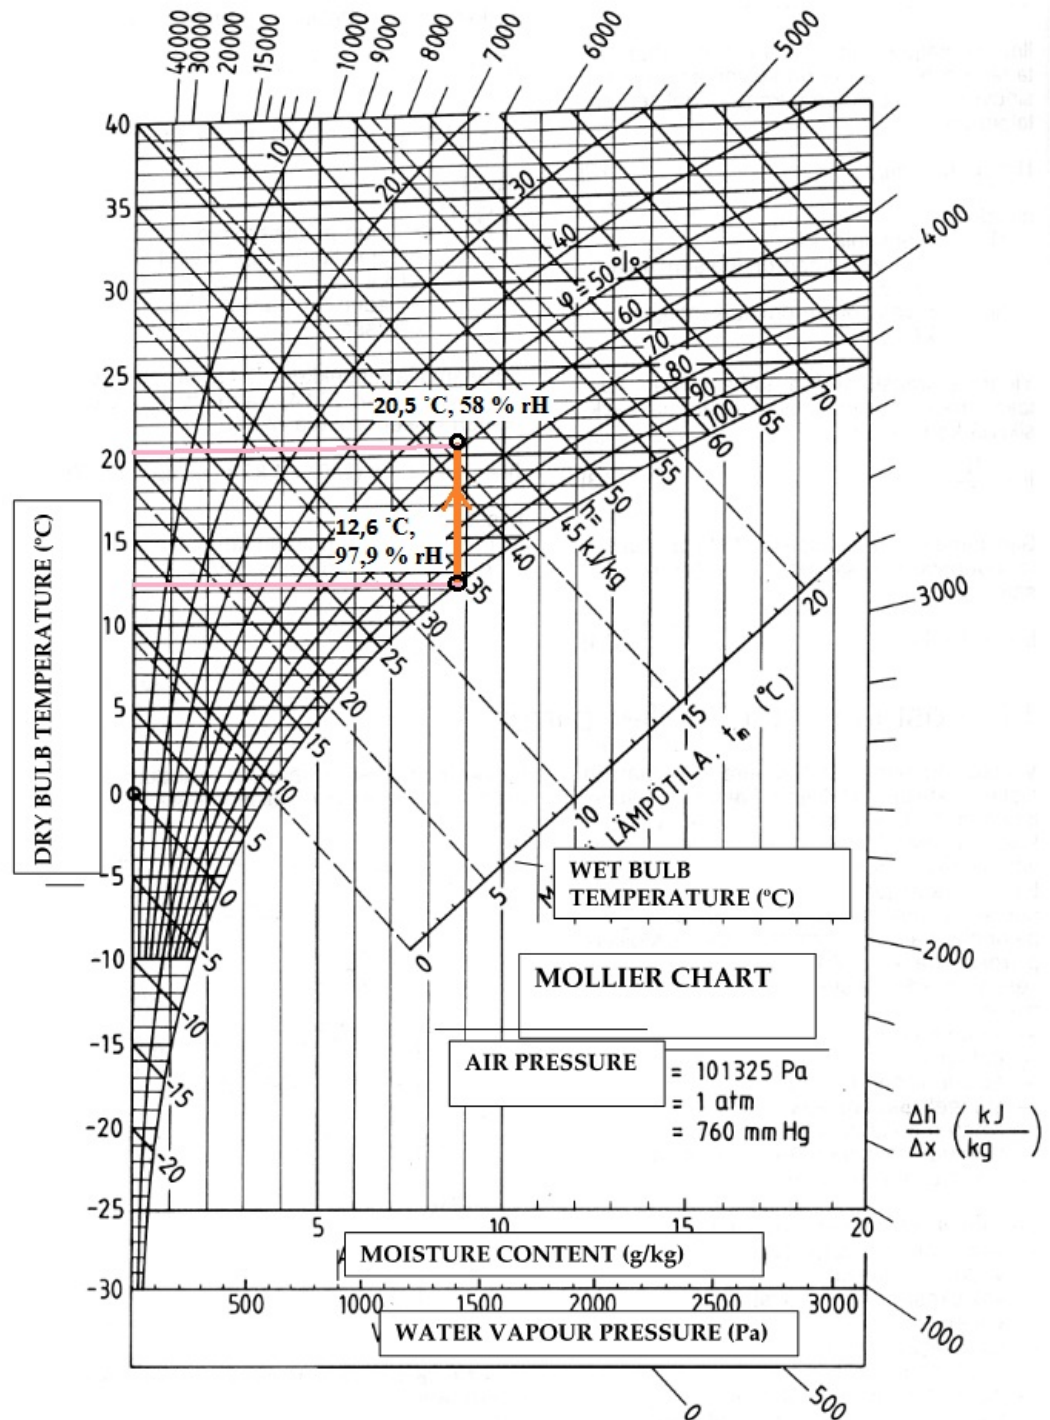
of 20,5 °C it's relative humidity decreases to the 58 %. This process is illustrated on the Figure 33. On the Figure 31 there is an another value of relative humidity at the end of the process, but this inaccuracy can be explained by moving air inside the room, uneven air heating and unknown temperature on which air is expected to be heated (only temperature of air in fixed point is known, near radiators, for example, it's another).

Figure 33. Mollier diagram with process of decreasing humidity inside the building.

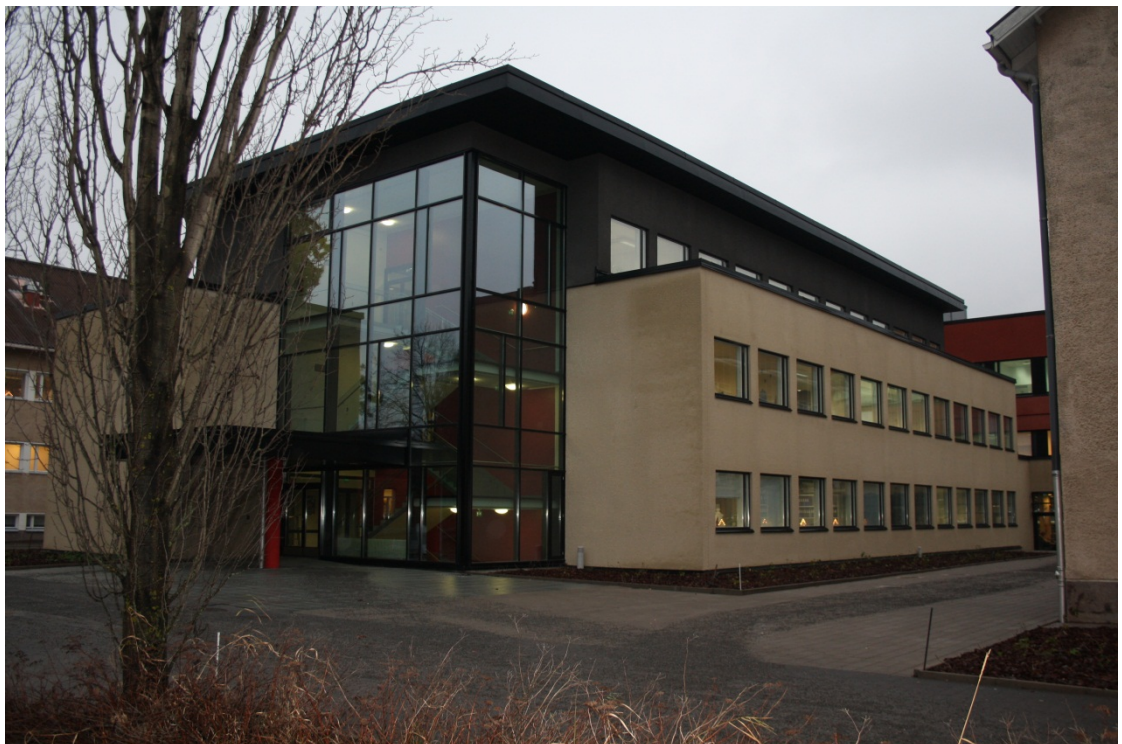
This building is situated near the center of Mikkeli. It was built in 2011. It is made of concrete, metal and glass and has 3 floors. The height of each floor is about 2,75m. The walls between the rooms are also made of concrete and plasterboard. The corridors are situated in the center of floors and rooms are on the both sides of them.

Figure 38. Office building (case 3).
