CIL Pilot Line Implementation

Bachelor's thesis
May 2014
Paperi-, Tekstiili-, ja Ke-
miantekniikka
International Pulp and Paper
Technology

This thesis was commissioned by SCA Hygiene Products' Nokia mill. The aim was to improve runnability and reduce downtime in packaging machines of converting line 1 of the Nokia mill by putting CIL into operation.

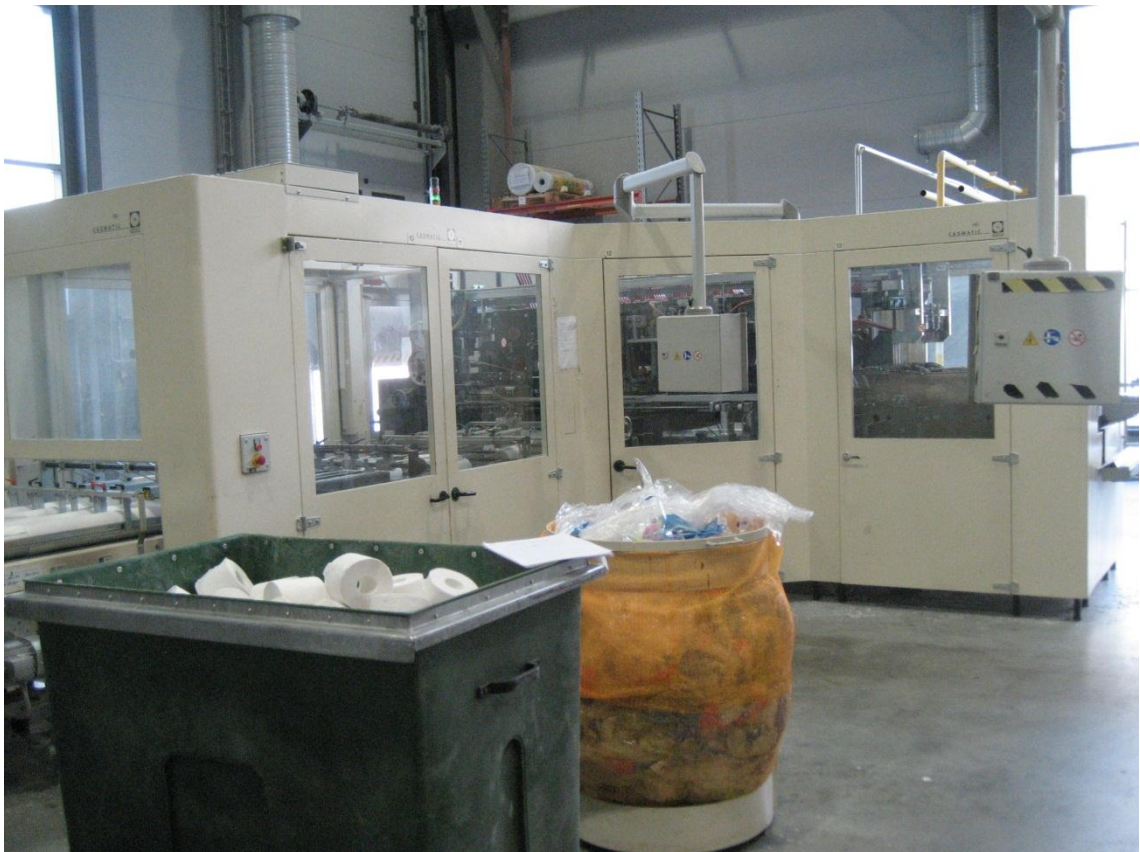
PICTURE 2. Körber Paperlink A5T in converting line 1

Packaging machine A5T is an automatic machine, which is made for wrapping toilet and kitchen towel rolls. Polythene film is used as wrapping material. The machine consists of mechanical, pneumatical and electrical parts, which are functioning together due to control processor. Packaging machine A5T has a wide range of different formats in its selection of packaging types, although, they are all for tissue papers. (Körber Paperlink A5T Operators Manual. 2006.)

The production cycle requires observation from one operator, who visually inspects that the machine is working properly. By using the latest knowledge of mechanical and electrotechnical information guarantees the high quality of the machine. The end product satisfies even the most demanding requirements. When packages come out from the machine, they are completely ready for storing or shipping to a customer. Picture of Körber Paperlink A5T is shown in picture 2. (Körber Paperlink A5T Operators Manual. 2006.)

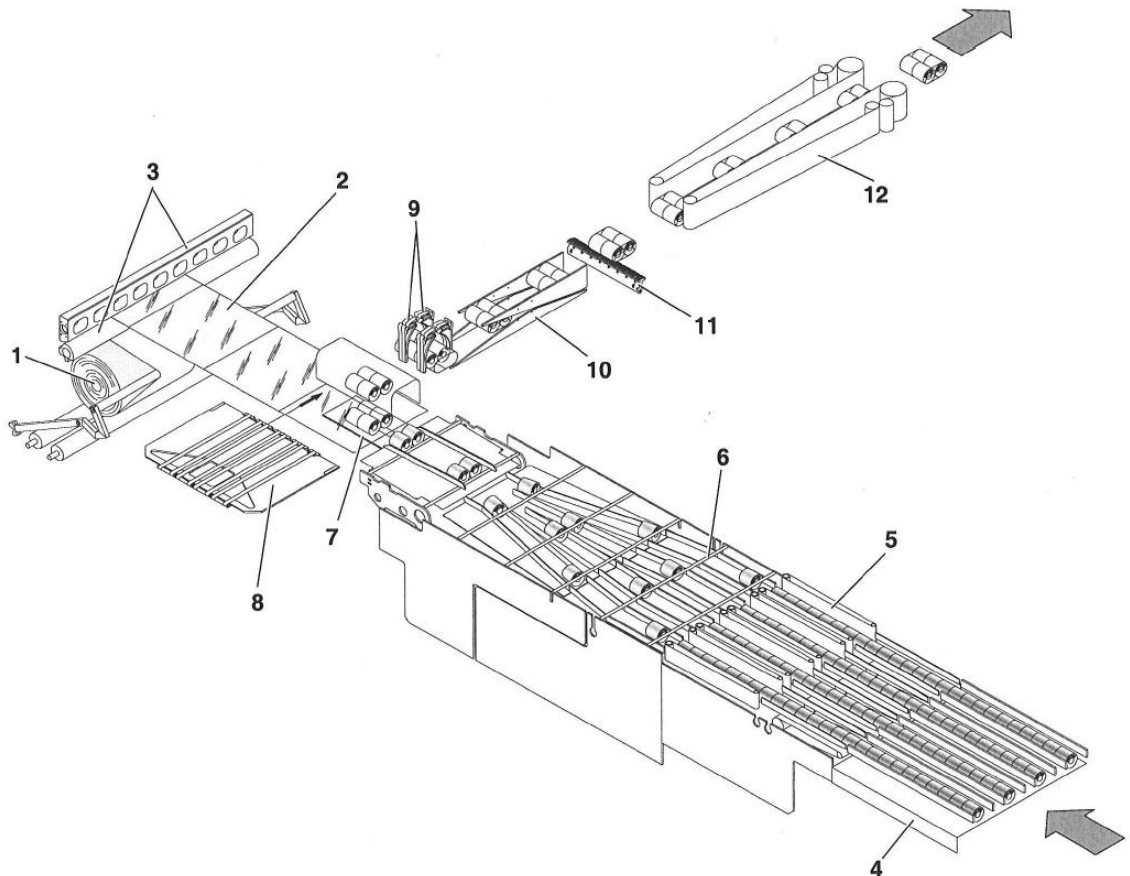
PICTURE 3. Function cycle of A5T packaging machine (Körber Paperlink A5T Operators Manual. 2006.)

The polythene film is unwound (1). Film is pulled by centering belts (2), and cut to the right size by blades (3). Toilet paper rolls come from conveyor to the accumulation belt (4), which transports the product to the launcher belts (5). Launcher belts separate the rolls according to the packages size, for example six or eight rolls. Then the initial feed (6) moves the rolls to the elevator (7). Elevator lifts rolls to the packaging film, and the lower folder (8) makes backside folding of the film. Drawer (9) moves the product and when it is against the bottom folder, the film wraps around the rolls forming a “tube”. Folders (10) finish the package by folding the sides. Lower sealer (11) heat seams the film crosswise, and seaming belts (12) seal the side foldings. Picture 3 shows the functioning cycle of Körber Paperlink A5T. (Körber Paperlink A5T Operators Manual. 2006.)

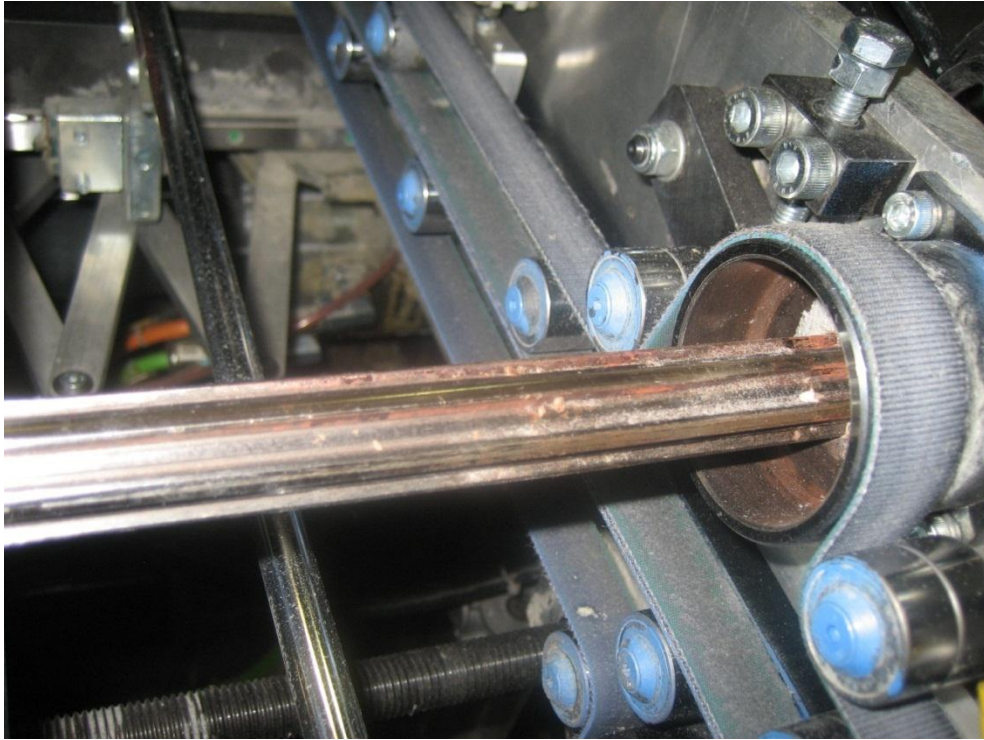
PICTURE 5. Axis of centering belts on initial cleaning day

Axis of the centering belts was selected as a CIL-target because it was noticed in initial cleaning event that the axes were rusty. It turned out that the axes had never been lubricated in the whole time that the packaging machines have been in the converting line, approximately six years. We discussed about this with the Nokia mills converting trainer, and decided to use CRC Dry Lube to lubricate the axes. The condition of axes on initial cleaning day is shown in picture 5. Frequency for lubrications would be one week, during the weekly cleaning events.

Next step was to make CIL-list about this action. First step was to think what equipment is needed to successfully perform this task. Of course, personal protection equipments are needed, as always in the production areas. Another thing required is CRC Dry Lube for lubing the axes, as mentioned earlier. These things are written to the CIL-list, so everyone is able to know what is needed for this task.

Before the actual performing, it is mandatory to think how this task could go wrong. In this case, it is important to point the lube straight to the axes, so it doesn't spill to the centering belts or anywhere else into the machine. Another thing is not to use too much lube, since the converting line is very dusty environment. Using too much lube would leave the axes wet and they would collect dust and make the axes dirty, and that would harm the process.

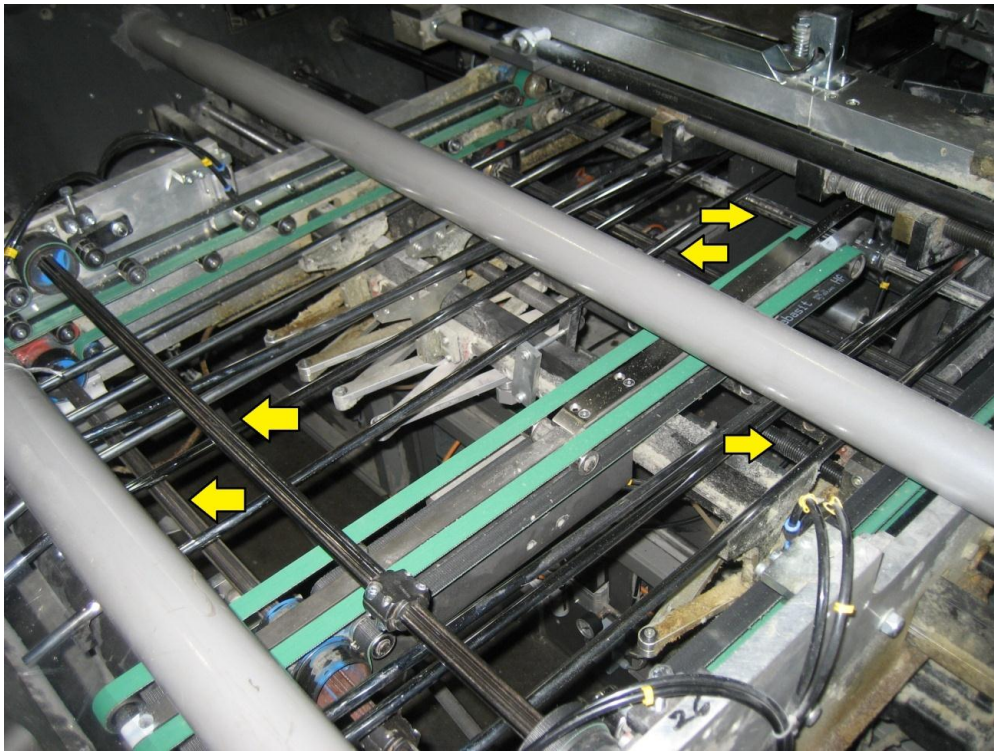
PICTURE 6. All axes of centering belts

When these things are checked, the actual lubing can be performed. Simply lube all the axes from the machine. Axes are pointed out by yellow arrows in the picture 6. After lubing check also the condition of the centering belts, that they are in good shape, and there are no fractures of other defects.

When we performed this task for the first time with the converting line operators, we noticed that it would be easier to spread the lube to the axes with a sponge. By spraying CRC Dry Lube to the sponge and then doing the lubing makes it more improbable that the lube gets in unwanted places. Using the sponge helps the performing because the centering line area is quite narrow, and it is hard to fit the lube can in every place needed.

HOLDERS for the CRC Dry Lube cans were also ordered after the implementation of this CIL-task. Holders are installed inside the packaging machine close to the axes. This way the Dry Lube is always in the same place, and time doesn't get wasted in finding Dry Lube cans around the converting line.

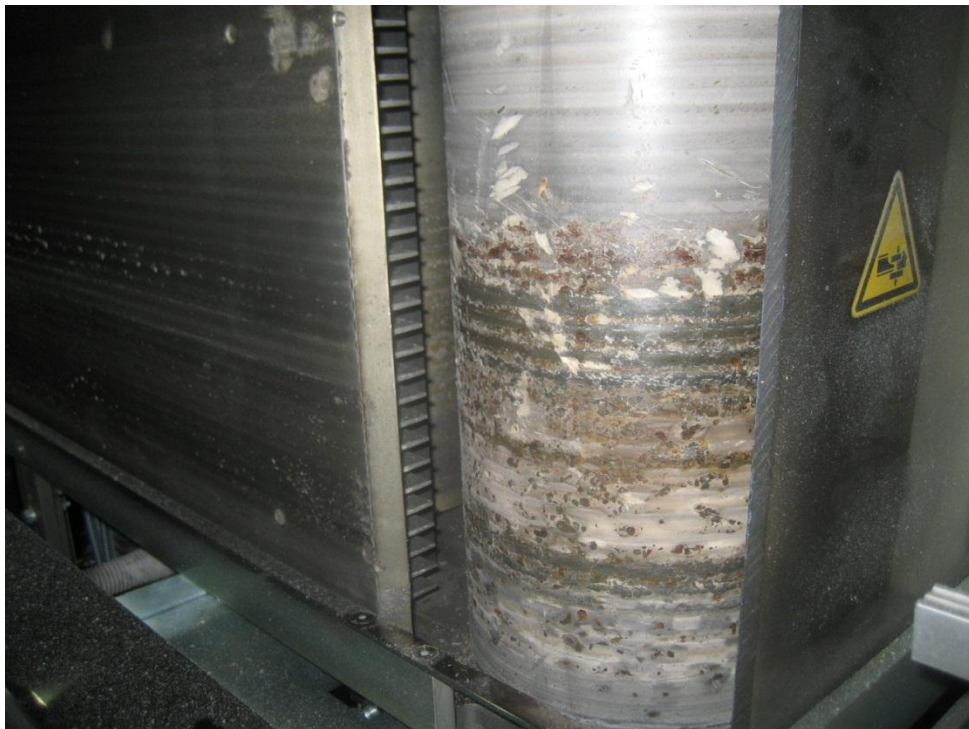
PICTURE 7. Tension roll of the seaming belts

Second CIL-target was the tension rolls of the seaming belts. The rolls that are in the process now are VRS-HYDRIL 11+-3PJ. It was noticed during the initial cleaning event that the rolls are in awful condition. The problem is that the seaming belts are in high temperatures, over 200°C, and during the process the film from the toilet paper roll

packages melts on the surface of the roll. There are no instructions yet how the rolls should be cleaned.

Tension roll is shown in picture 7. Brown material on the rolls surface is the melted film. Holes, which show as white marks on the roll, are traces left from knife some other sharp object. Someone has been trying to remove the melted film with a knife, which is definitely not a good way of cleaning the rolls. As seen from the picture 7, it harms the surface of the roll.

I interviewed the maintenance team of the mill, workers on the warehouse and even an external maintenance team that worked on the converting line during shutdown week. No one seemed to have a clear idea about the cleaning of the rolls. The rolls are resistant to chemicals, so they won't help in the cleaning. Best suggestions for cleaning the rolls were to sand or peel the melted film off the rolls. These are not very good ways for this particular action, because the rolls are in a narrow place, and it takes a long time to take the rolls out of the machine. Point of CIL-task is that it is easy to perform during normal work or cleaning events. Removing the rolls for every time for cleaning is not that kind of action.

Supplier of the rolls, Vaahto roll service, was contacted. I told development engineer of Vaahto roll service about this cleaning problem. She also suggested peeling as the best way for cleaning the rolls, but we had to dismiss the idea because that is not possible in our process. We had to think some alternative ways for solving the cleaning problem. Vaahto started testing other roll materials that the film used in the process wouldn't stick. When the test results were ready, Vaahto suggested rubber filled nitrile rolls. In their tests film didn't stick on to the rolls at all. Only problem was that the rolls heat resistance is only 140-150°C, when in the process it is over 200°C. Next proposition was rolls coated with fluororubber. Film didn't stick on these rolls either, and its heat resistance abilities would suit in our process. Only problem was this time that Vaahto can't get this rolls as hard as our rolls are now. The hardness on rolls is 95 Shore A, and fluororubber rolls are possible to get in hardness 90 Shore A. I discussed about this with RST and maintenance teams, and they said that the difference in hardness doesn't affect the process.

We also contacted Teknikum, which is a roll supplier too, considering this same subject with the tension rolls of the packaging machines. To our surprise they suggested different kind of rolls that Vaahto had suggested to us, and they wouldn't recommend the use of fluororubber at all in this kind of process. Teknikum's engineer asked that could he come to visit the Nokia mill and see the packaging machines in action. We are now planning on the details of this visit.

Tension roll of the seaming belts didn't make as a CIL-list because the cleaning is hard to put into action with the knowledge we have now. RST team is working on solution for the cleaning problem. Whether it is a new cleaning method or different roll material, the problem will be fixed.

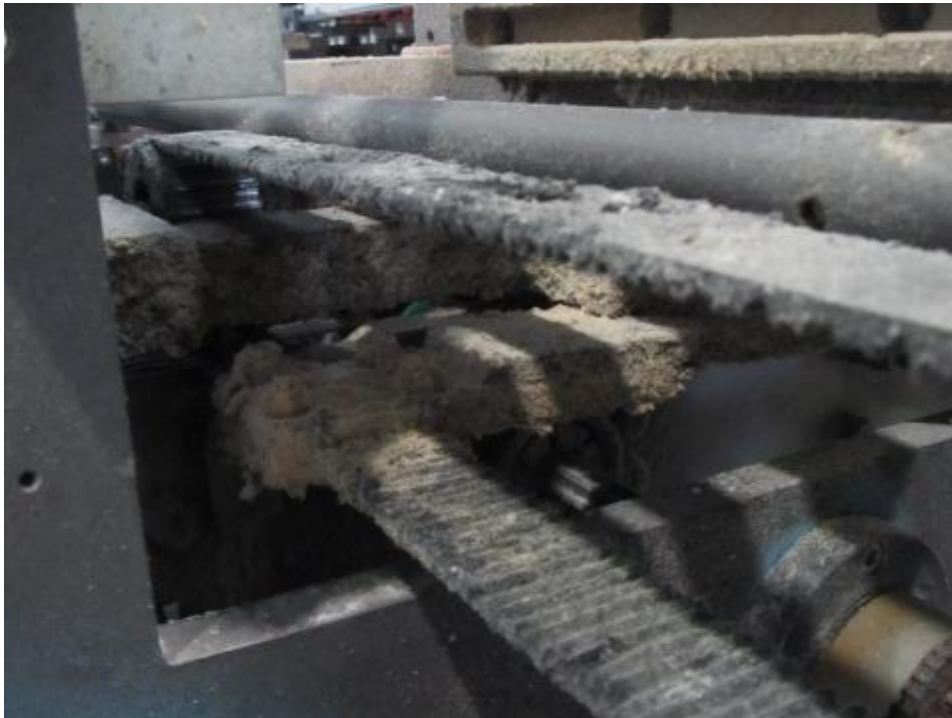
PICTURE 8. Belt of the back folder

In the packaging machine 1 lubrication doesn't work properly, and there is oil in places where it shouldn't be. It was noticed on the belts of the back folder. Oil in unwanted places causes impurities because dust sticks to it. This is shown in picture 8.

The cause of this oil leak is still unknown and to find the root cause of the problem RCA is needed. RST team is currently working on this problem so we don't know the answers yet.

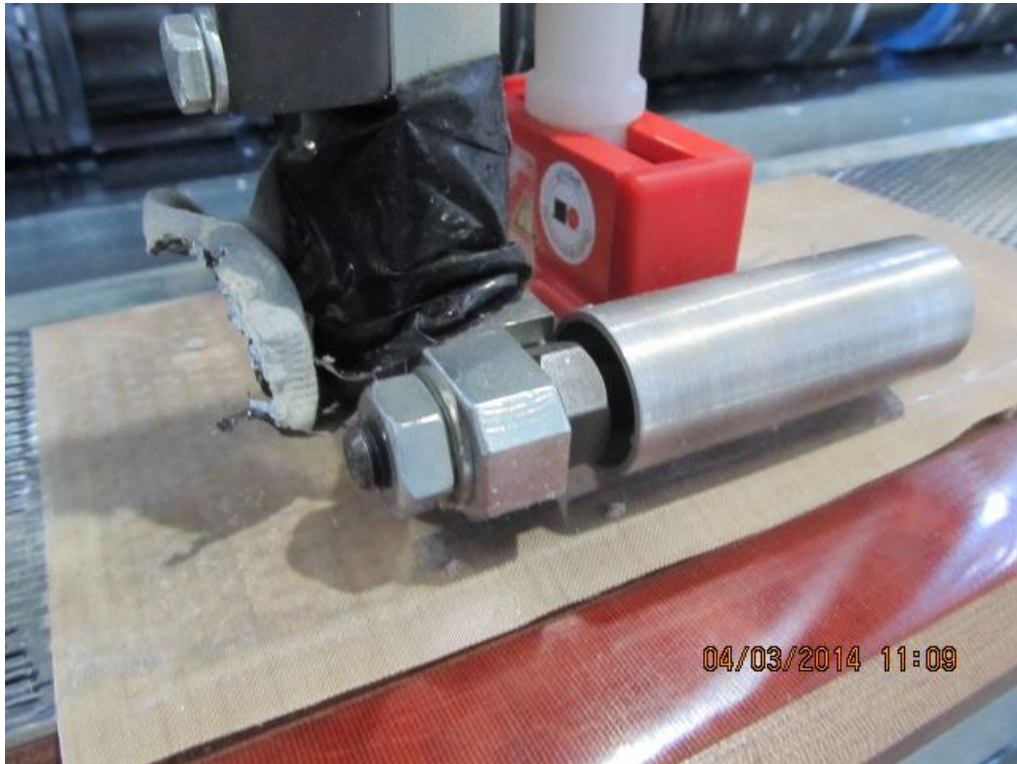
PICTURE 9. Ionizer of packaging machine 1

The function of the ionizer is to charge handle cord, so it sticks to the packaging film until they are seamed together by the seaming belts. Ionizer is the red box in the picture 9.

The problem here is that without the black tape, as seen in picture 9, the ionizer grounds to the support of the ionizer. That causes electric arc between ionizer and the support.

The theory of CIL says that no tapes are allowed in the machines, so this tape has to be removed. But it can't be done until the solution for the grounding and electric arc problem is found. Using the root cause analysis is a good way of doing that. One thought was that maybe the ionizer is in too high volume. We don't know the answers yet as the RST team is still working on this problem.

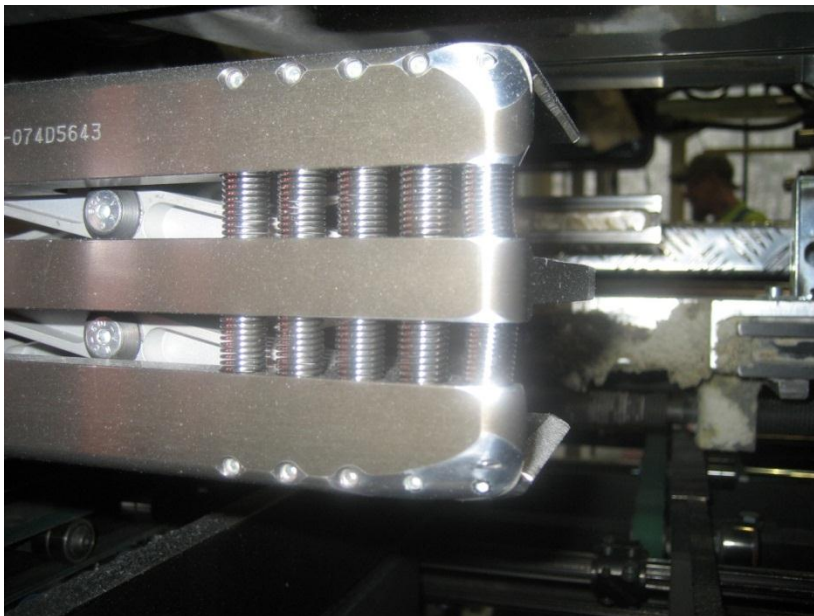
PICTURE 10. Worn-out moving folder

Another thing slowing down the elimination of the defect list is that some parts of the machine are very time-consuming to replace and the line needs a shutdown in order to replace these parts. It is also important to shop around with the suppliers of these parts to get them for best price. Moving folders are one example of this kind of part of the packaging machine. Moving folder is shown in the picture 10. It is clearly visible that the folder is very battered.

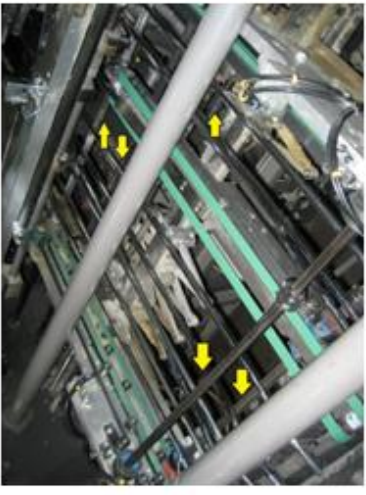
<p>Location: Axes of the centering belts on both packaging machines</p>	<p>Description: Lubing of axes of the centering belts</p>	<p>Equipment: CRC Dry Lube, personal protection equipment</p>	<p>Frequency: Weekly cleaning event</p>

<p>Before starting make sure that Dry Lube or oily dust doesn't spill on the belts.</p> <p>Performing:</p> <ol style="list-style-type: none"> 1. Clean the axes from dust by using compressed air 2. Lube all axes of the centering belts from both packaging machines with CRC Dry Lube 3. Check the condition of the belts, that there are no fractures or other defects <p>The tasks purpose is to improve reliability of the centering belts.</p>
