Electrical survey and risk analysis of a museum building

Bachelor's thesis

HAMK Valkeakoski Automation engineering

Fall 2017

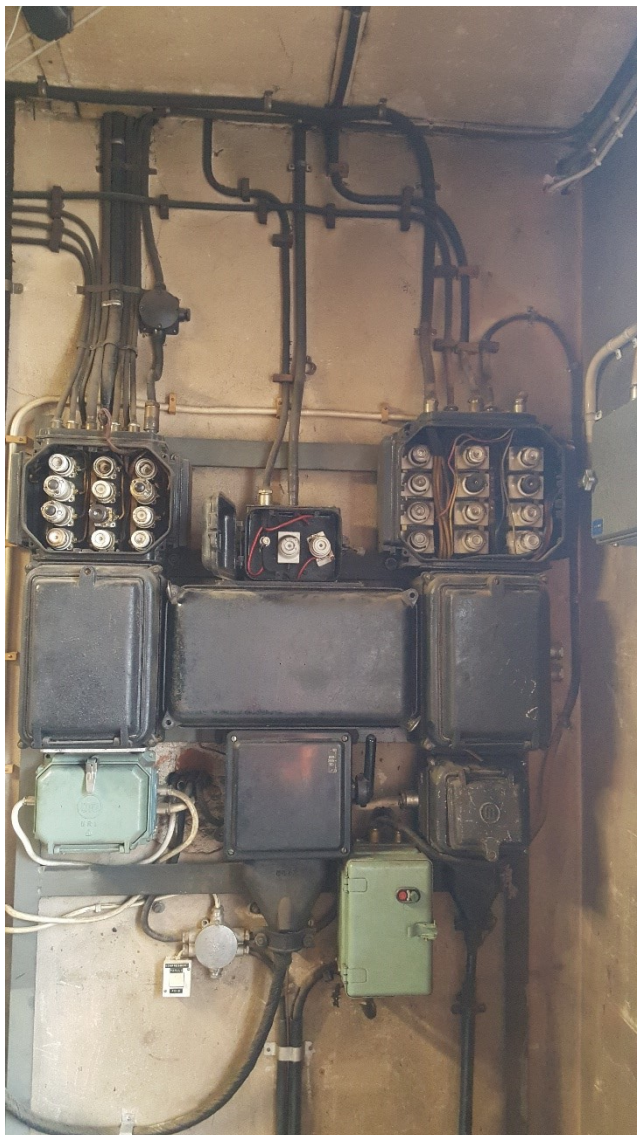
Figure 15 C. Main distribution cabinets.

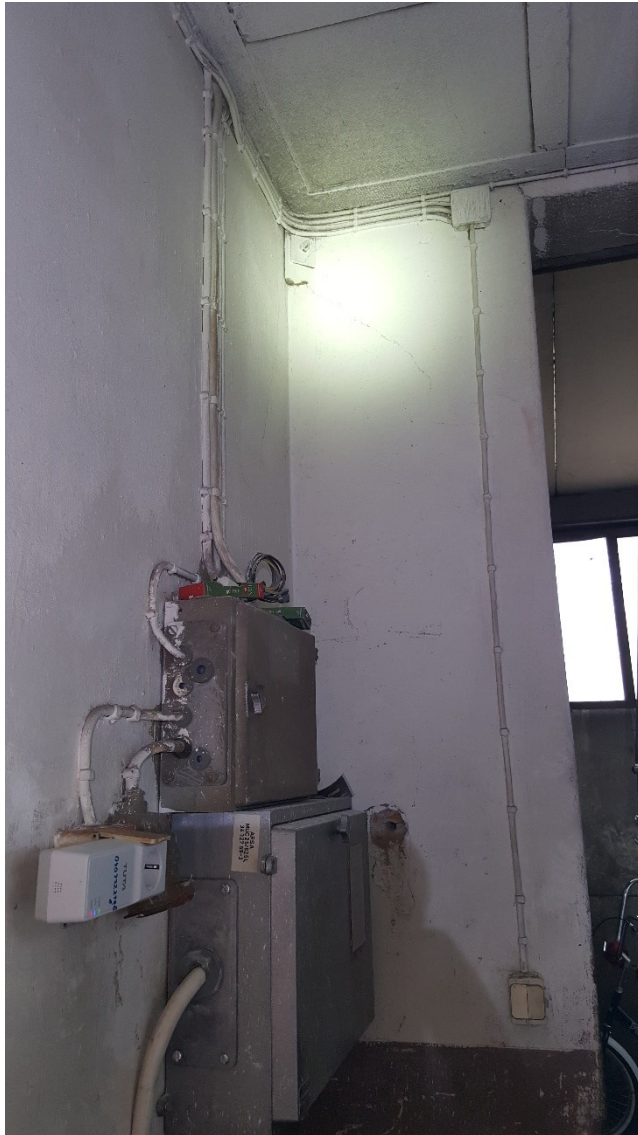
Figure 16 D. Service hall cabinet

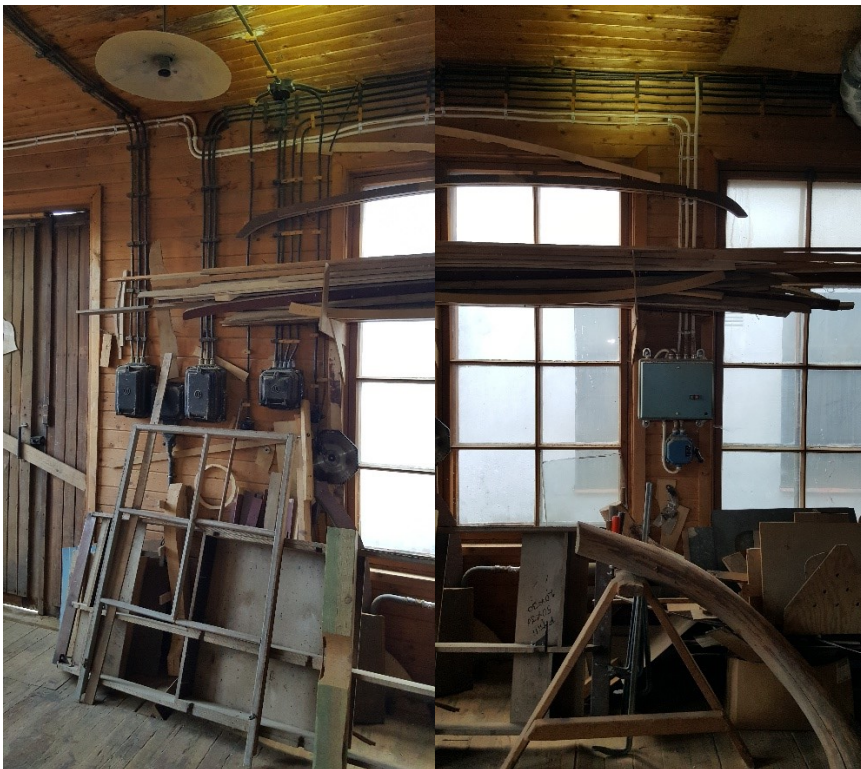
Figure 18 F&19 F. Wood workshop cabinets

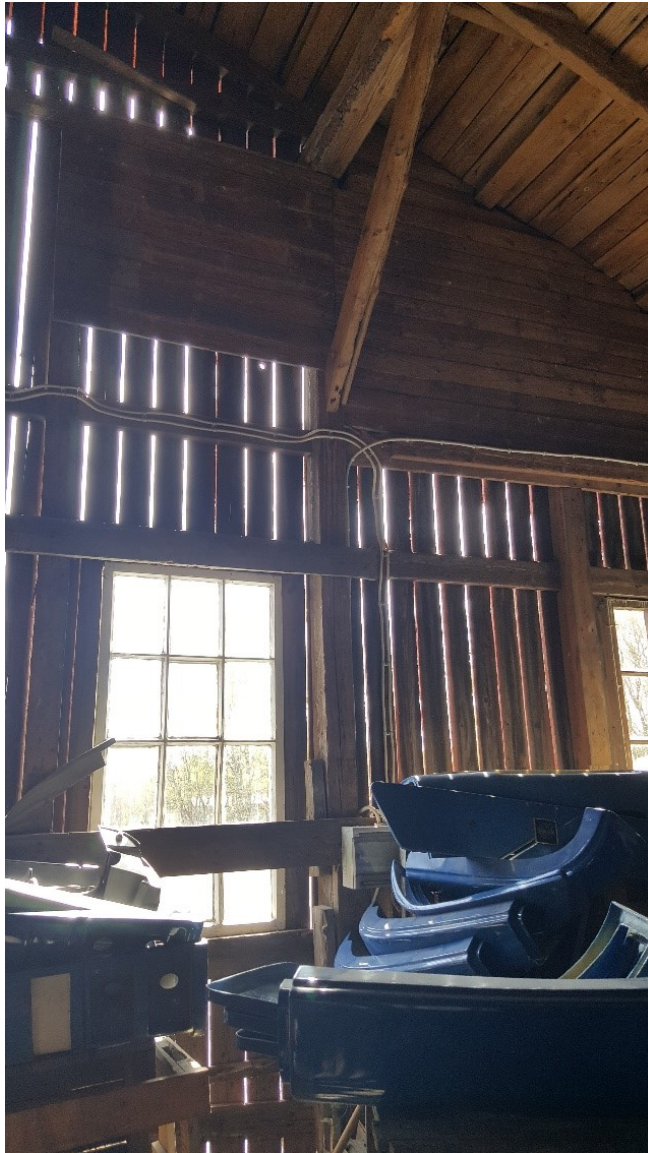
Figure 20 S. Warehouse cabinets

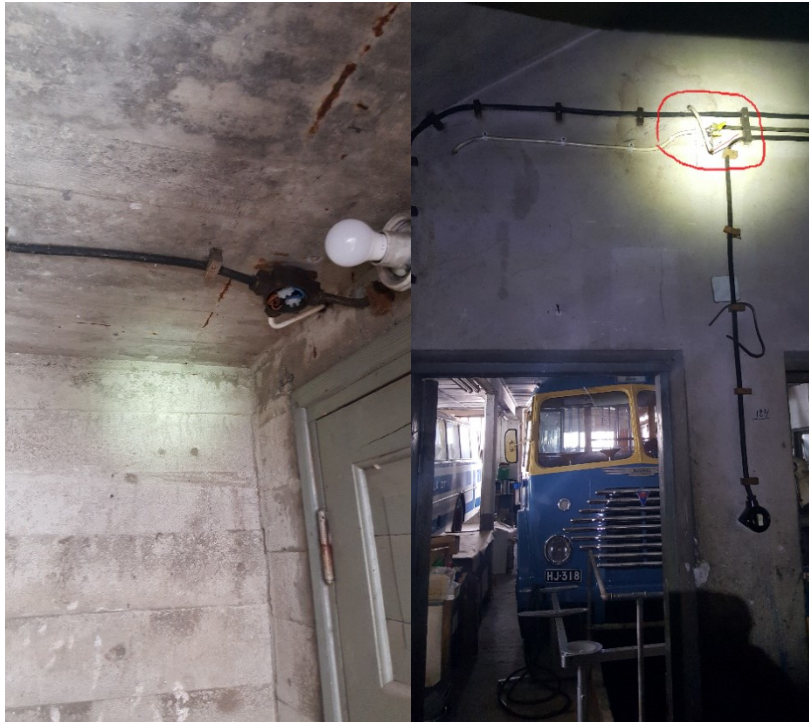
Figures 21,22,23 and 24 illustrate the defects in PK1.

PK1 defects 1.3 Incomplete junction boxes

1.9. Cables cut upstairs.

Figure 21 room A Missing cover & 22 room C missing distribution box.

Old system replaced with a new system.

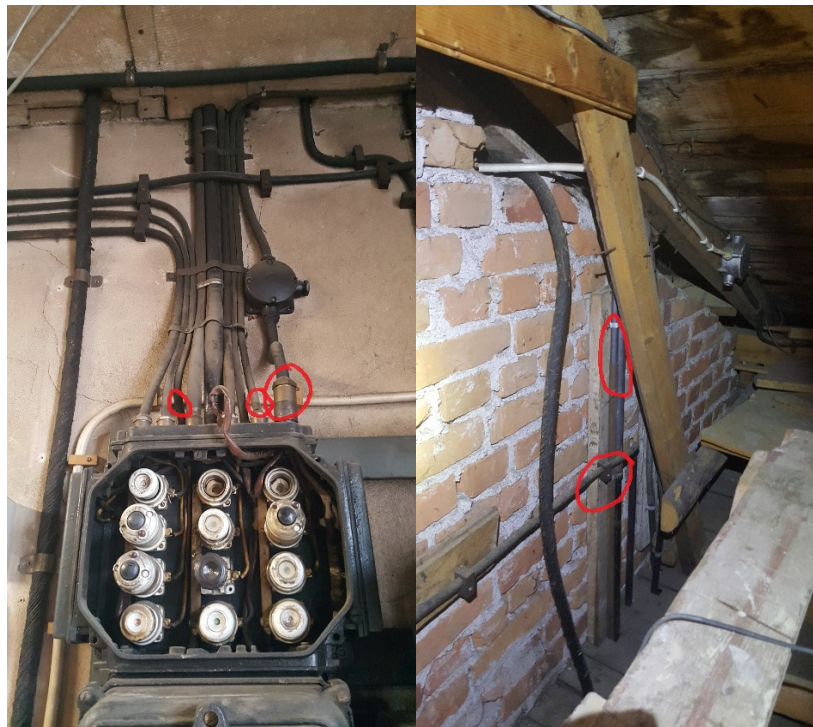
Figure 23 room C Cabinet PK1 & 24 room H cables on the attic.

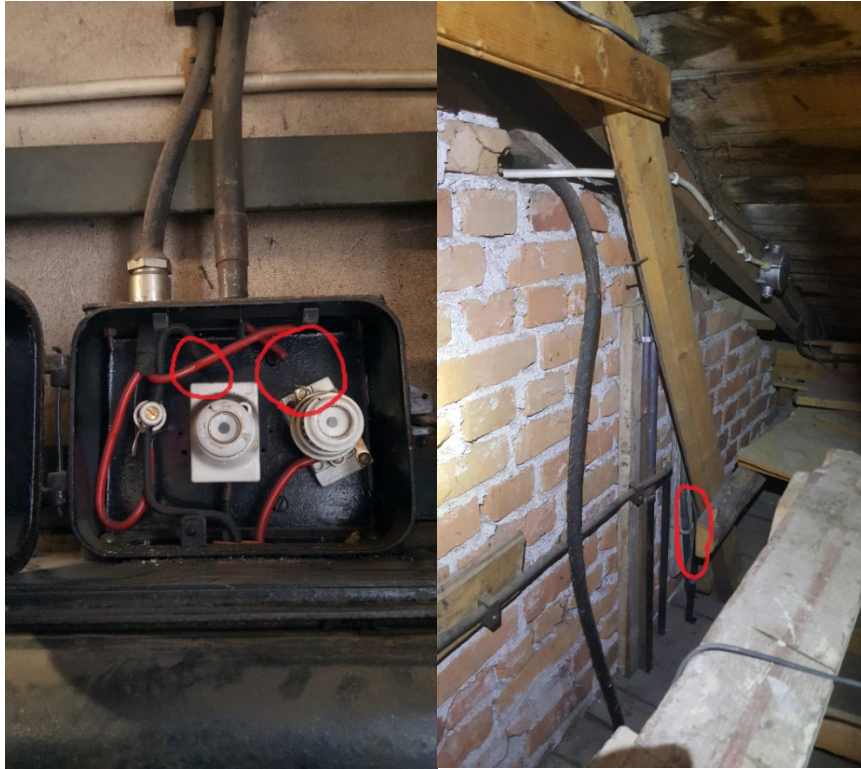
Figures 25 & 26 illustrate the defects in PK2.
 PK2 defects Cables cut and not removed.
 Old system replaced with a new system.

Figure 25 room C Cabinet PK2 & 26 room H corresponding cables on the attic.

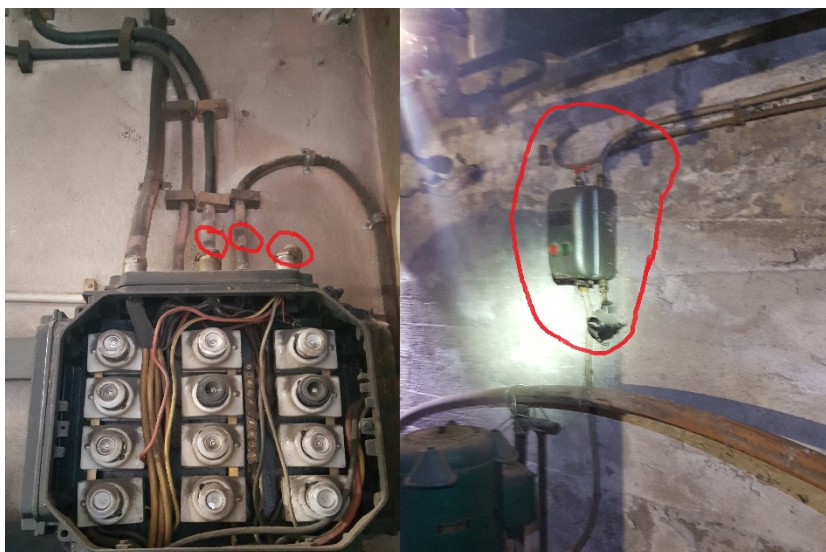
Figures 27 & 28 illustrate the defects of PK3.

PK3 defects 3.3 System disabled
 3.4 System disabled
 3.5 System disabled

Figure 27 room C Cabinet PK3 & 28 room B system in basement.

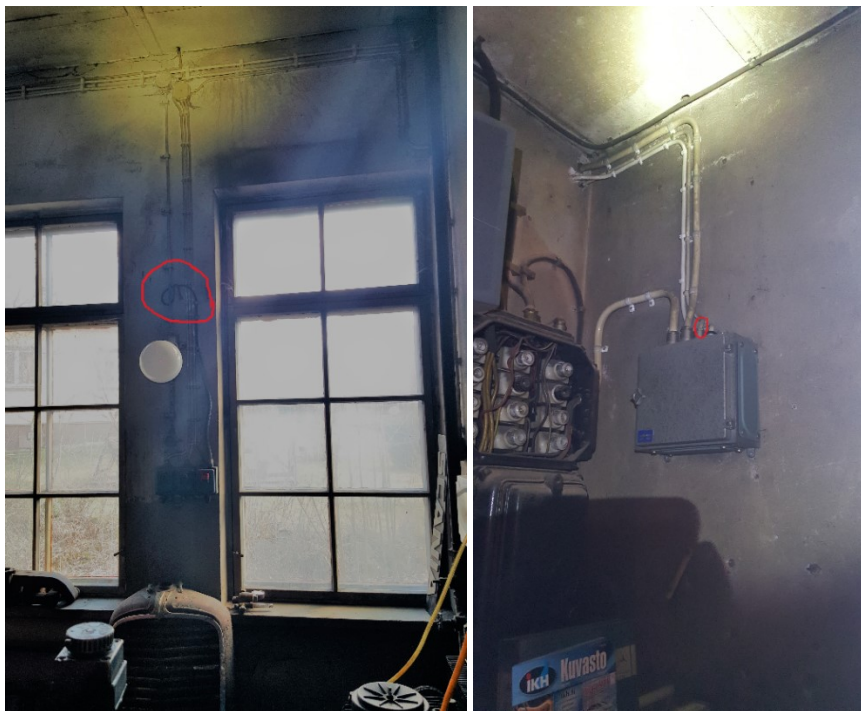
Figures 34 &35 illustrate the defects of PK11.
 PK11 defects Open ended cable, System disabled.

Figure 34 room H Open ended cable & 35 room C cabinet PK11.

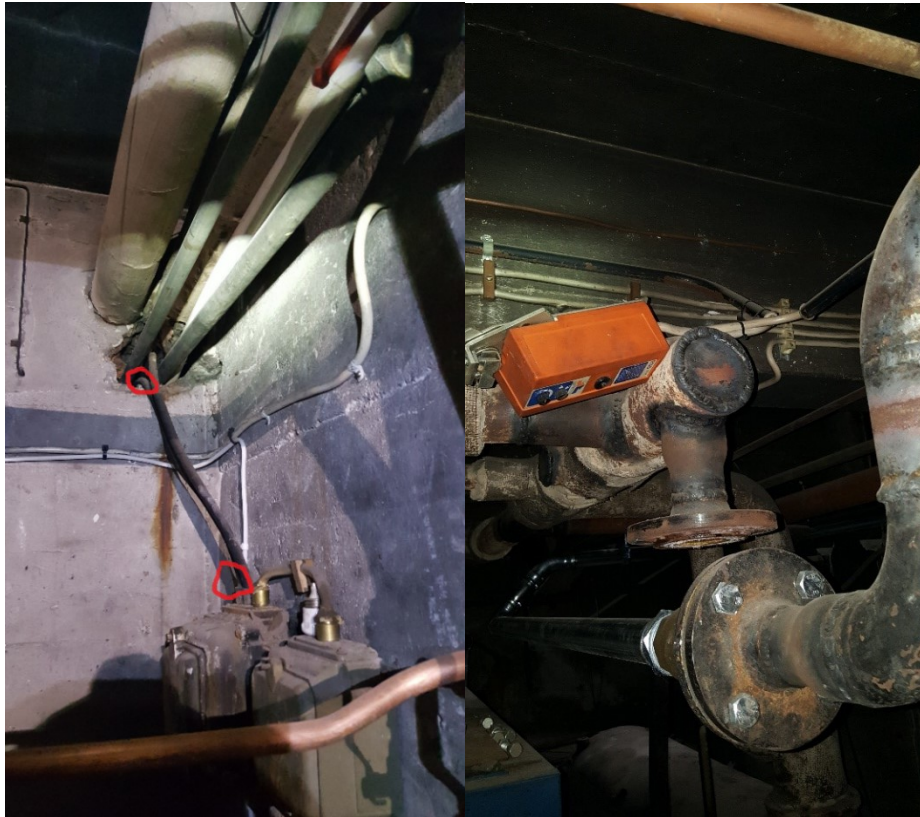
Figures 39 &40 show the defect of TT1.
TT1 defects 1.1 System disabled.

Figures 39 room B Cabinet TT1 old output &40 room B old heating system out of use.

4.4	Disassembly of open ended cables
TT1	
1.1	Removal from cabinet and disassembly
PUU1	Replacement of cables and distribution boxes
PUU2	Replacement of cables and distribution boxes
