Saimaa University of Applied Sciences
Technology, Lappeenranta
Double-degree programme in Civil and Construction Engineering
Civil Engineering

MODERN TECHNOLOGIES IN RENOVATION AND RESTORATION CASES

Bachelor's Thesis 2019

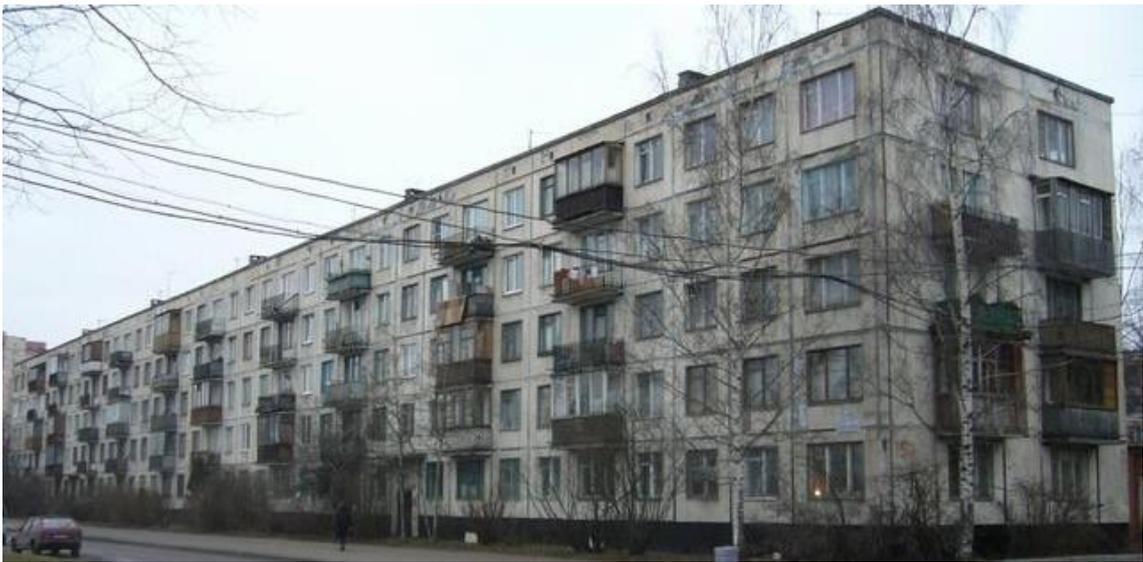
Figure 2.2. Standard panel house. Series 1-507.
<http://domavspb.narod.ru/index/0-26>

The renovation field also has a strong correlation with the Soviet Union legacy. After the Second World War the government was trying to solve housing problem by massive building of standard panel houses. The main characteristic of such structures was an opportunity to build it as fast and cheap as possible. However, still these standard houses are a low-quality dwelling with a short lifecycle, poor esthetical appearance and low energy efficiency rating. For this reason, in Russian Federation renovation program has begun for this type of buildings to rise up energy efficiency, accommodations and to change cities' appearance.

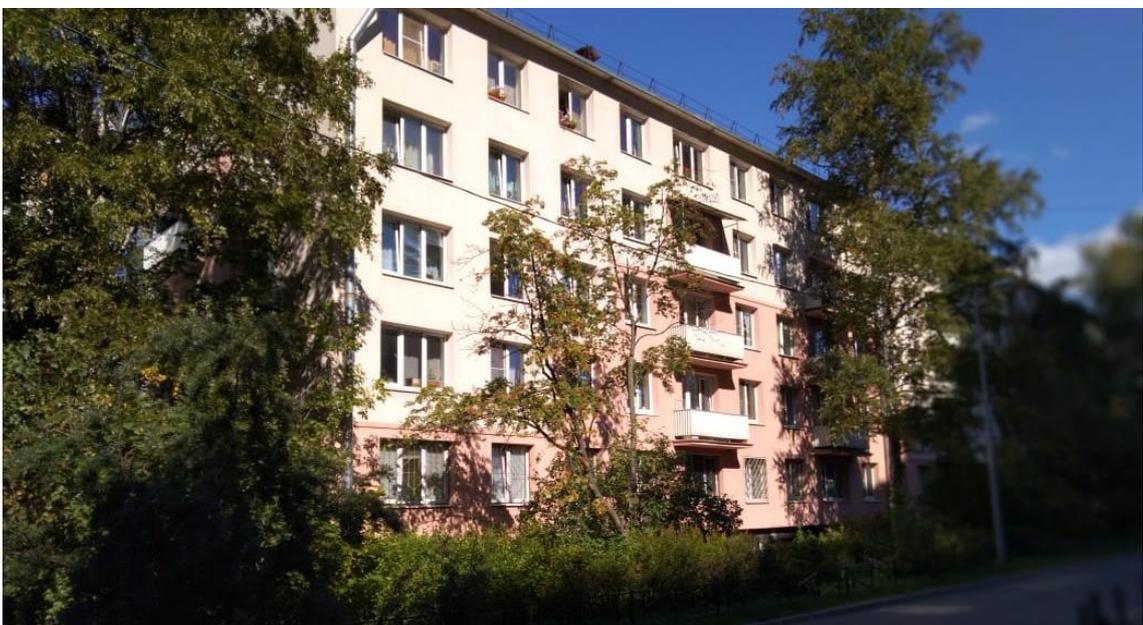
Figure 2.3. Renovated panel house. (Photo by the author)

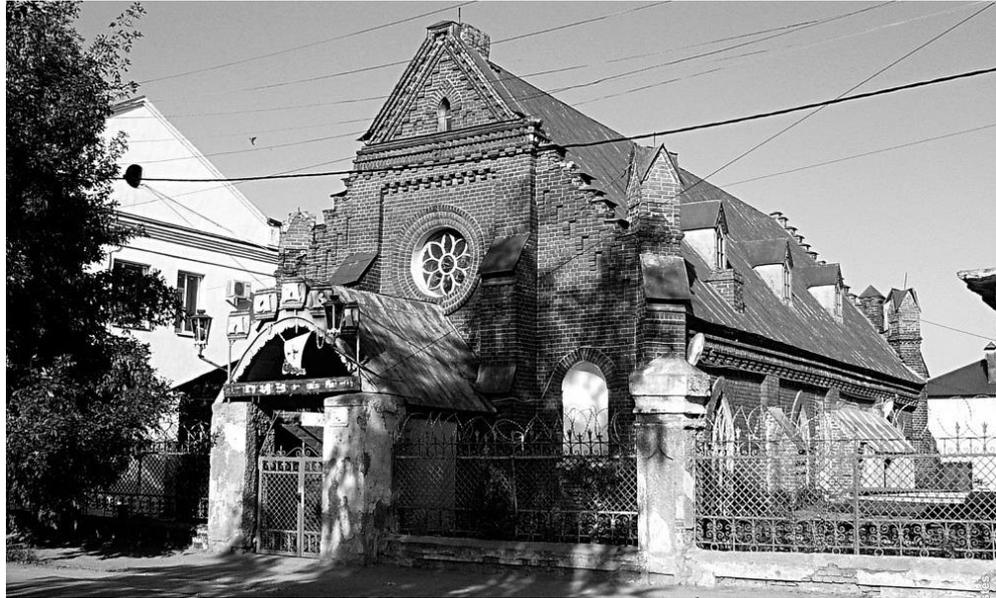
Figure 3.1. Jeiletz Deutsche Kirche before inappropriate restoration. Lipetsk region.
<http://vif-vrn.ru/viewtopic.php?t=868>

In the Figures 3.1 and 3.2 examples of ignoring the restoration rules are shown. Undoubtedly, such method of restoration is much cheaper than an appropriate way with saving of the original appearance. However, this decision significantly changed not only considered church, but also the appearance of its surrounding, turning the whole street into an unaesthetical place. Therethough, the economy on the materials and architectural decisions is inadmissible as well as regulation laws cannot be canceled to keep cities comfortable and precious.

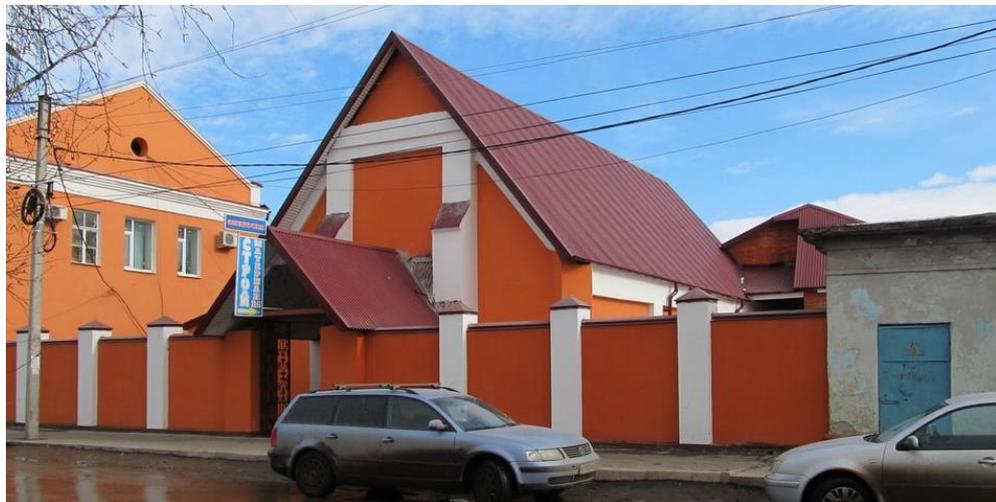
Figure 3.2. Jeiletz Deutsche Kirche (Currentry – building material shop) after inappropriate restoration. Lipetsk region.
<http://vif-vrn.ru/viewtopic.php?t=868>

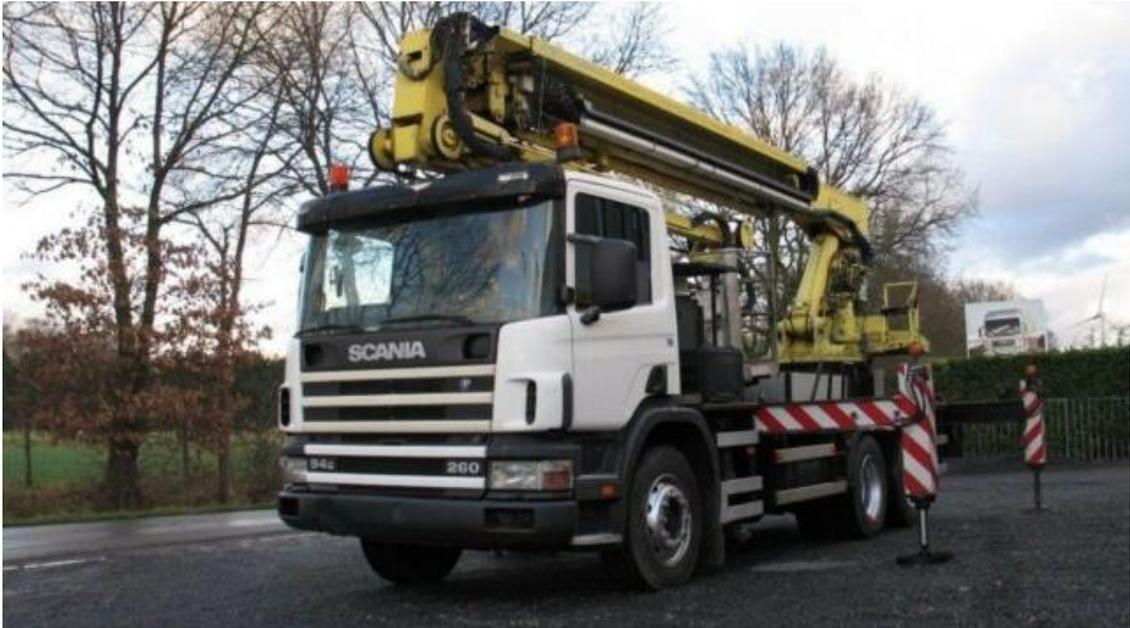
Figure 4.1. Bucket Truck Scania.

If this particular problem is taking place due to a height of a building, special cars with elevators could be used (Figure 4.1). However, a rent of such a bucket truck is expensive and seems irrational, if only one top element of the building should be investigated. For example, the total cost of a bucket truck rent with work of two operators in Helsinki will be equal to roughly 600 euros per hour. Meanwhile the professional drone DJI Mavic Pro PLATIMUN costs about 1463 euros. In such cases a usage of drones is one of the most effective and

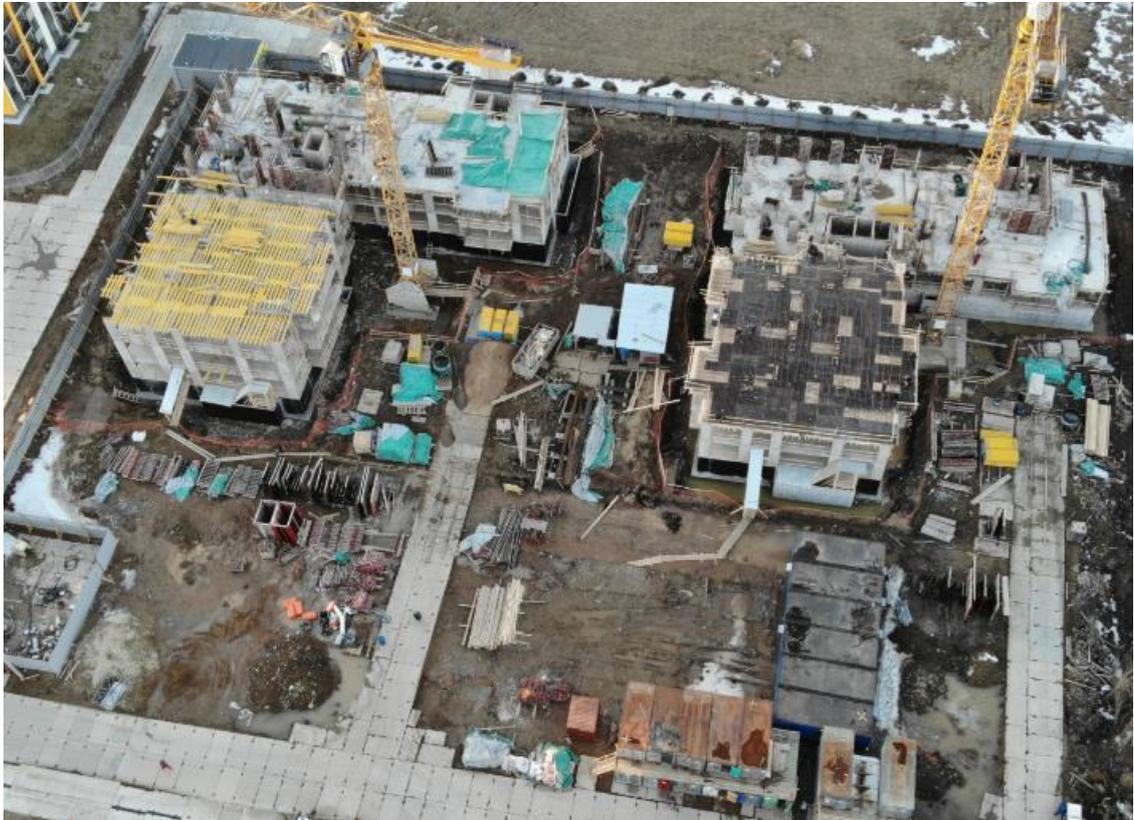
Figure 4.2. The view on the construction site in the city Pushkin. Photo was captured by a drone.

Quattro copters (drones) could be widely used in the renovation and restoration fields. They are very suitable for an aerial surveying, which helps a project company to create a proper situation plan and reach a full and clear picture of a construction site and an associated area. This method is especially effective for big cities with a dense development, where many things cannot be seen from the ground because of other objects hiding them. Drones could also be very useful for a photofixation document with its possibility to take close photos of final cornices, dripstones, fielded panels and other architectural elements, which could be a part of historical heritage. Moreover, this facility can help to measure these shaped elements for a proper design and do it without any risks for people. Possibility of viewing from a height and great distance also gives an opportunity to control a construction process, when the design stage of a project is finished (Figure 4.2). Additionally, this method allows to do this from different points of view, while the picture could be received by a client or a project manager even from the office. For example, quattro copters could easily solve the problem, which was described in Chapter 3.2 and appeared during the restoration project of the Russian Research Geological Institute named after

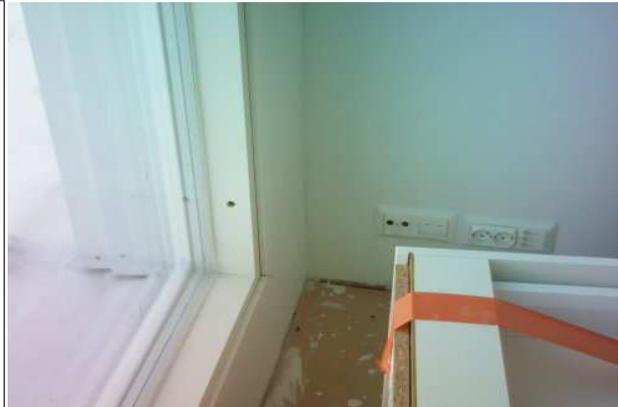
Thermal image 4.

Place: Window's corner	Date of research: 13.3.2019
-------------------------------	------------------------------------
