# Water characteristics of landfill leachate in Uusikaupunki

BACHELOR'S THESIS  
March 2020

Energy and Environmental Engineering

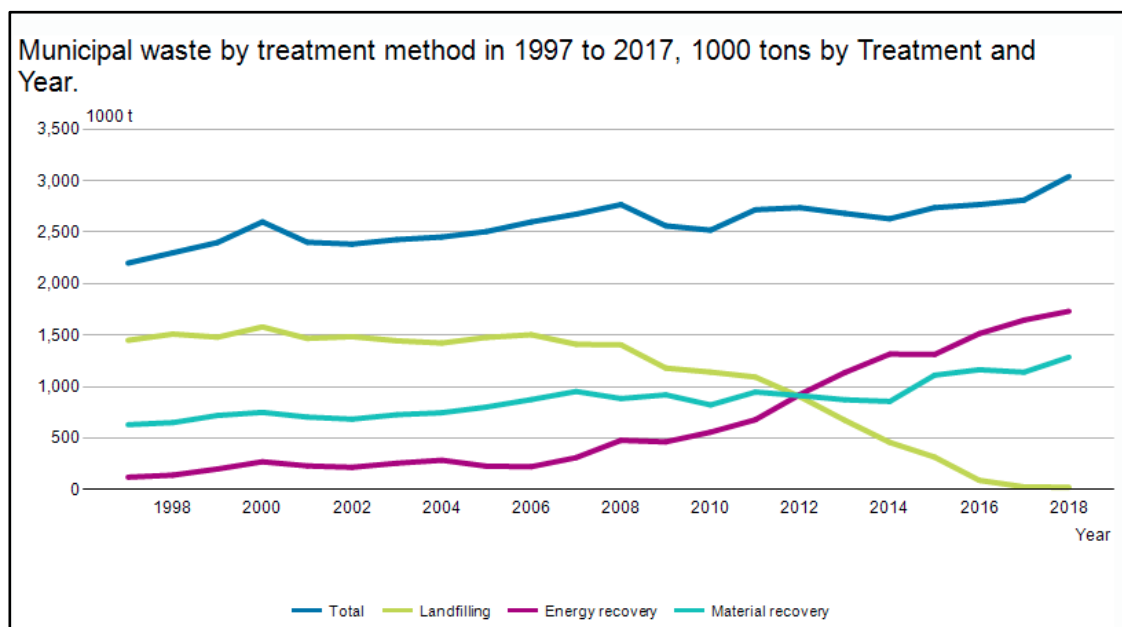
FIGURE 1. Treatment method of municipal waste in Finland from 1997-2017 (Published with the permission of Statistics Finland)

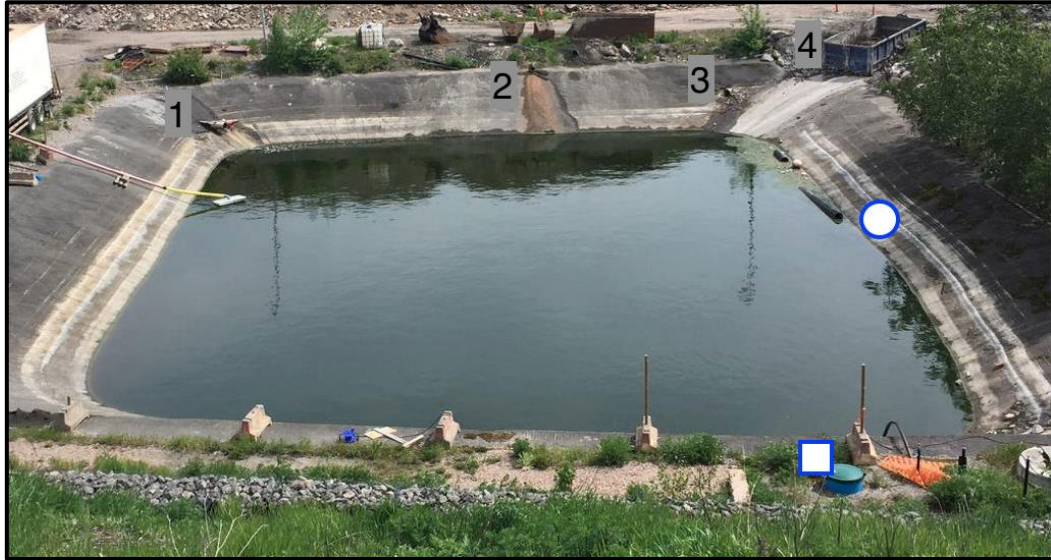
PICTURE 1. Sampling locations and inlet numbers

As one can observe above the inlet sites are numbered 1-4 left to right to provide consistency throughout the monitoring program. The leachate pool sampling location is denoted by the blue and white circle on the right-hand side of the photo; while the outlet site (a well) is denoted by the blue and white square near the bottom of the photo. The above photo was taken on June 3<sup>rd</sup>, 2019; while all of the inlet pictures (below) were taken on August 7<sup>th</sup>, 2019.

As one can observe above (Picture 1), Inlet 1 is the left-most sample site. A more detailed photo of the site can be found below (Picture 2).

As one can observe above (Picture 1), Inlet 2 is the second left-most sample site. A more detailed photo of the site can be found below (Picture 3).

As one can observe above (Picture 1), Inlet 3 is the second right-most sample site. A more detailed photo of the site can be found below (Picture 4).

As one can observe above (Picture 1), Inlet 4 is the right-most sample site. A more detailed photo of the site can be found below (Picture 5).

One can observe the leachate drainage pool and sampling location spot above in Picture 1. No further picture is required.

As one can observe above (Picture 1), outlet is the bottom most sample site. A more detailed photo of the site can be found below (Picture 6)

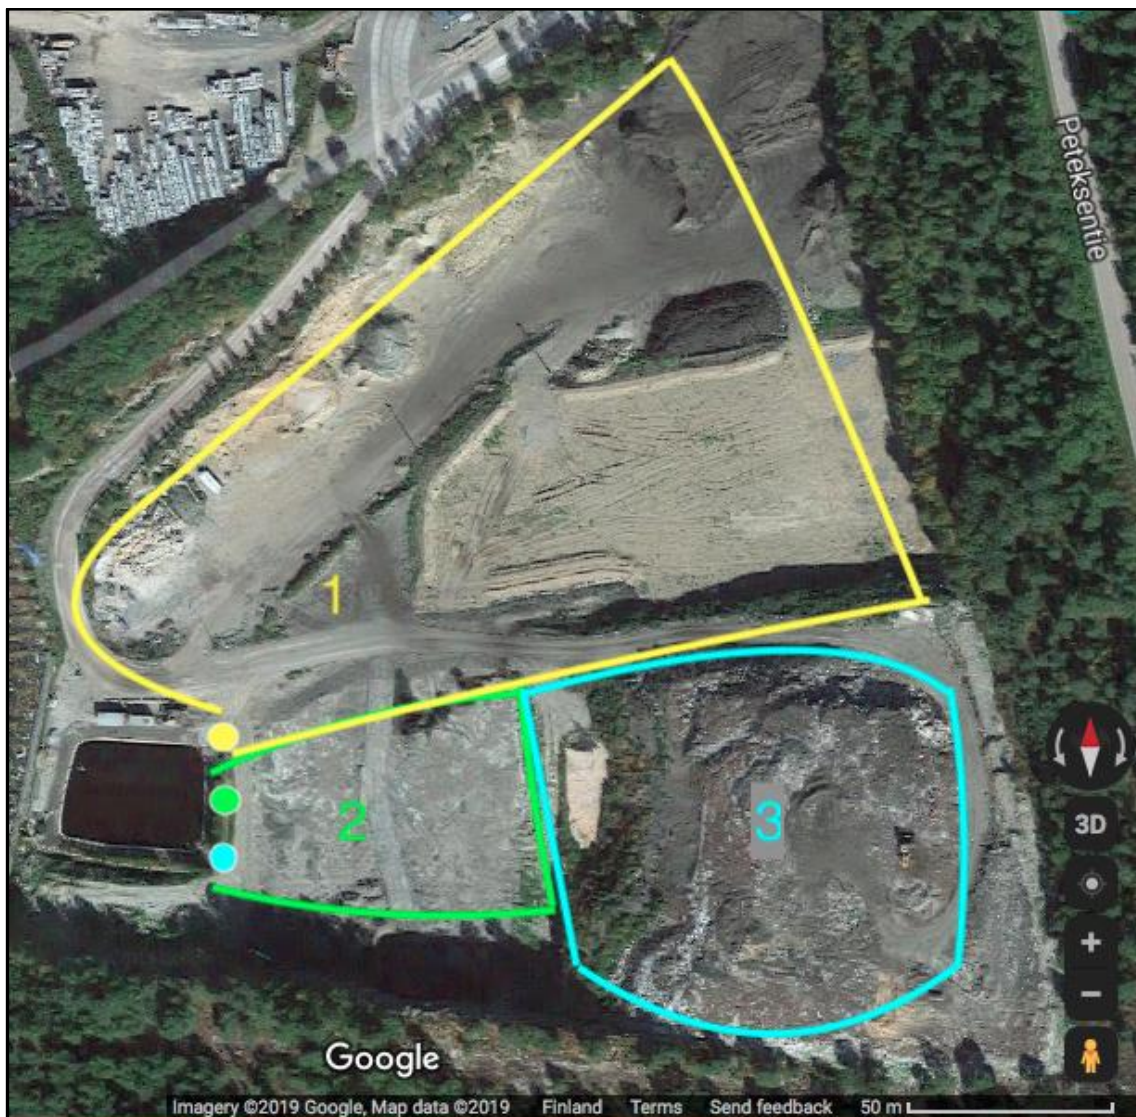
FIGURE 3. Inlet catchment areas (Google 2019)

In Figure 3, the sampling sites of each catchment area is denoted by the color coded circle.

The catchment area related to inlet one can be observed above, in Figure 3. Generally, the contents of inlet one consists of rainwater runoff within the yellow highlighted area. The contents of rainwater runoff can vary due to particular activities done in the area such as, salting of the roads, blasting of rocks, and the expansion of the area. As well as, the amount of precipitation and water used on the road surfaces.

The “catchment area” related to inlet two can be observed above, in Figure 3. This “catchment area” is situated under the current landfill and consists mainly of material breakdown happening inside of the landfill. The material in this section (highlighted in green) of the landfill contains, but may not be limited to, non-hazardous soils, insulation, asbestos, and various non-hazardous ash.

The “catchment area” related to inlet three can be observed above, in Figure 3, and highlighted in blue. Inlet three also consists of landfill leachate, however, the “catchment area” of inlet three is from the older part of the current landfill. This section of the landfill consists mainly of municipal waste which entered the landfill between the years 2007 and 2016.

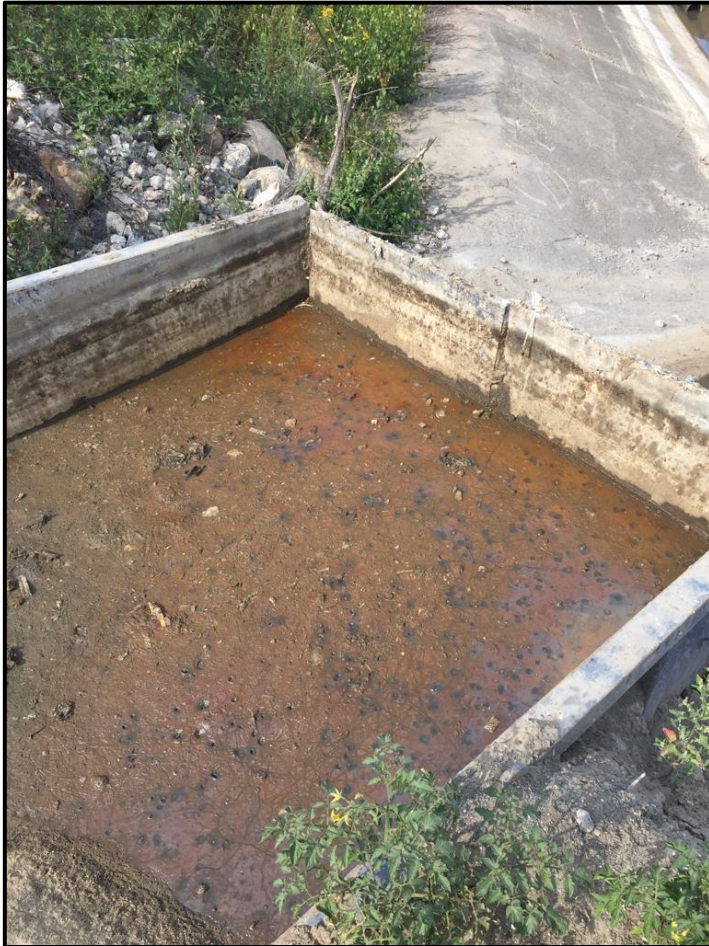
PICTURE 5. Sample site of inlet 4

Although inlet four is not shown above in Figure 3, one can view inlet four in section 3.1.4. The contents of inlet four generally come from sewer waste, in particular, the sand and other particles left inside of the sewer system. The inputs were varied due to an inconsistent refilling/disposal schedule.

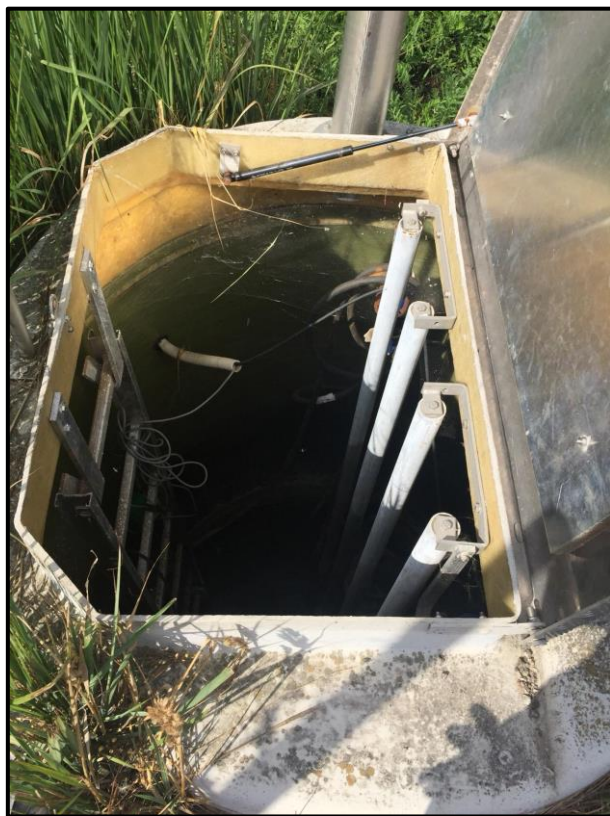
PICTURE 6. Sample site of the outlet.

The samples taken from the outlet were taken with a telescopic sampler, due to the depth of the well.

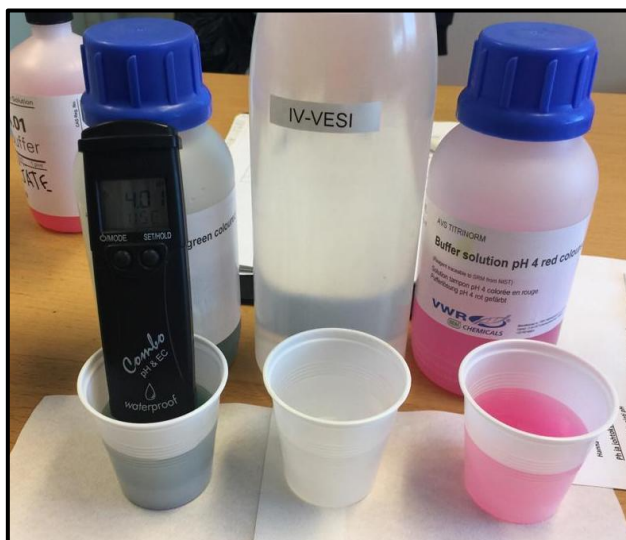
All three of conductivity, pH, and water temperature were recording utilizing the same device. The device was manufactured by Hanna Instruments and the model is the HI 98130 Combo pH & EC (Picture 7).

The meter was cleaned between each sample with distilled water and then dried to avoid any contamination and increase the accuracy of the reading. Furthermore, the meter was calibrated 3 times on; May 23<sup>rd</sup>, June 26<sup>th</sup>, and July 26<sup>th</sup>.

The calibration intervals were done at the recommendation of Hanna Instruments. An example of the calibration process can be viewed below in Picture 9.

PICTURE 7. Photo of the calibration process from July 26<sup>th</sup>, 2019

The error of the device is reported as + or – 0.5°C, 0.01 pH, and 2% for the conductivity, by the manufacture. Other equipment included but may not be limited to; plastic cups, telescopic sampler, safety gloves, paper, safety glasses, and distilled water.

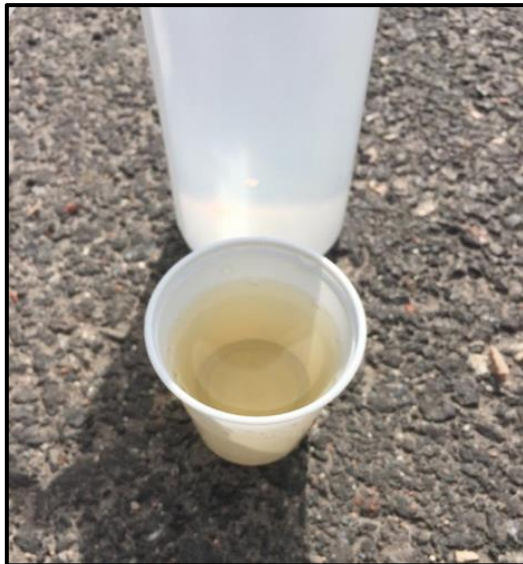
The samples taken from the four inlets and the leachate pool were done utilizing the proper safety equipment and a plastic cup. One can view an example of a sample taken on June 12<sup>th</sup>, 2019 from inlet 1, below in Picture 8.

PICTURE 8. Example of a recorded sample

After, recording the data values the sample was discarded into the leachate pool. The meter was then properly cleaned with distilled water and dried to ensure accuracy and avoid contamination.

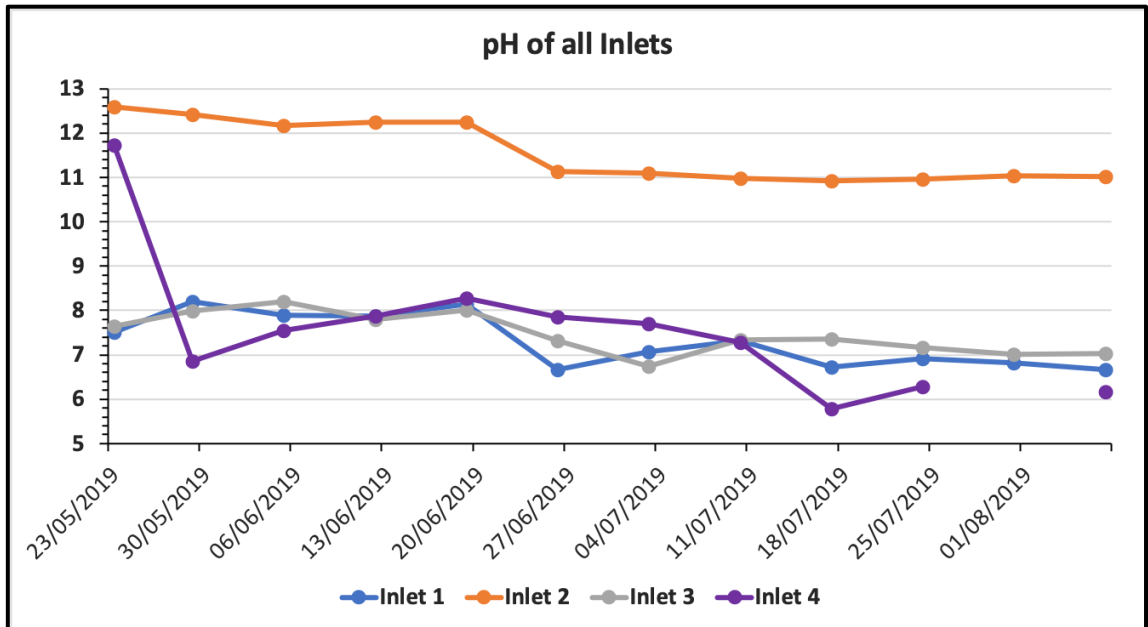
FIGURE 4. pH of all inlet locations

As displayed in both Figures there is a slight downward trend as the summer progressed. The drainage pool and outlet typically were separated by a constant amount and the outlet almost always had a lower pH value than the pool itself.

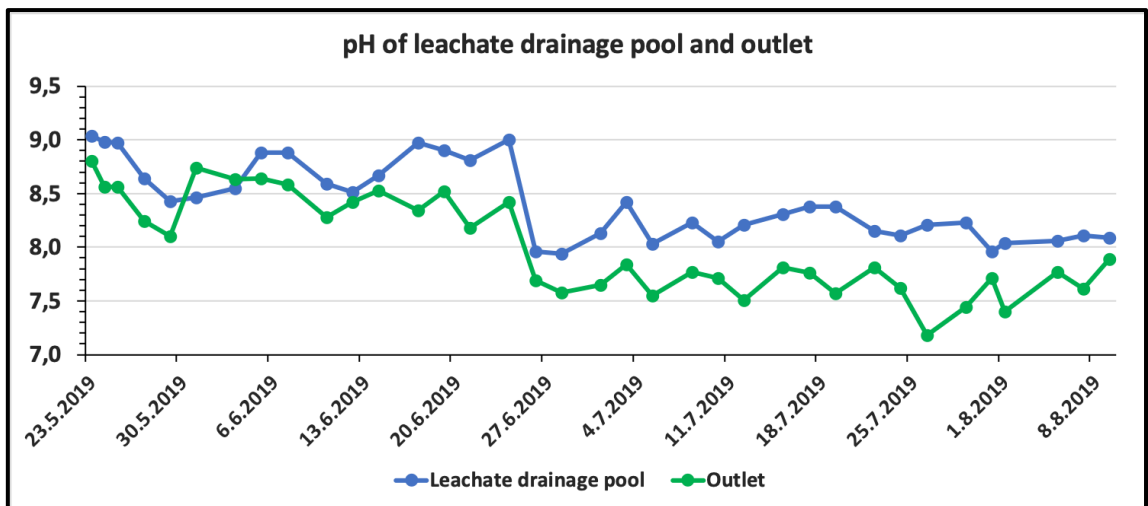
FIGURE 5. PH of the leachate drainage pool and outlet
