Marina Paramonova

AIRTIGHTNESS OF A BUILDING ENVELOPE

Bachelor's thesis
Degree Programme in Building Services Engineering

2019

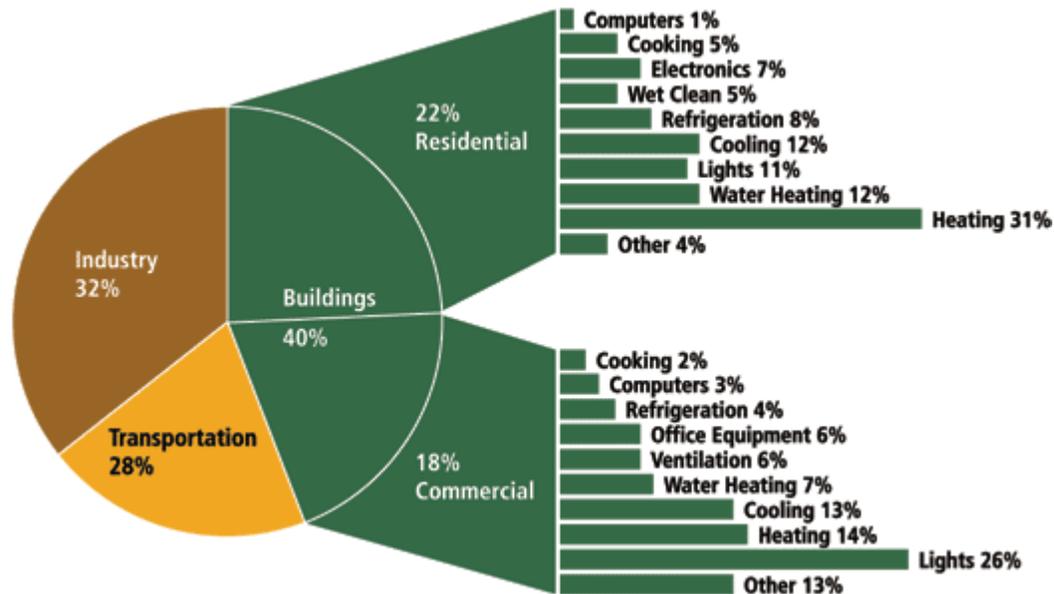
Figure 1. Energy consumption by sector /5/

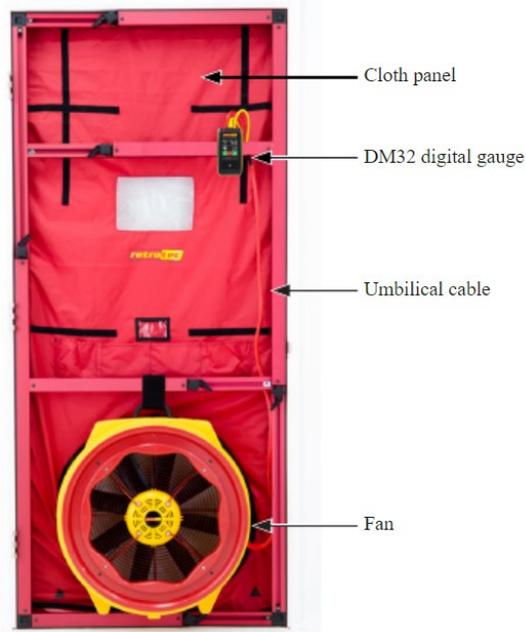
The devices for the blower door test include not only a fan with variable speed but also an adjustable frame and flexible airtight panel usually made from dense fabric which perfectly fits every door frame. There is also a pressure meter to measure the pressure difference between inside and outside areas of the building, computer with the software to control the speed of the fan, analyze the results and make a report and devices for locating the leaking points in the building envelope. Figure 2 shows the basic set of equipment for the blower door test, model Retrotec 5000

Blower Door System, all the parts are named. Such systems are usually used for residential buildings or small commercial building. The number of fans may be increased for testing larger buildings.

Figure 2. A basic set of the equipment for blower door test /10, p. 1/

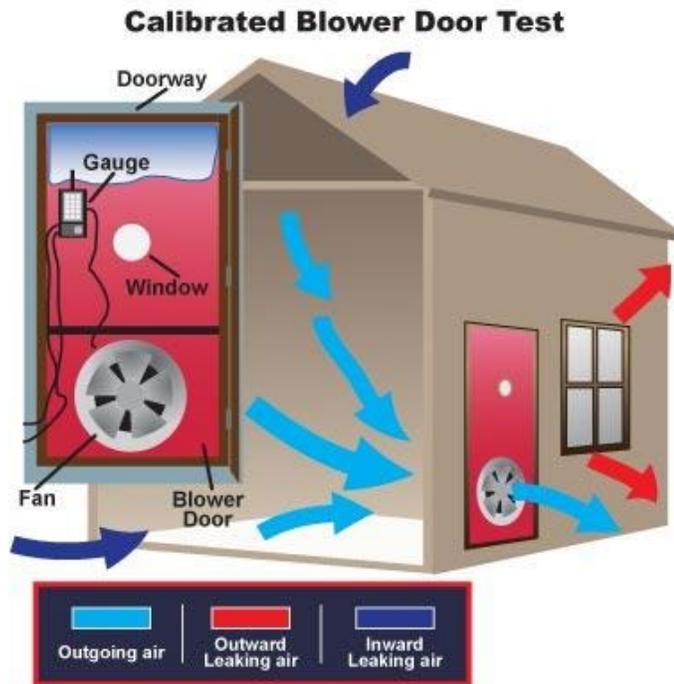
There are two types of blower doors: calibrated and uncalibrated. It is better to use the calibrated one because it provides information about the amount of air exhausted outside of the building during the time unit. When using the calibrated blower door it is possible to define the amount of air leakage but it could not be done by using not calibrated blower door. /12./ The main points of the calibrated blower door test are presented in figure 3.

Figure 3. Calibrated blower door test /11/

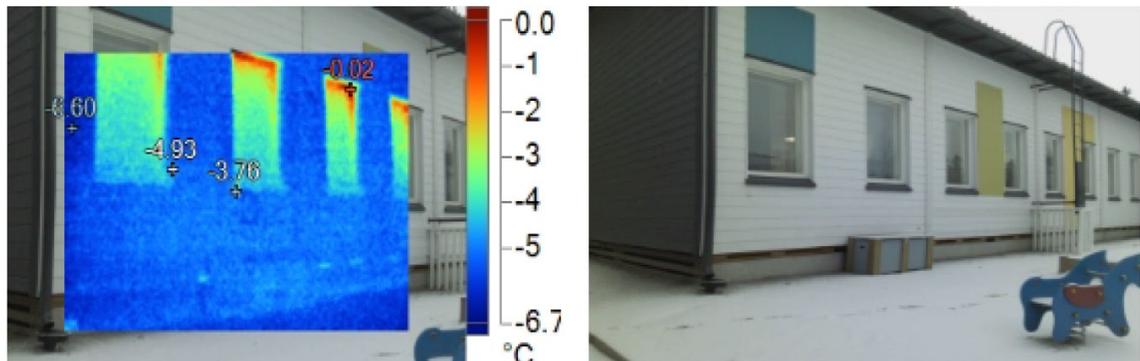
Figure 4 shows an example of how a thermal image of a building looks like.

Figure 4. An example of a thermal image of a building made in the outside

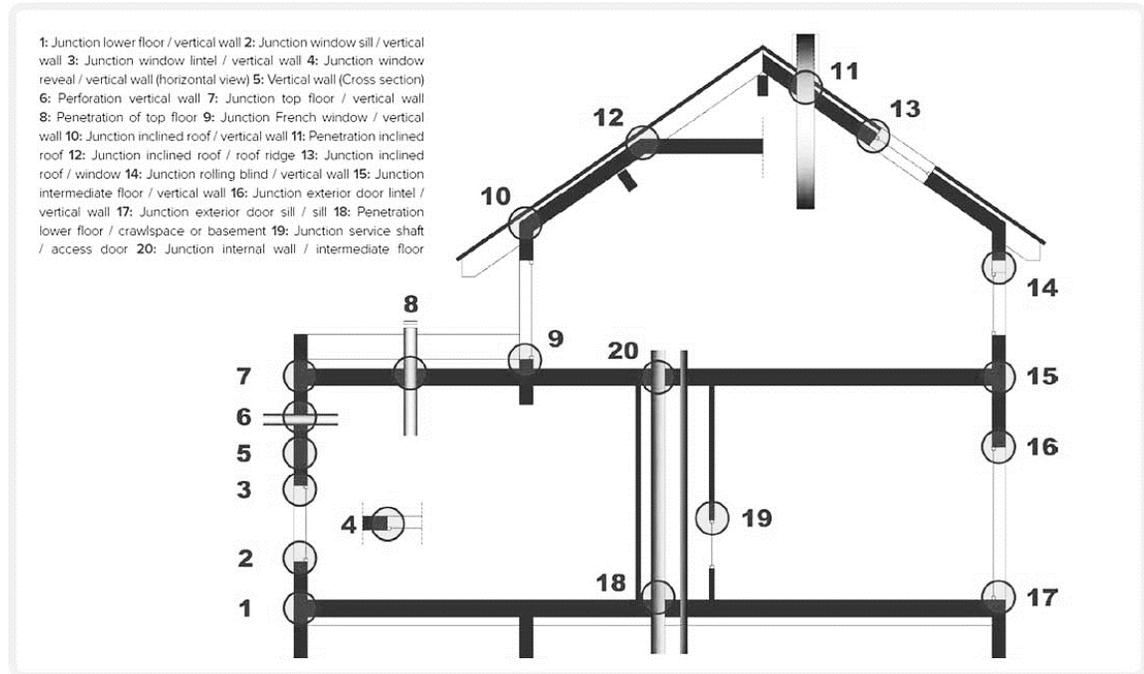
The main leakage points are usually located in the connections and interfaces between the building envelope components. They are presented in figure 5. The

main junctions, which are shown in the picture should be insulated to avoid air leaking through a building envelope. These points are usually checked with a thermal imaging camera or a smoke pencil during the blower door test.

Figure 5. Diagram showing some of the potential main junctions and penetrations in a building envelope, where good airtightness detailing and workmanship will be required /14/

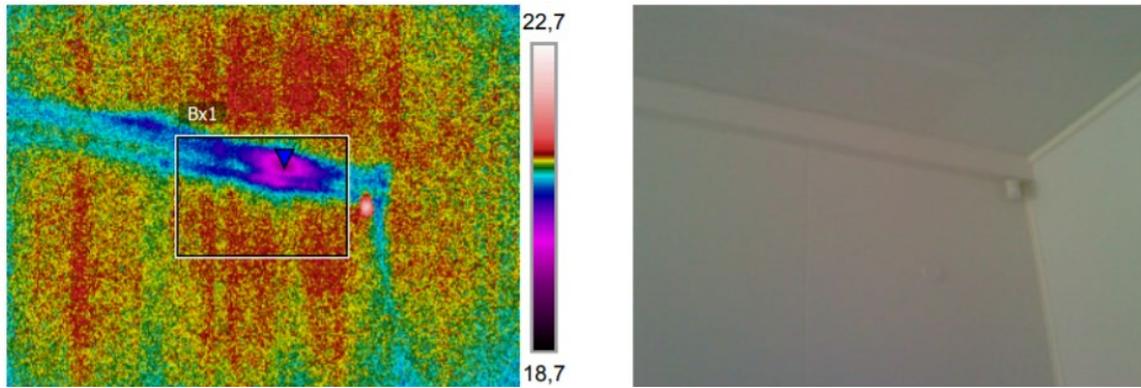
According to regulations in Finland, both temperature and pressure differences between inside and outside spaces of a building are required to verify the thermal performance of the finished structures and for air leakage detection /15, p. 2/. Figure 6 shows an example of the thermal image that is made in the conditions of under pressure of 50 Pascals inside the building where air leakage of the building envelope is detected.

Figure 6. An example of a thermal image made in the created conditions of under pressure inside the building to detect air leakage

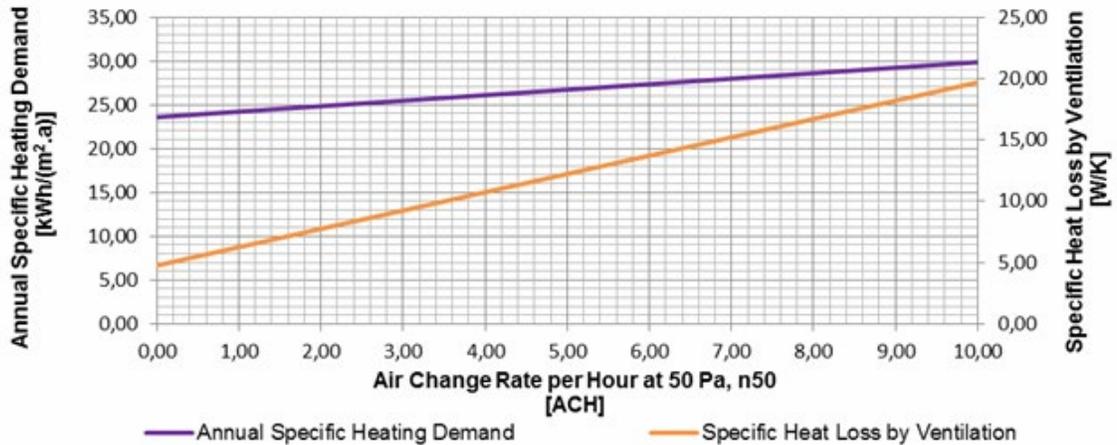
Figure 7 represents the dependence of the annual specific heating demand and specific thermal loss by ventilation from airtightness of the reference energy-efficient building with a heat recovery system, which efficiency is 85%. The reference building's location in Central Europe, it is made from wooded mass materials and contains two storeys. The net heated area is 150 m², the area of the building envelope is 420 m² and the volume of the building is 440 m³. /16, p. 4./

Figure 7. Relationship between air change rate and annual specific heating demand and specific heat loss by ventilation /16/

It is obvious that the lower air change rate and air leakage rate the building has the lower its heating demand. According to figure 7 specific heat loss for ventilation is 4 times more and the heating demand of the building is 1,25 times more if the building has poor airtightness.

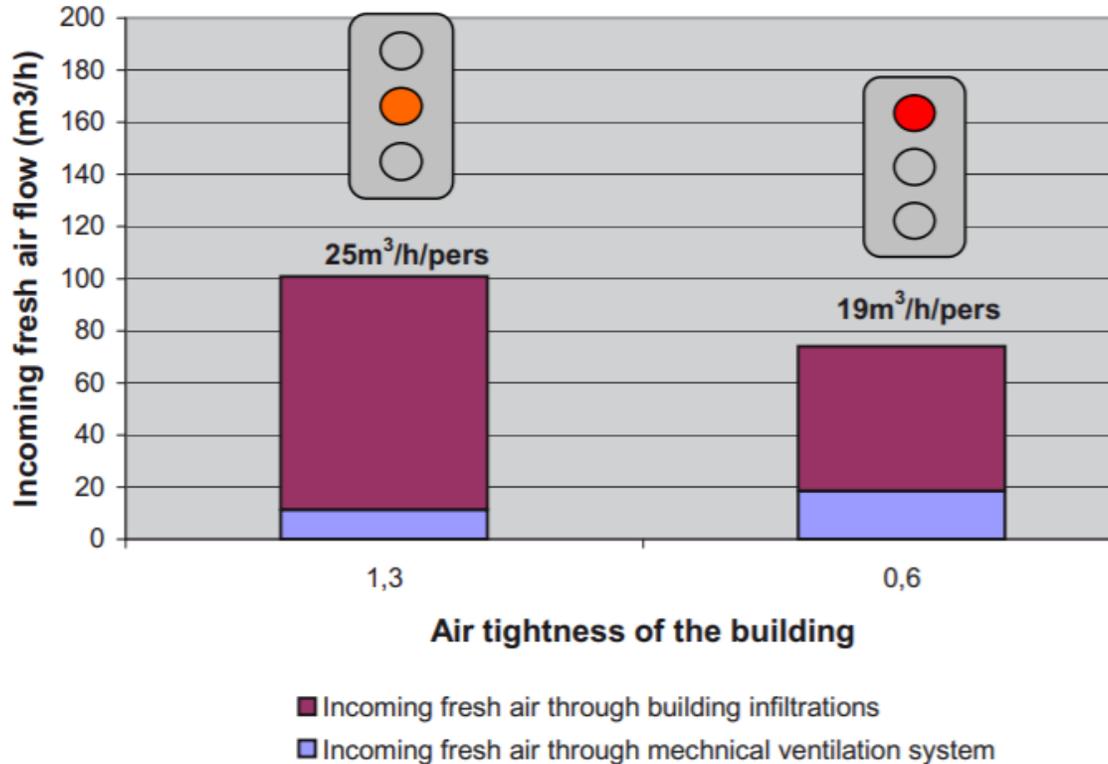
However, increased airtightness of the building leads to decreasing of air coming inside the building. It may increase the number of indoor air pollutants. The research shows that improved airtightness of the building from 1,3 to 0,6 ACH may reduce incoming fresh air for 33% and reduce indoor air quality level. Figure 8 shows the changes that happen when the airtightness of the building envelope is improved without adjusting ventilation. In the first case, the indoor air quality is moderate and in the second case, the indoor air quality is considered to be poor. The results are got from the simulations using SIREN software from French CSTB official body (“Centre Scientifique et Technique du Batiment”) and indoor air quality is level is estimated according to CO₂ concentrations. /17, p. 6./

Figure 8. Incoming fresh air repartition with humidity-controlled ventilation /17, p. 7/

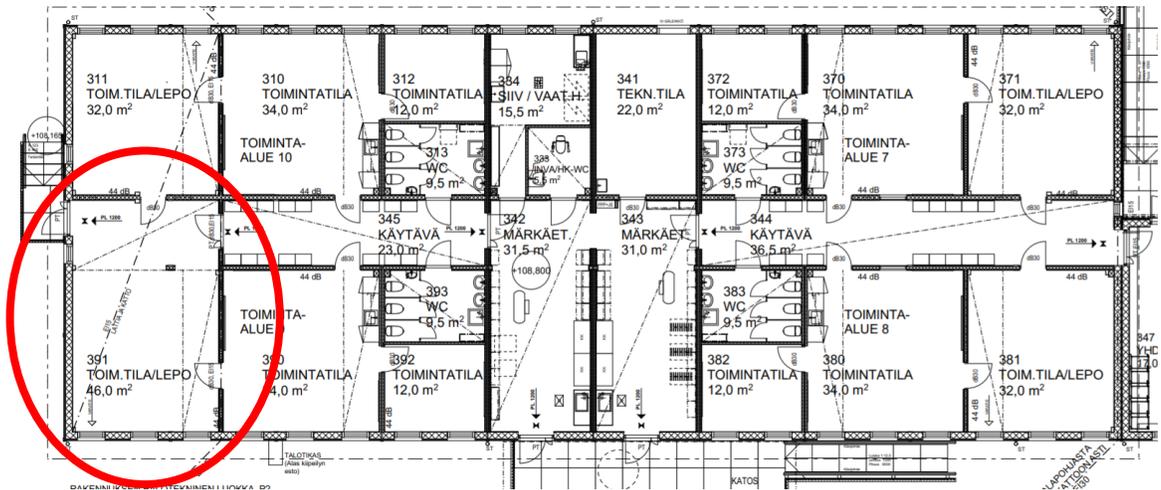
The location of the sample room 391 on the plan of the first floor is presented in figure 10. The area of the room is 46 m².

Figure 10. The location of the sample room 391 on the plan of the first floor

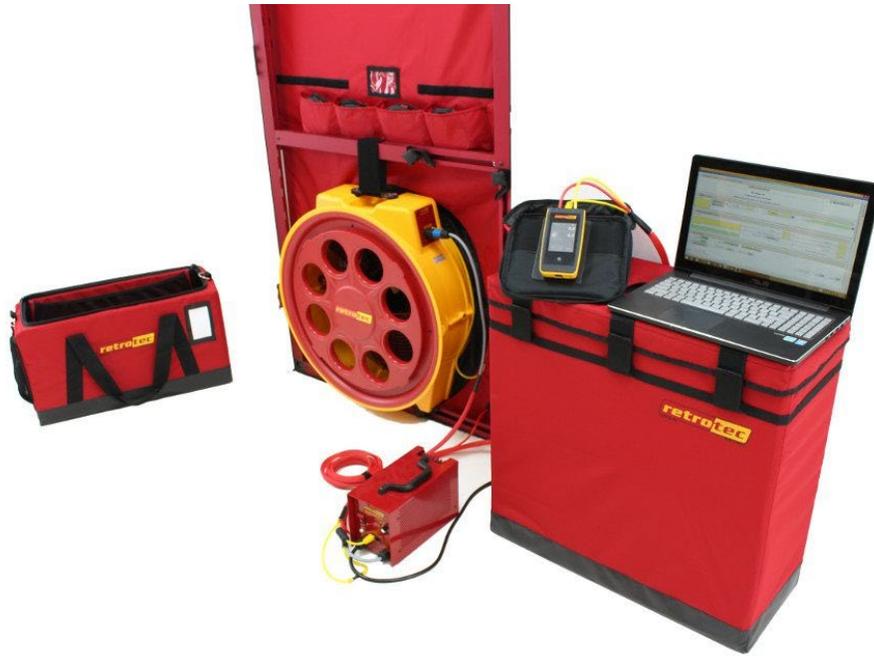
The blower door test took place to define the airtightness of the building envelope. Equipment: Retrotec 6000 fan, DM32 WiFi digital pressure gauge. The installed equipment is shown in figure 11.

Figure 11. The installed equipment Retrotec 6000 with DM32 WiFi digital pressure gauge /19/

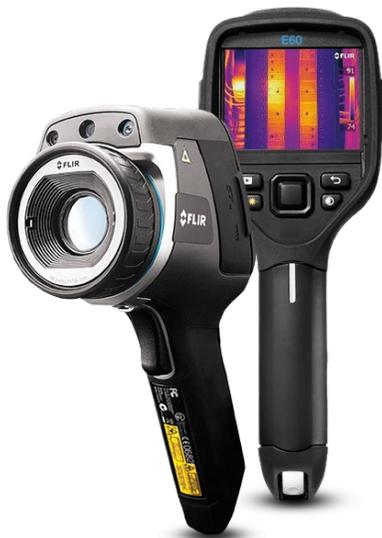
When the depressurization was completed, air leaks in the building envelope were detected by thermal camera FLIR E60. The camera is shown in figure 12.

Figure 12. Thermal camera FLIR E60 /1/

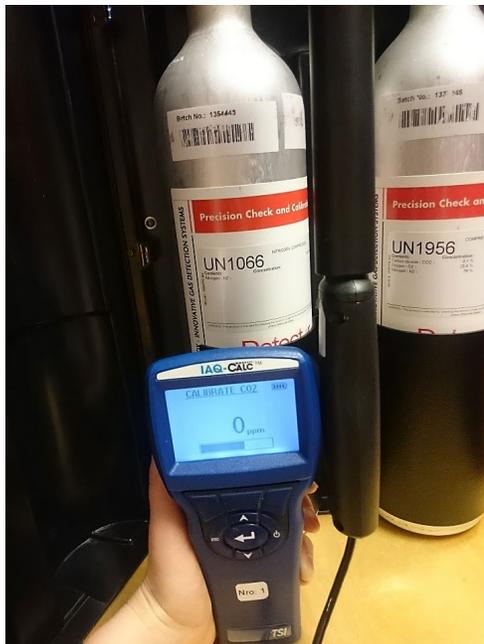
The CO₂ concentration was measured by data logger TSI IAQ-CALC 7535. Before the start of the monitoring, the device was calibrated. The calibration process is presented in figure 13.

Figure 13. The calibration process of TSI IAQ-CALC 7535

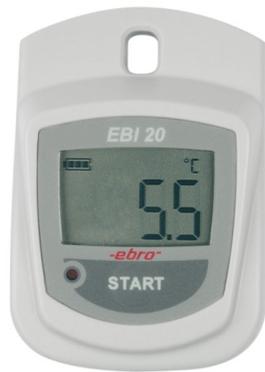
Temperature and relative humidity were monitored by –ebro– EBI 20 data logger. The device fulfills the guidelines according to international standard EN 12830. The device is presented in figure 14.

Figure 14. –ebro– EBI 20

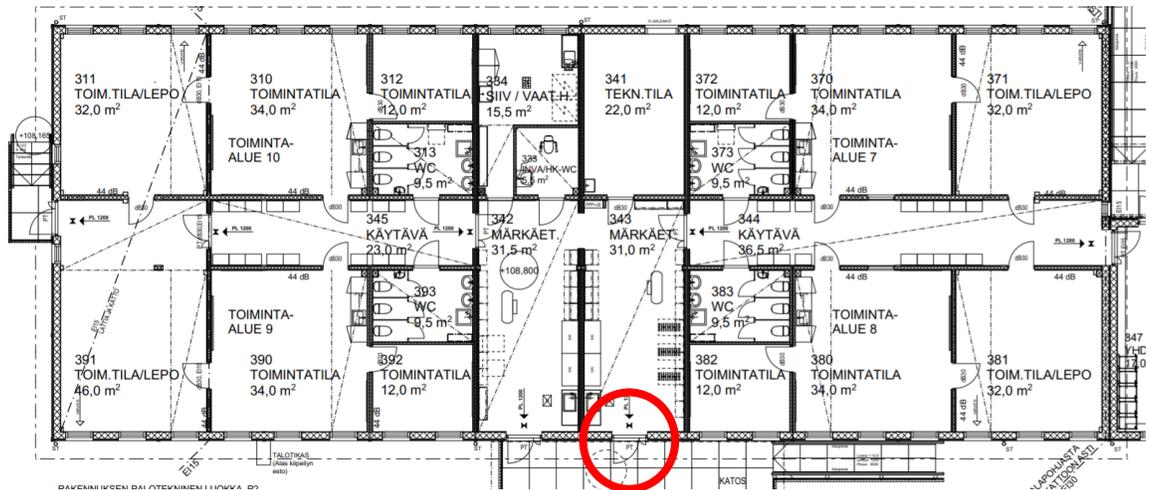
The blower door fan was installed on the main door. The location of the blower door fan is shown in figure 15.

Figure 15. The location of blower door fan

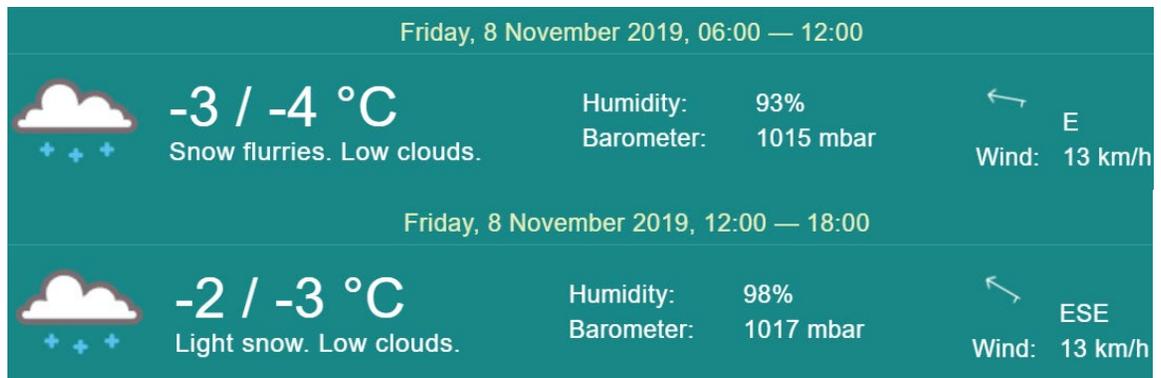
Thermal conditions monitoring took place on 08.11.2019. The weather conditions during the monitoring day are presented in figure 16.

Figure 16. Weather in Lahti on 08.11.2019 /20/

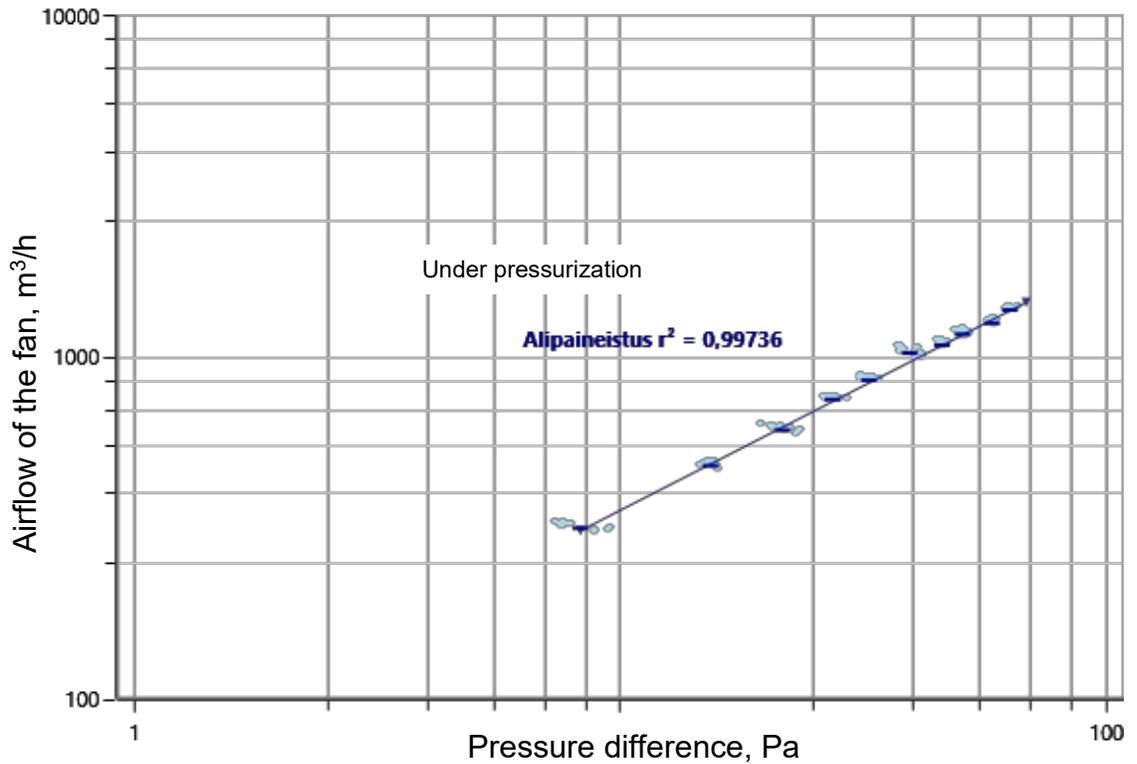
The air leakage curve is presented in figure 20. It is created by the Retrotec software according to the data in table 3. It shows the airflow rate of the blower door fan to create the test pressure difference.

Figure 20. Air leakage curve created by the Retrotec software

According to the air leakage rate, the class of the building may be defined. According to the limitations for air leakage rate the studied daycare center has class B. That means that the studied building has a high airtightness of the building envelope that shows a good quality of the construction. Figure 21 shows the determination of the class of the building according to the air leakage rate. It must be mentioned that the energy class of a building depends not only on air leakage rate but on many other things that have an impact on the energy demand of a building.

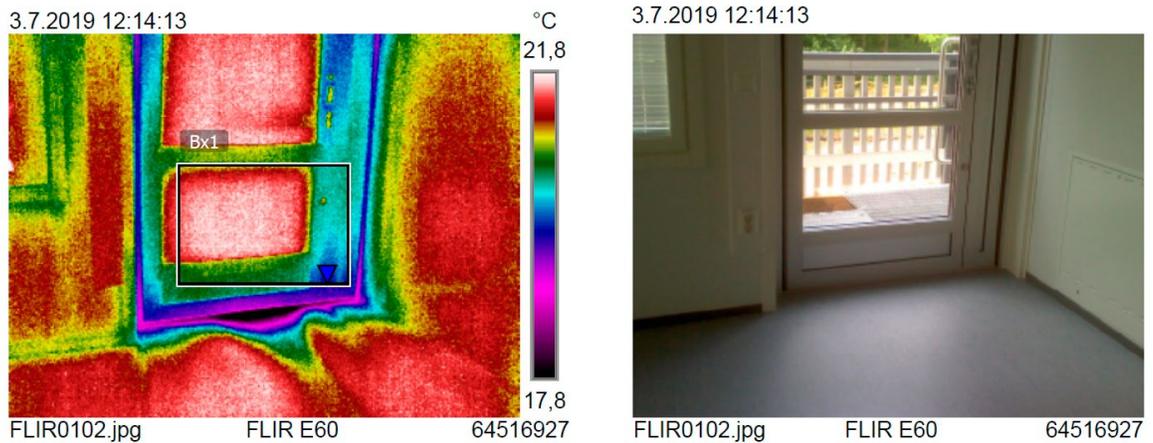
As it may be seen in the thermal images, the temperature differences are small that means that the air leakages are relatively small and do not influence much on the thermal comfort of the residents. However, that means that the sample room 391 is relatively airtight and the income of the fresh outside air may be reduced that may cause poor indoor air quality. That is why the indicator of indoor air quality, CO₂ concentration should be monitored and it should be checked if this value meets the target values. The results of the monitoring are presented below.

Figure 22. The air leakage detected by the thermal imaging camera that is caused by the outer door in the sample room 391

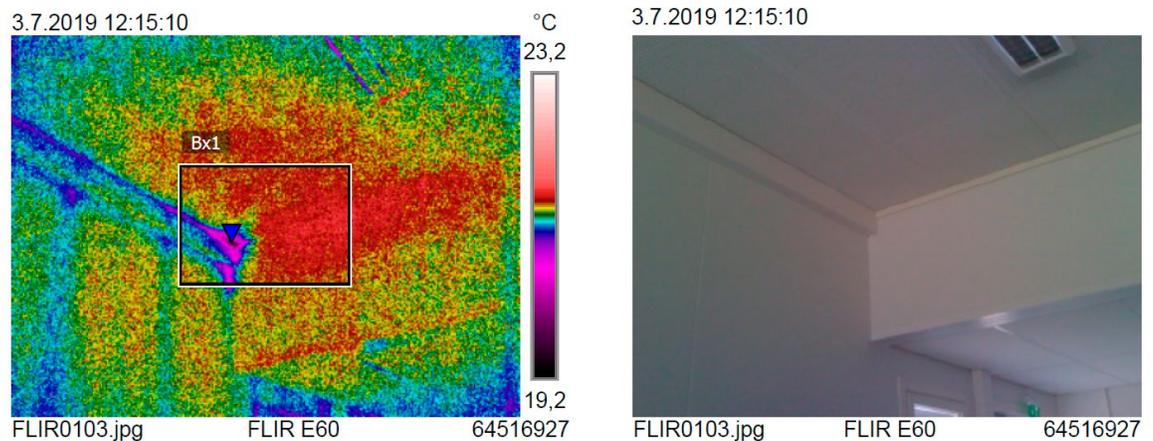
Figure 23. The air leakage detected by the thermal imaging camera that is caused by the crack in the building envelope in the sample room 391

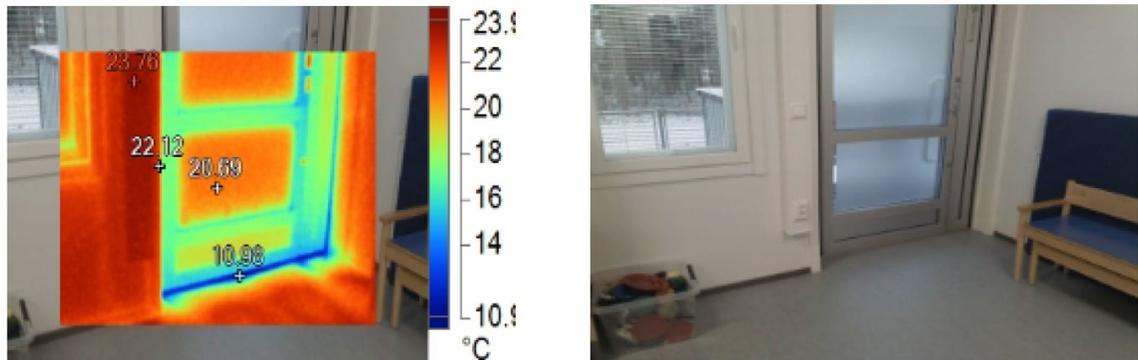
There is a thermal image taken on 08.11.2019 by the thermal imaging camera Fluke TiS45 (figure 24). The outside temperature was -3°C, the inside temperature was +21,5°C, no created under pressure. The image shows that the temperature difference in winter is relatively high that is why the thermal conditions should be

monitored and it should be checked if the temperature and relative humidity meet the target values. The results of the monitoring are presented below.

Figure 24. The outer door in the sample room 391

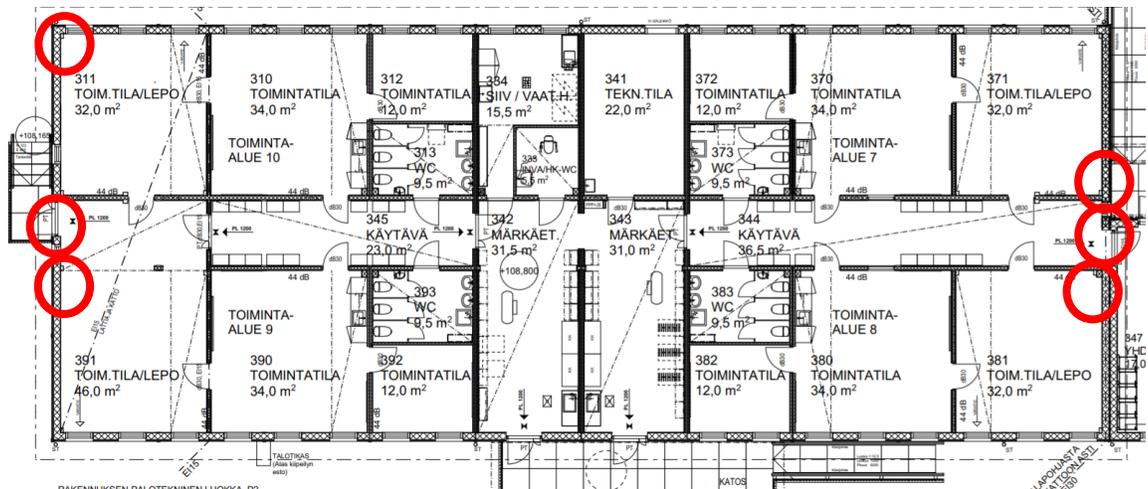
All the leaking points in the building are presented in figure 25. The full reports of the blower door test that took place in the building on 03.07.2019 are presented in appendix 2 and appendix 3. All the leaking points of the building envelope are located in the most common places.

Figure 25. Leaking points detected by the thermal imaging camera FLIR E60 at the created under pressure of 50 Pa inside the building

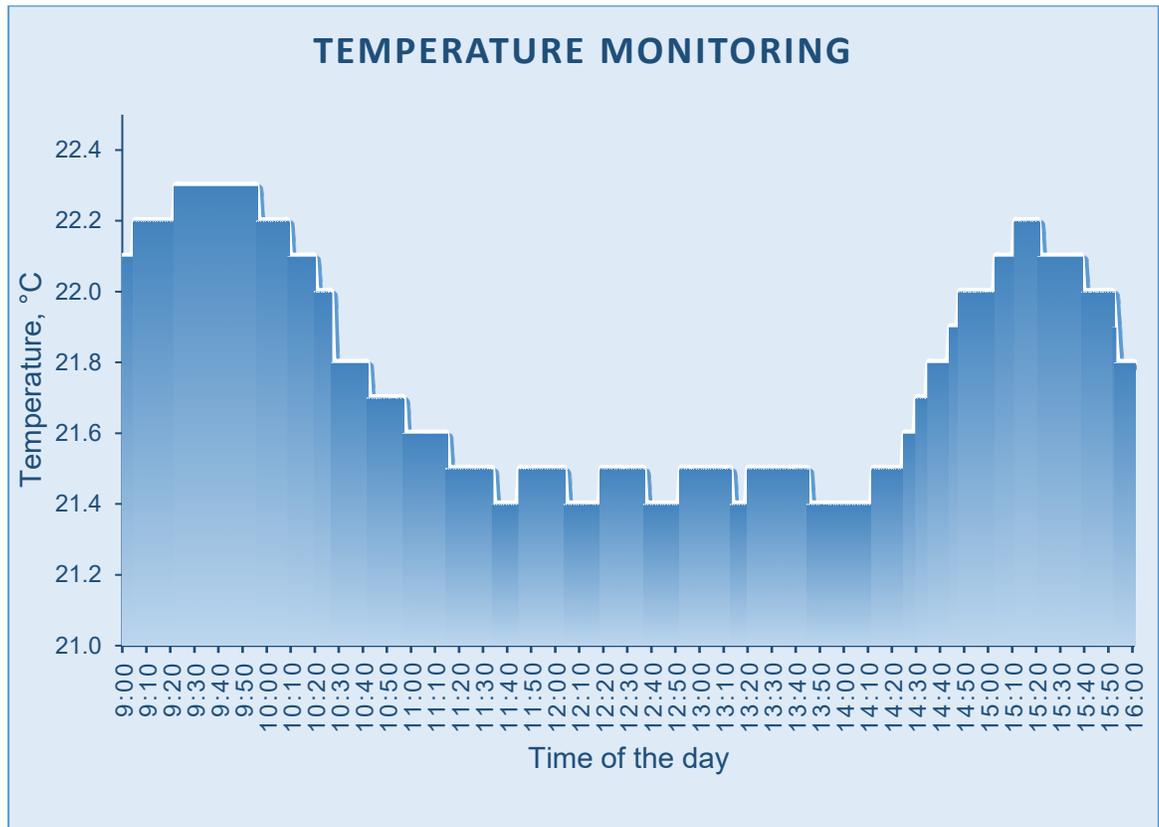
The monitoring results show that the maximum temperature in the sample room 391 did not exceed 22,3°C during the monitoring hours. The average temperature was 21,8°C that is very close to the design value of 21°C. The minimum temperature inside the room during the monitoring hours was 21,4°C. These values show that the temperature did not fluctuate much even when the room is occupied by the maximum number of people. The temperature also did not drop below the lowest comfort value of 20°C that means that heat loss for air leakage is well compensated. Figure 26 represents the results of the temperature monitoring that took place on 08.11.2019 from 9:00 till 16:00.

Figure 26. The results of temperature monitoring on 08.11.2019 at 9:00-16:00 in room 391

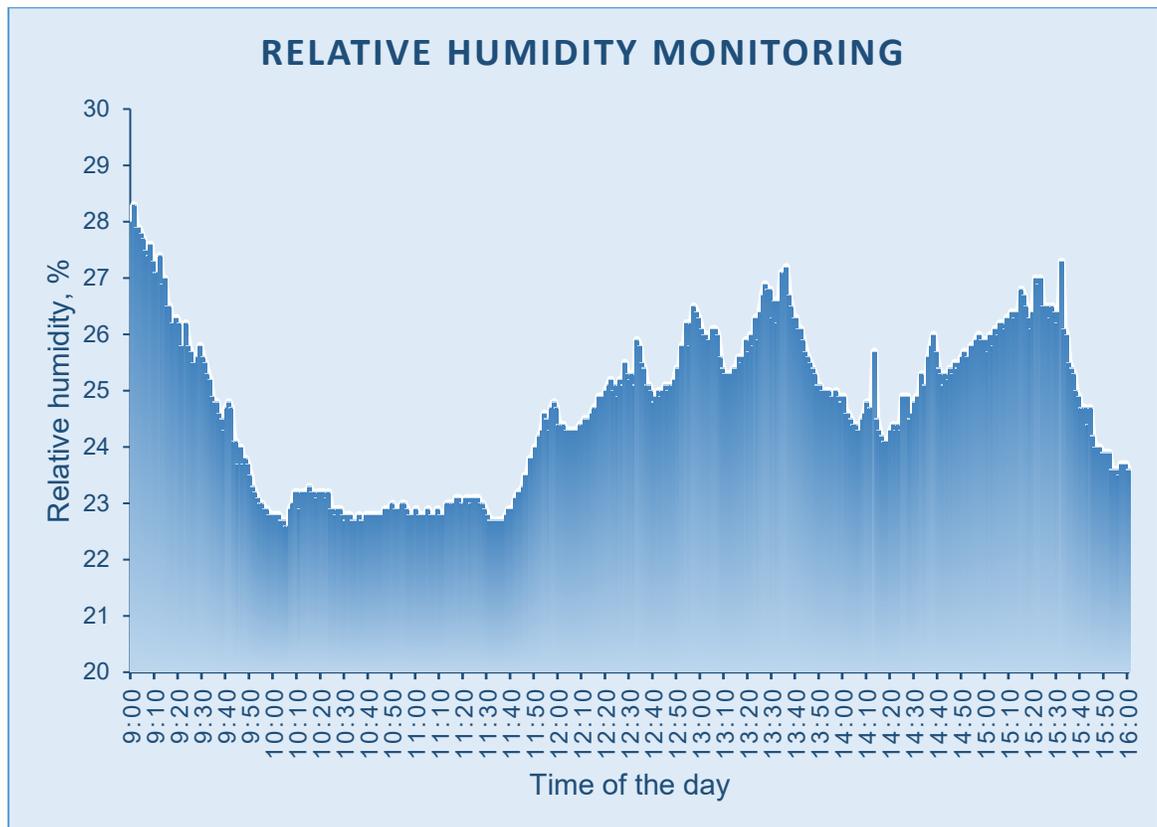
The results of the monitoring of relative humidity show that the highest relative humidity during monitoring hours in the sample room 391 was 28,3%. The average value for relative humidity is 24,7%. The minimum relative humidity was 22,6% when the room was not occupied by the group of children and adults. The comfort range for relative humidity inside the building is considered to be 40-50%.

However, in winter the indoor relative humidity is usually lower than in summer because the air is relatively dry in winter. The average calculated moisture content in the outside air is 2,86 g/kg. The average calculated moisture content in the indoor air is 4,07 g/kg. The results of the monitoring of relative humidity in the sample room 391 is presented in figure 27.

Figure 27. The results of relative humidity monitoring on 08.11.2019 at 9:00-16:00 in room 391

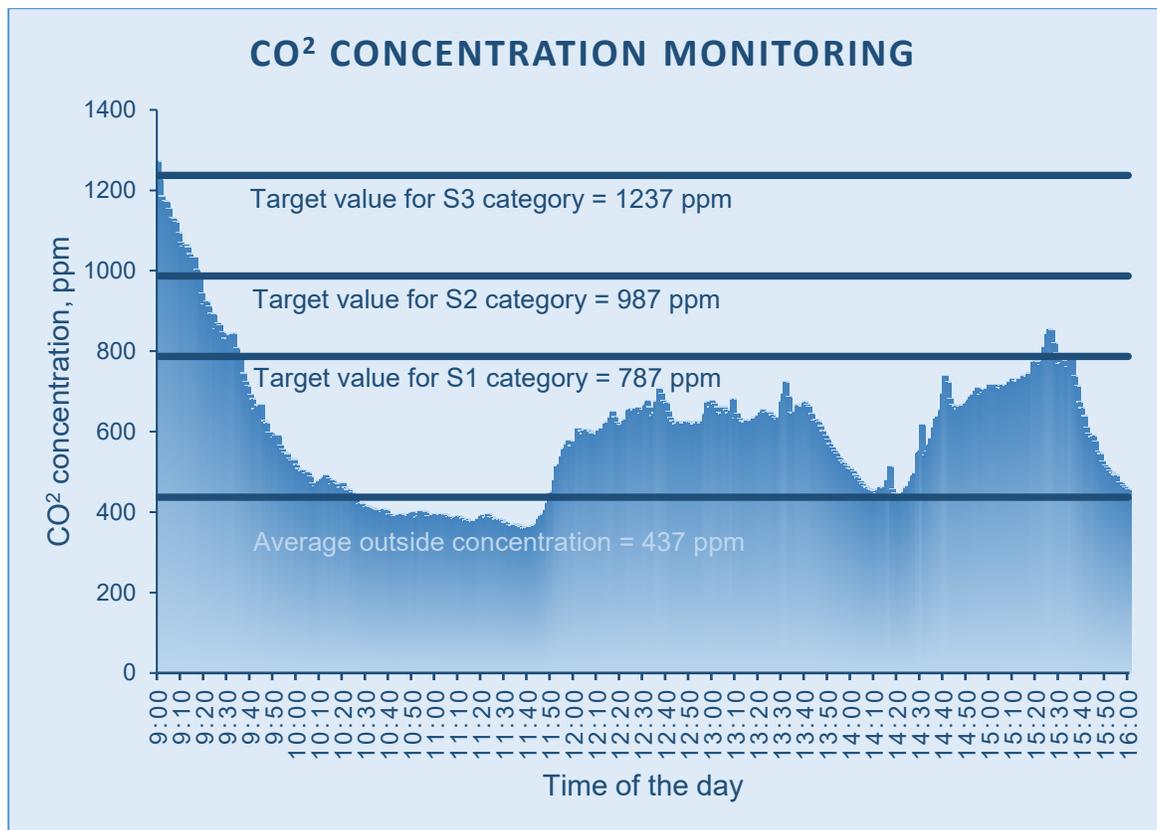
The results show that most of the time indoor air quality in the sample room 391 is considered to be high. However, at the beginning of the monitoring, the indoor CO₂ concentration exceeded the acceptable range. That means that the supply airflow rate of the ventilation system maybe not enough for the higher occupancy.

Figure 28. The results of CO₂ concentration monitoring on 08.11.2019 at 9:00-16:00 in room 391

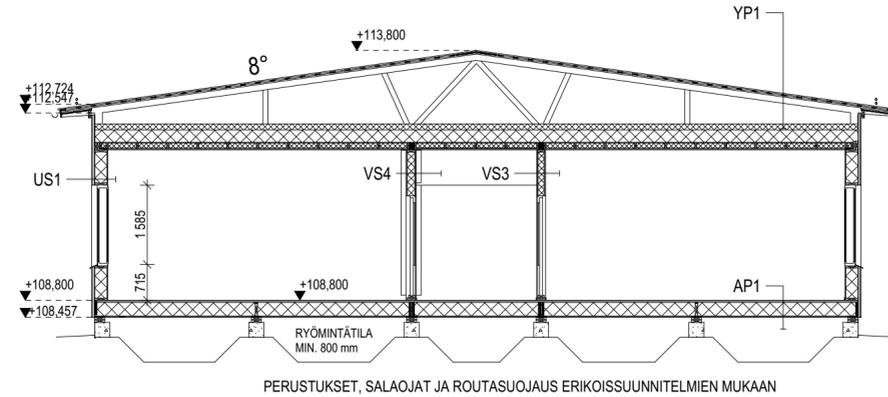
LEIKKAUS C - C

KIPSILEVY EK 13 mm
PUURUNKO 42x66 mm 66 mm
+ MINERAALIVILLA 70 mm
KIPSILEVY EK 13 mm
