The Impact of the Irrigation System and Agricultural Production on Water Quality in Chókwé Irrigation Scheme

Thesis

Anne Hakala, Liisa Pekonen

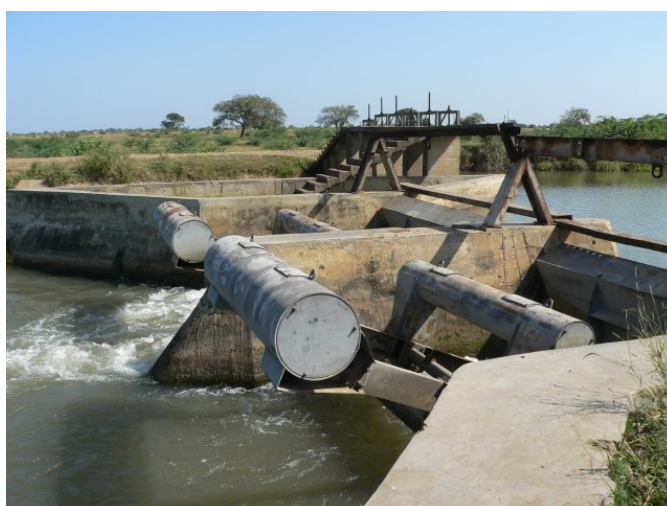
PICTURE 15. A small hydraulic structure in an irrigation channel to control water discharge (source: Liisa Pekonen, 2007)

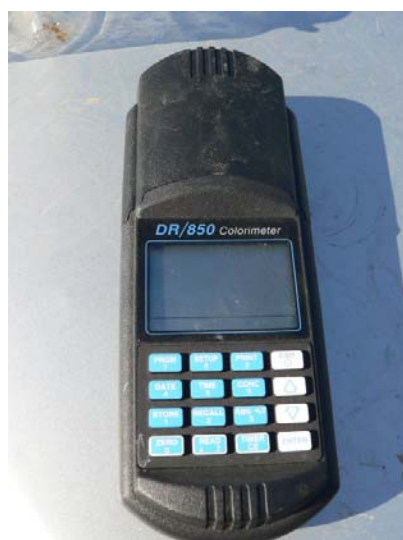
PICTURE 19. Hach's portable colorimeter (Source: Liisa Pekonen, 2007)

Method	Program	Reagent/reagents	Sample/ mL	Time
Diazotiza-tion Method	60	NitriVer 3	10 mL	~17 min
Absorpto-metric Method	95	No reagent	10 mL	~3 min
HRDO Method	70	Accu Vac Ampul	50 mL	~4 min
Amino Acid Method	85	Molybdate reagent, Amino Acid Reagent Solution	25 mL	~12 min

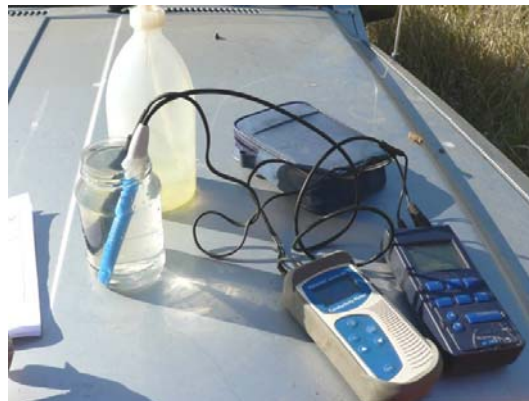
PICTURE 20. Conductivity and pH meter (Source: Liisa Pekonen, 2007)

Conductivity was measured using Palintest* Micro 500 Conductivity meter. The equipment was borrowed from the UEM. After every sample the measuring stick was cleaned with distilled water.

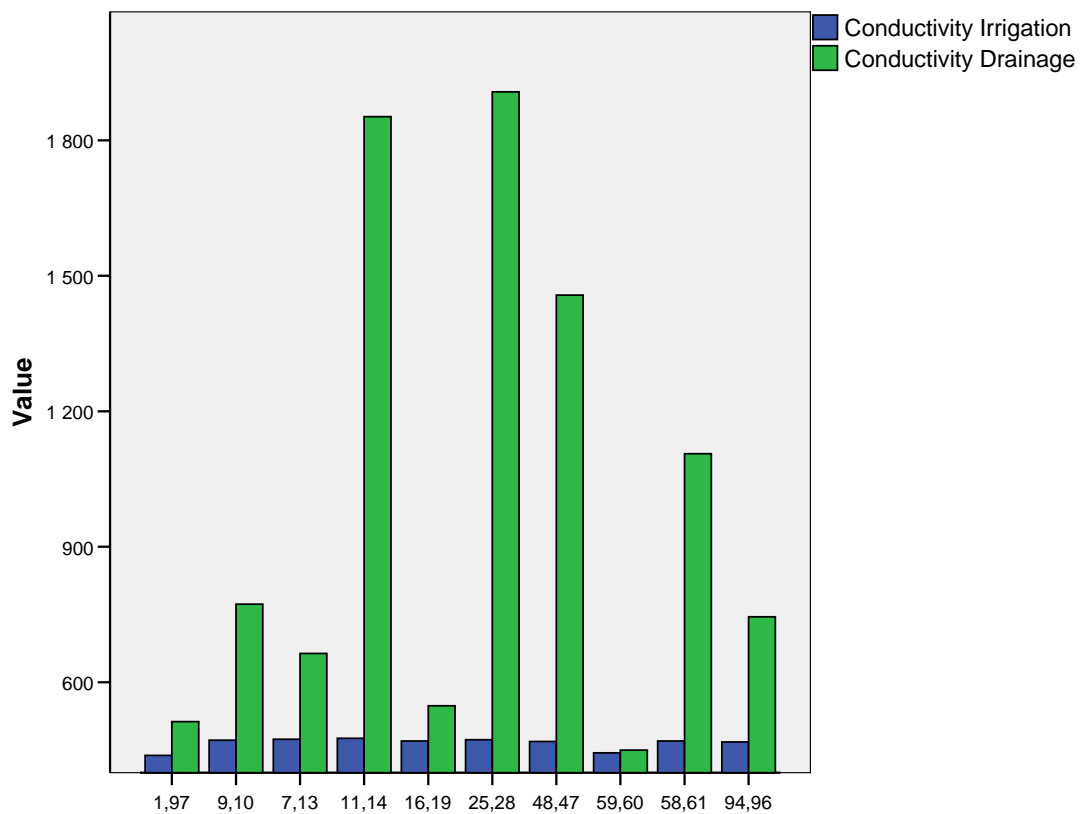
Figure 7. Conductivity values (μS) of 10 irrigation- and drainage channels
