# Predictability and the modern maritime environment

**Diesel engine failure prediction and monitoring techniques-  
A case study**

Master's thesis

Master of Engineering, Autonomous Maritime Operations

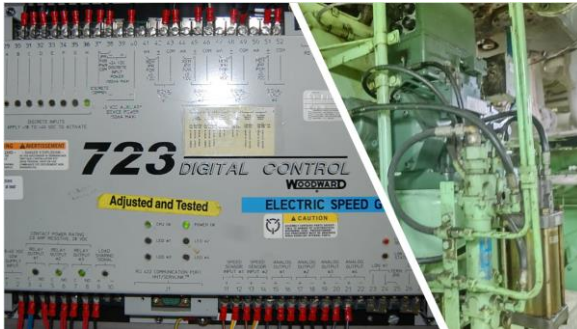
**Figure 6. Engine speed governor and actuator. (Author’s collection).**

This engine generation utilizes the SaCos99 safety and control system that was introduced in late the 90s. Engine is electronically controlled by the “Woodward 723” through the Woodward PGG-EG200. This is a mechanical-hydraulic pressure compensated governor, combining a speed setting motor for remote control with manual speed control. (MAN Energy Solutions, 1995, p. 36). Refer to Figure 6 below.

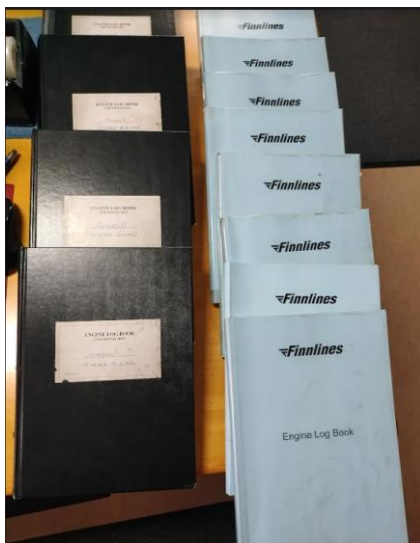
**Figure 11. Engine logbooks Finnmill. Author's collection.**

Following up on the engine logbooks for the selected time frame of the event log provided a useful way of explaining the reasons behind each event. Most of the content of the logbooks was of such quality that it gave the author necessary details in regard to time stamps and more specific circumstances as well. To understand a specific event, it is important to know aspects such as the ship's route and schedule as well as essential parameters such as load pattern, fuel in use, and possible known factors affecting the engine behavior at a specific time stamp.

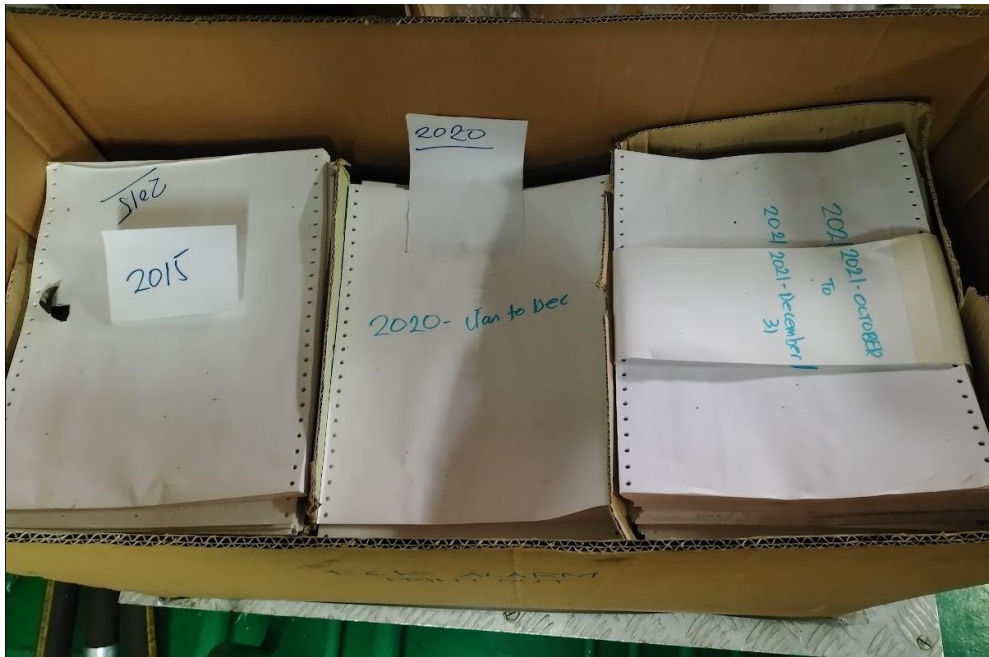
Figure 14. Event log archive. Author's collection.

In this thesis only events somehow related to the main engines are of interest. However, to select events that are of interest the full content of approximately 24000 pages had to be investigated.

As mentioned earlier, a specific time window was found to provide the best quality. This window had the least errors related to print quality and did have other important records supporting the information. In total, this author sent about 3500 pages for scanning to the premises of MAN ES in Augsburg. These pages of the event log are range from the year 2016 to 2018. This content is considered as confidential and is therefore only shared with the commissioners. There were considerable parts of the log that the mass scanner could not recognize due to poor quality of the original printout such as the example in figure 15.

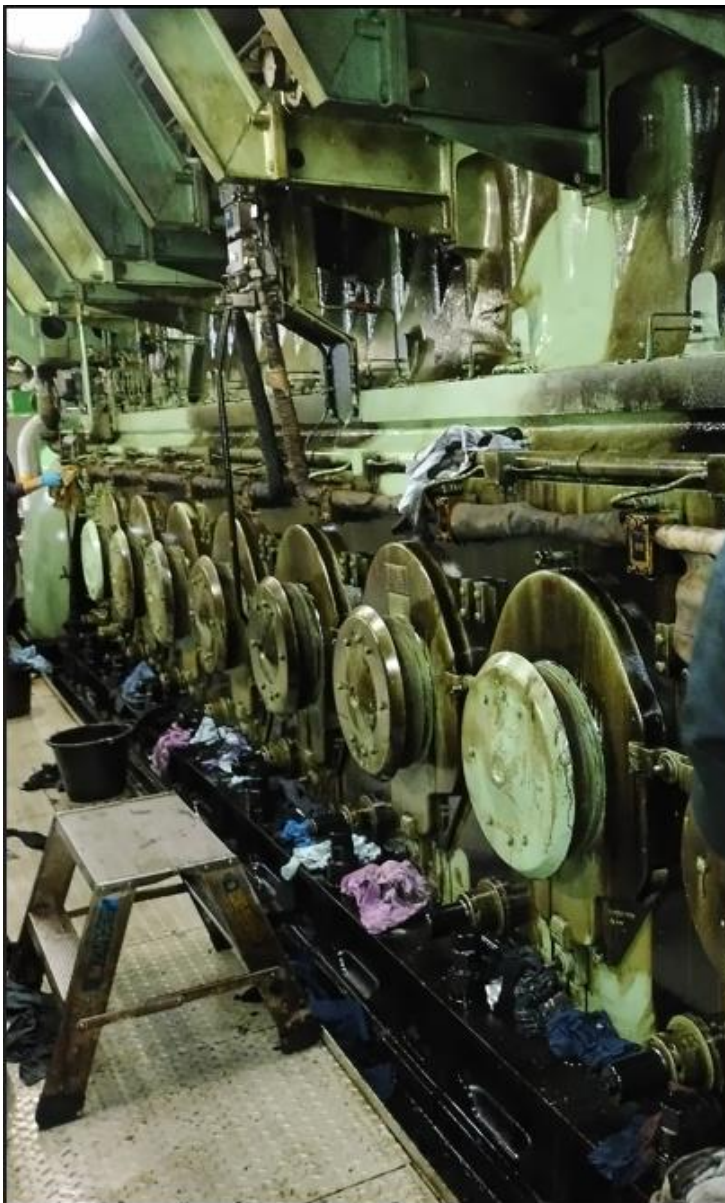
**Figure 24.** Crankcase safety valves have released pressure to the atmosphere. (Author's collection).

The following pictures were taken after this event and aim to illustrate the consequences of the crankcase explosion and the associated damages.

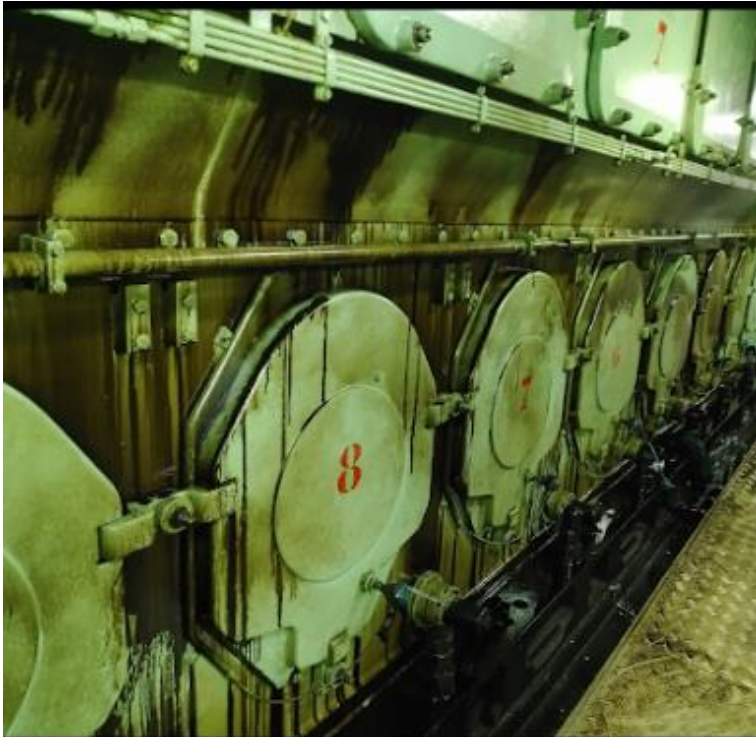
**Figure 25. Operating side of engine. Fasteners keeping crankcase covers in position broken off between cylinder four and five. (Author's collection).**

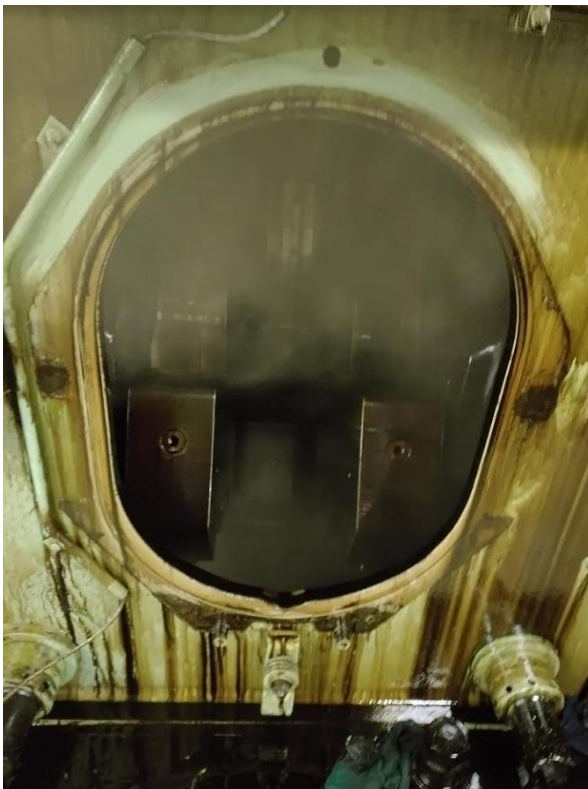
**Figure 26. Crankcase venting before fault tracing commence. Photo taken approximately 30 minutes after the explosion. (Author's collection)**

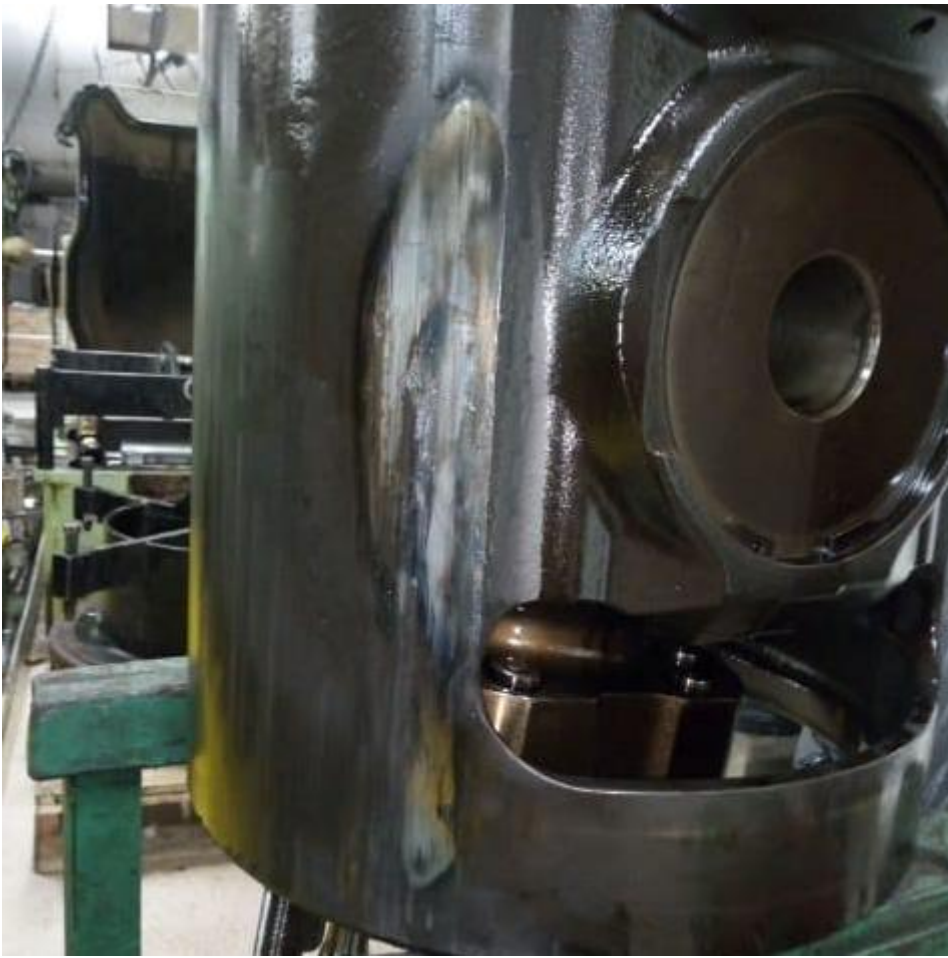
**Figure 28. Damage on piston of cylinder 7. Deep scoring and severe overheating. (Author's collection).**

In this case, the component damage were limited to the piston (034), liner (050), and due to severe liner overheating the backing ring, also called water jacket (part of assembly 050) could not be separated from the liner without causing additional damage to these parts. Refer to Figure 29 on page 34.

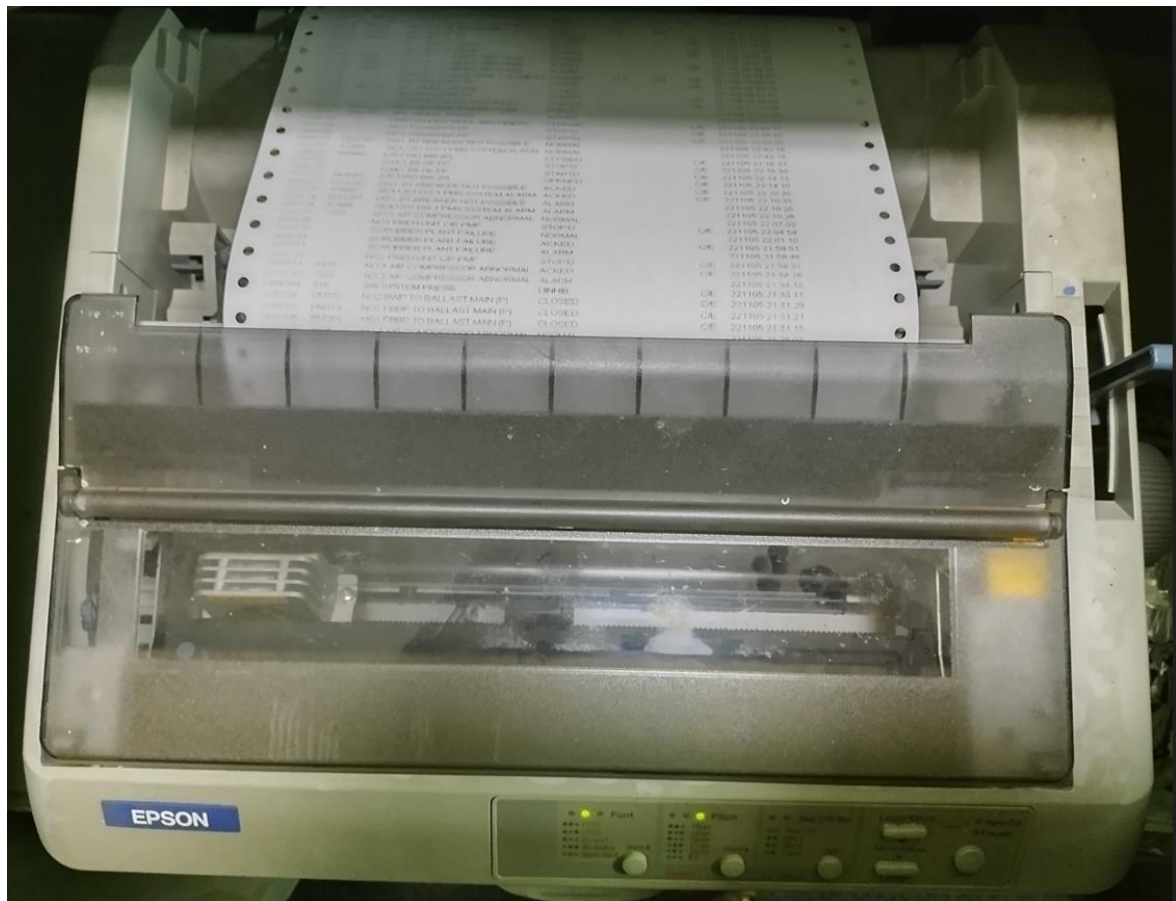
**Figure 39. Event log printer. (Author's collection).**

This chapter target various digital tools and the aim is to clarify a basic perspective of material availability during the thesis process. During the writing of this thesis, it was observed multiple times that additional digital tools for data storage would have made the process a lot easier and more efficient. The largest contributor in terms of background material for the research process of this thesis was the alarm and event log. As of today, it is only available in A4 matrix paper format making any precise search very challenging. Every single page of the event log was analyzed and checked manually and due to lacking availability as well as quality the selected time window of the log was rather limited. Total availability was close to 24000 pages from which the adapted time window incorporates roughly 3500 pages. Below Figure 39 presents the event log printer.

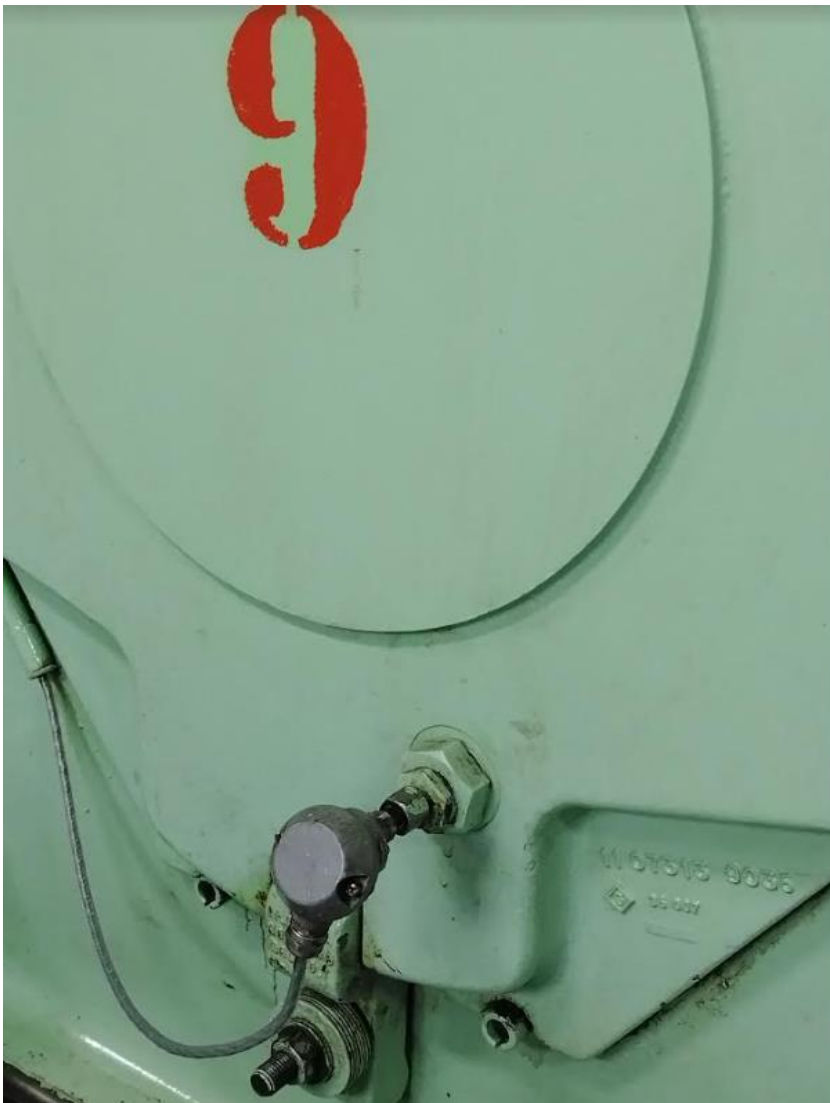
Figure 45. Splash oil temperature sensor PT100. (Author's collection).

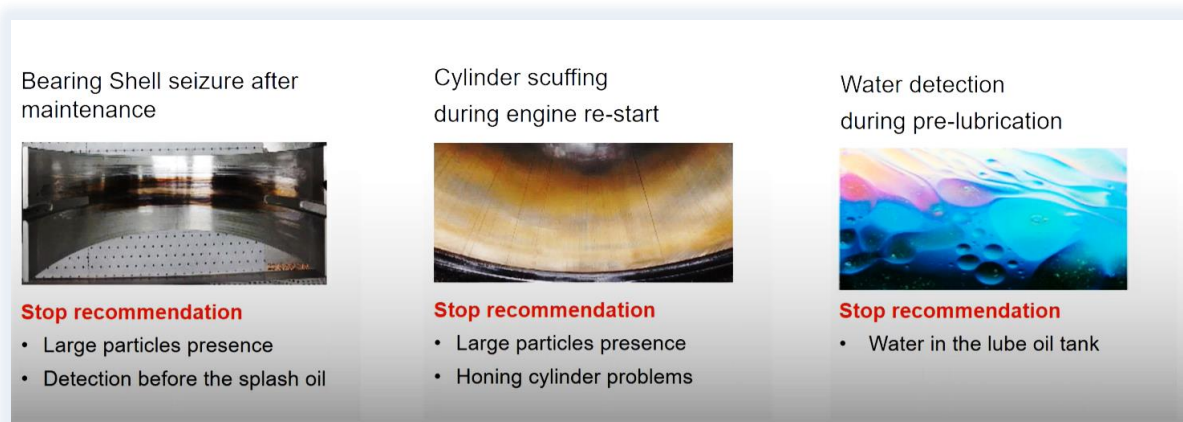
**Figure 52. Example of anomalies detection feedback. (MAN Energy Solutions, 2020b).**

As the topic address, MAN fluid monitor targets the engine lubricating oil and is an existing monitoring option. It is a live (real time) feature for monitoring quality of the lubricating oil and acts as a part of the MAN condition monitoring solution. Additionally to temperature and pressure deviation, the system detects pollution and contamination of the lubricating oil caused by combustion residues, fuel, solid ferrous material (metal), non-ferrous material and water. According to MAN ES, 70% of major damages reveal a pollution of the engine lubricating oil. The system is already considered well proven after 50 000 hours in operation. (MAN Energy Solutions, 2022c).

The fluid monitor system is a stand-alone solution that can easily be included in the existing monitoring system on-board to effectively alert the operators whenever there is an anomaly found in the lubricating oil. Due to the design, the user has a good overview of the status – it is not only a simple alarm switch. Instead, this system highlights the reason for triggering an alarm and guiding the operator towards the root cause. Below Figure 53 show the basic display view on-board.

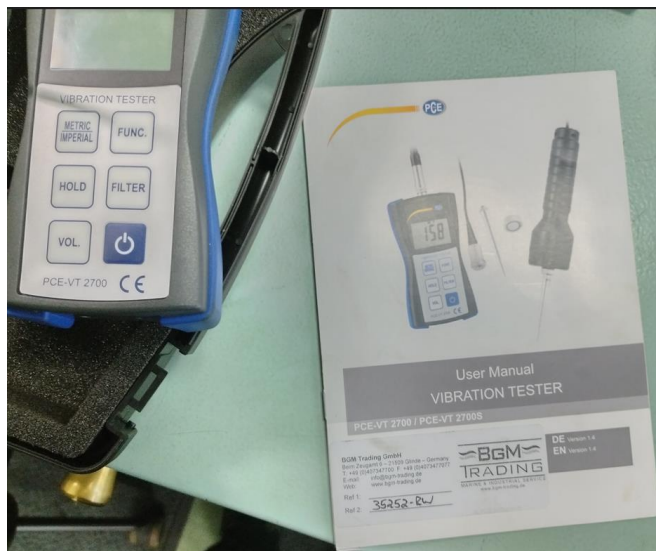
**Figure 57. Vibration tester instrument PCE-VT 2700. Author's collection.**

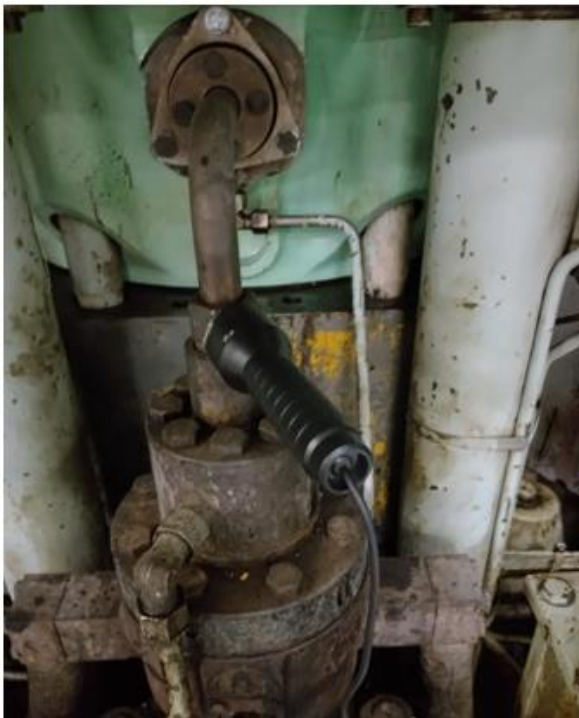
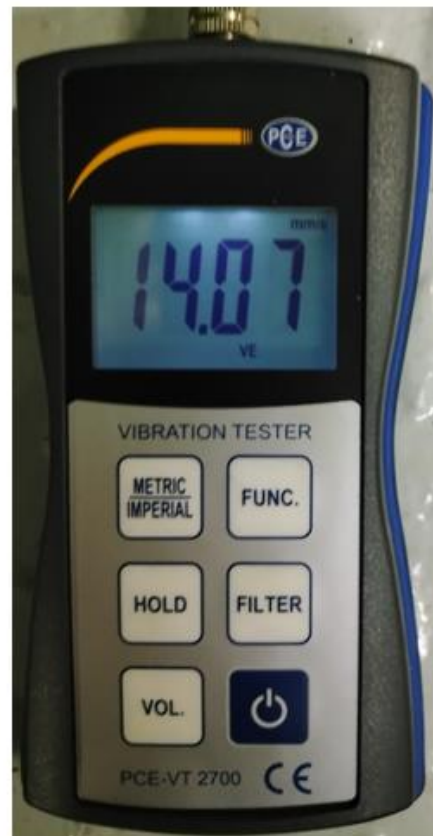
**Figure 58. Measured vibration in mm/s<sup>2</sup> at 65% engine load. Author's collection.**

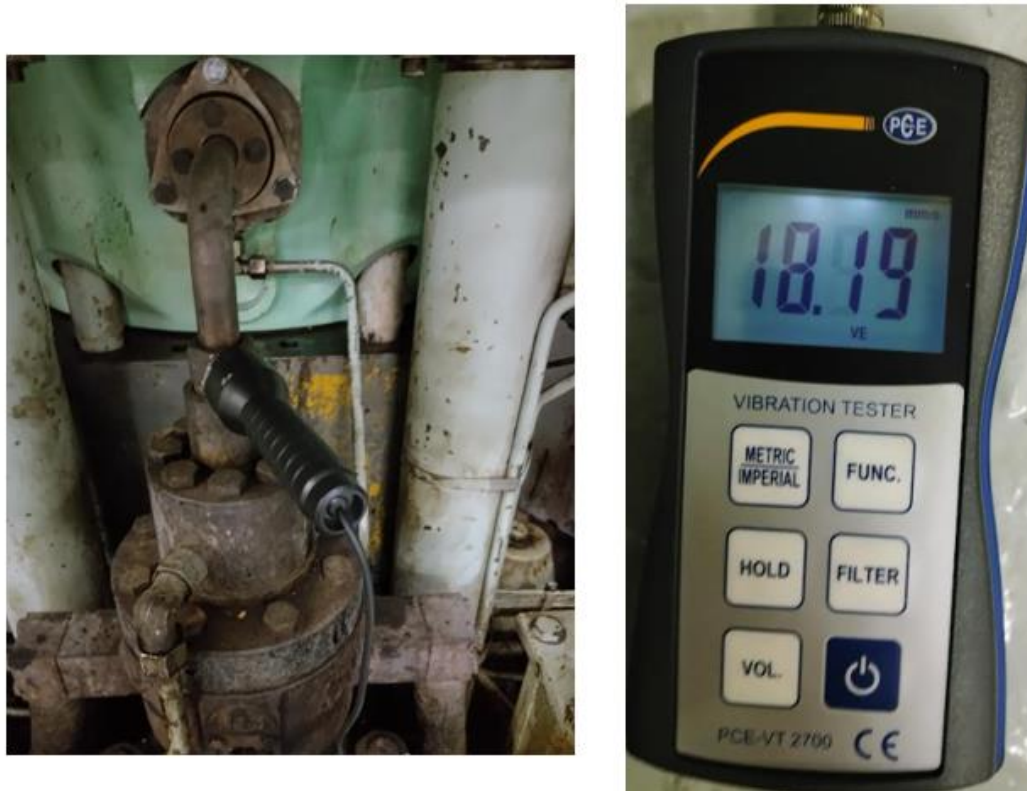
**Figure 59. Measured vibration in mm/s<sup>2</sup> at 65% engine load. Author's collection.**

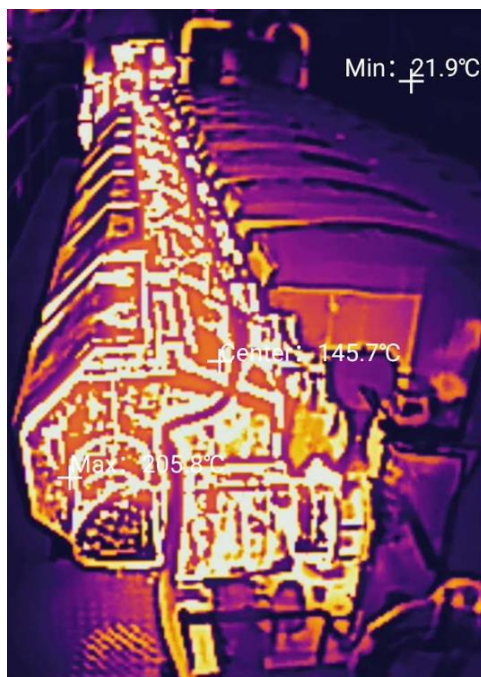
**Figure 62. Engine exhaust piping view from free end. Author's collection.**

By combining this technique with some level of artificial intelligence and machine learning, it can effectively provide important information regarding hot spots for instance and automatically alert if there is a surface temperature that increase risk of fire. If we look at

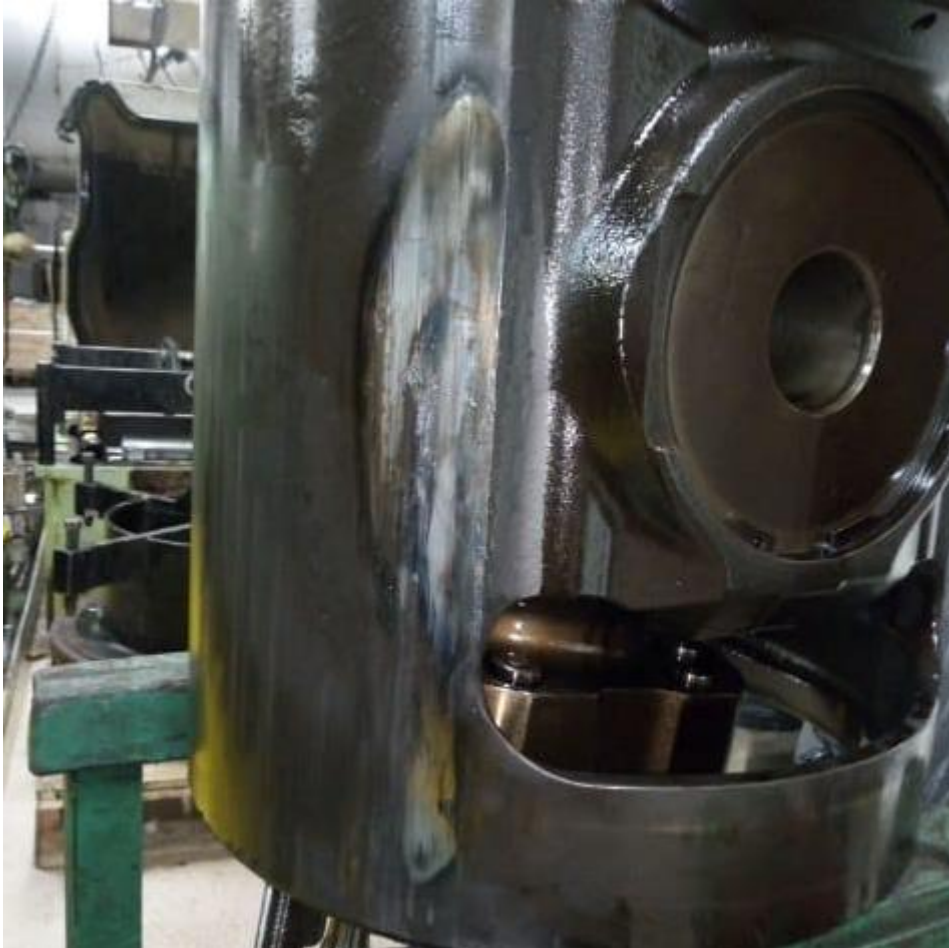
**Figure 65. Damages on piston of cylinder 7. Deep scoring and severe overheating. (Author's collection).**

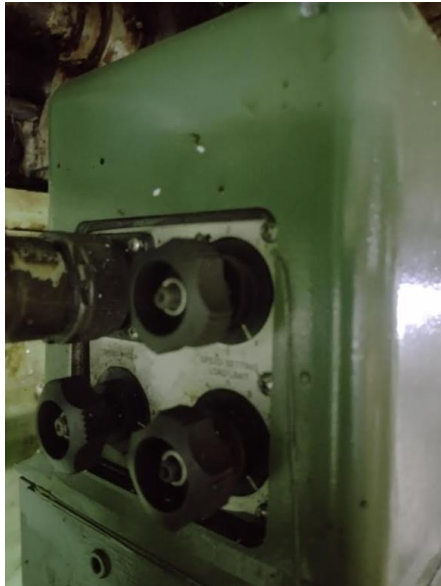
**Figure 71. Mechanical Governor control. (Author's collection).**

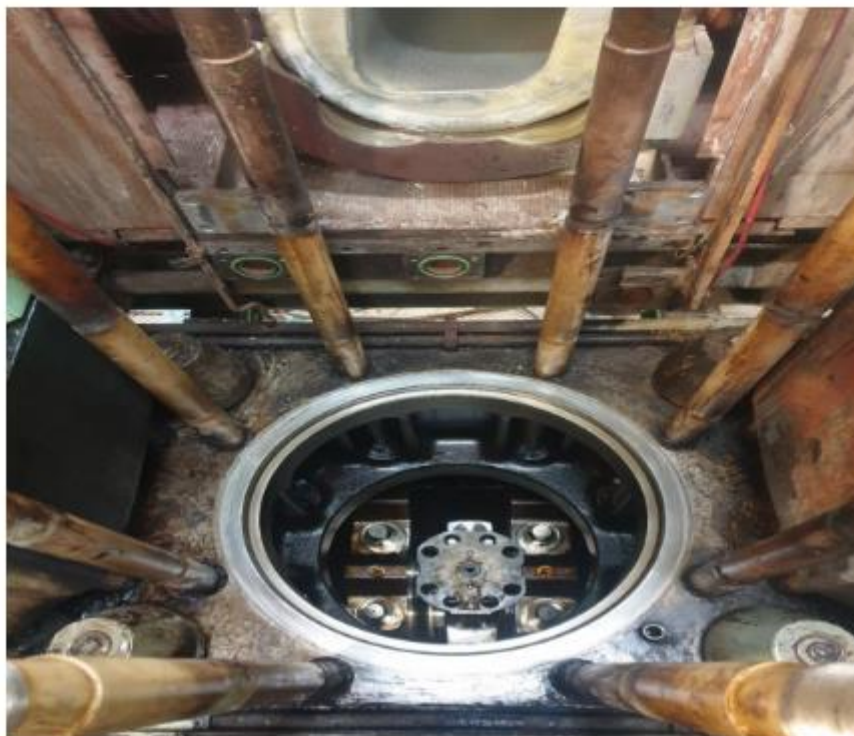
- ✓ Connecting rod big end untightened. BEB shells replaced by new.
-

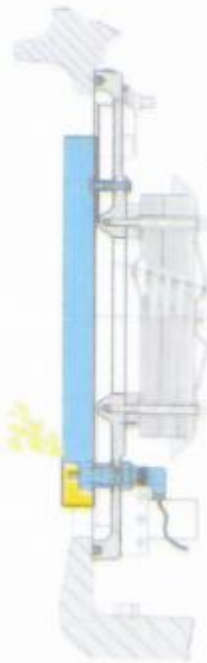
Figure 2: Position of the temperature sensor in the crankcase cover

<b>Experience</b>	MAN B&W Diesel AG introduced splash-oil-temperature monitoring as safety system on engines in 1999 (see figures 1 and 2). Since then, this system was subsequently installed in more than 150 engines and is also used as standard safety equipment in our four-stroke Diesel engines since the end of 2002. During the 6 years of operating experience, the splash-oil system proved to be extremely reliable and required only minor maintenance. More than once, it saved the running gear from severe damage. The special advantage of the splash-oil system is that any disturbance in normal operation, which causes an oil temperature increase, is recognised reliably and promptly. The splash-oil system is unable to prevent disturbances in normal operation, it is, however, able to minimise the extent of possibly severe damage.
<b>Reason</b>	Although the splash-oil system proved to be absolutely reliable in practical operation, we had to note now and then that the importance of the splash oil emergency stop is underrated. No matter how efficient a system may be, it only works if alarms and stops are taken seriously and promptly responded to.
