SUSTAINABLE WASTEWATER NETWORK MANAGEMENT IN LEMPÄÄLÄ MUNICIPALITY

Bachelor's thesis
April 2012
Environmental Engineering
Department (TAMK)
Tampere University of
Applied science

Peter Paul Obijaju	Sustainable wastewater network management in Lempäälä Municipality
Final thesis	36 Pages
Supervisor	Hilda Szabo
Commissioned by	Water Utility department of Lempäälä municipality in August 2011

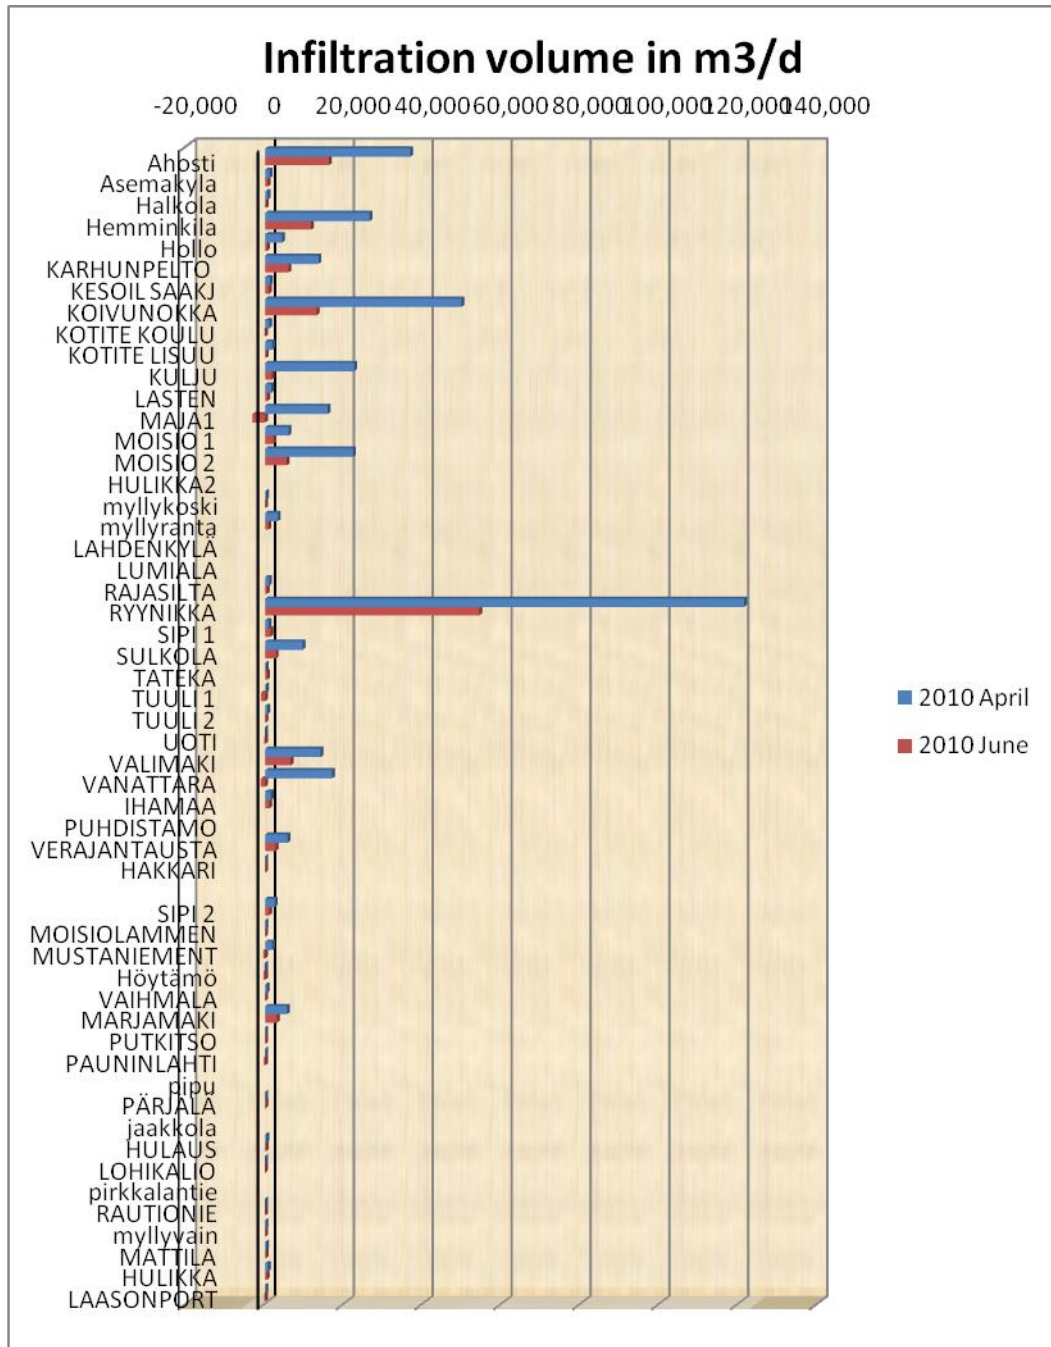
Figure 7.4 Graphic presentation of the infiltration flow for wet and dry periods.

Some of the areas which showed high infiltration wastewater in 2010 were investigated in 2011 and leaks were found. Such areas includes Moisio2, Vanattara, kulju, koivu, Hollo, and Hemminkila. In Rynnkka there was a very high flow but no leaks was found in the investigation in 2011.
