# Metal stitch reconditioning analysis

Niklas Eurs

Bachelor's thesis

**Title:** Metal Stitch Reconditioning Analysis

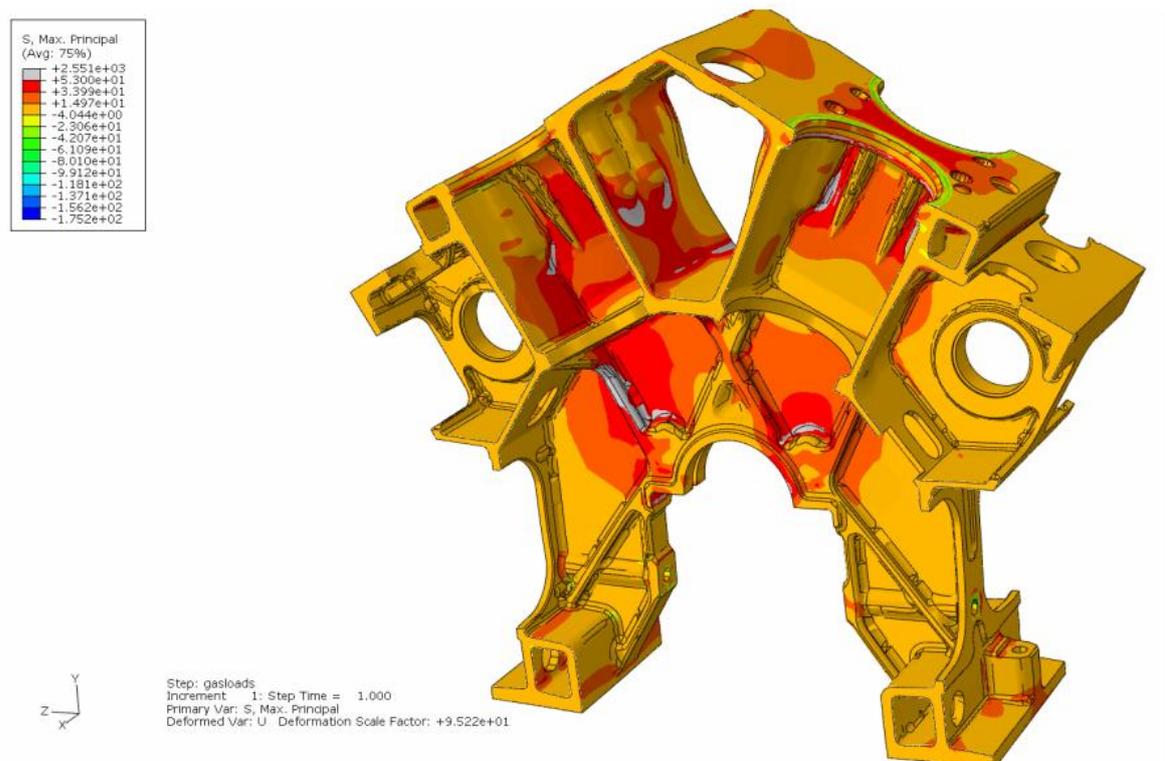
Figure 4. Maximum principal stress, general.

These calculations and FEM pictures could be helpful in the future when Wärtsilä is about to decide to stitch or replace an engine block after a breakdown has occurred.

By comparing the actual damage to FEM pictures, one can decide if the damaged site is at a highly loaded place or a low stress area.

If the damage is located in a low stress area, then could be suitable for metal stitching.

If the damage is located in a high stress area, then it could be good to consider replacing the engine block and by that avoid possible re failure.

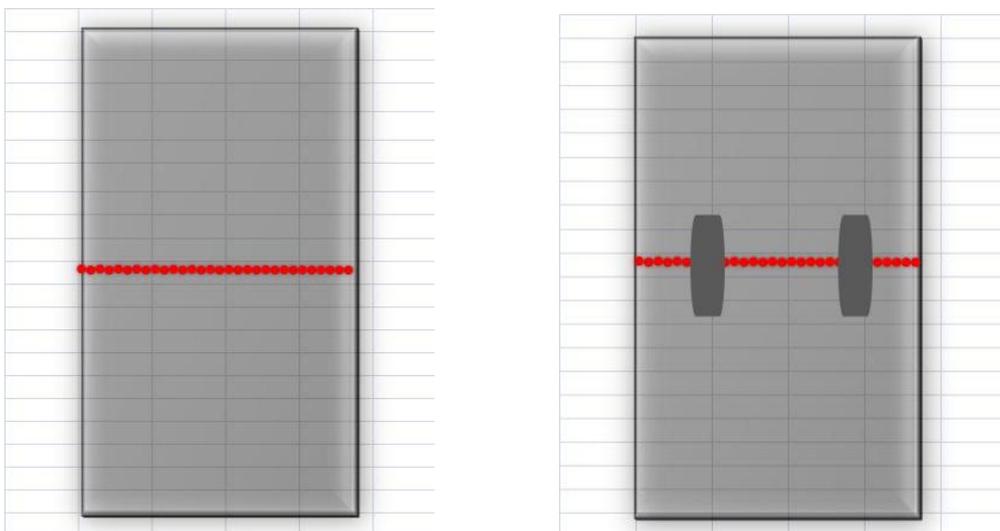
Figure 16. Couple of stitched plates to be tensile tested

All in all 16 test plates were cut out from Vasa 32 main bearing caps and machined to 250\*60\*12mm. The material is GRP500, and the calculated tensile strength for a piece of this material and size would be approximately 360 000 N. The plates were cut into two pieces and sent to Lock and Stitch in Turlock, California. LnS stitched the test plates I prepared. After receiving the test plates back to Finland two of the test plates were crack tested with magnaflux both for better visibility of the repair and to see if any cracks could have been propagated already during the performing of the repair. One small shallow crack was found on test plate no.16, nothing severe. After this 11 of the 16 test parts were sent to Metlab in Tampere for tensile testing. The remaining 5 will be used for dynamic testing of the repaired joint later on when the tensile strength is known.
