The Accessibility of Cultural Attractions for All Senses in Kerava

Aino Laine, Mila Toivanen
Degree Programme in Tourism
Bachelor's Thesis
September 2015

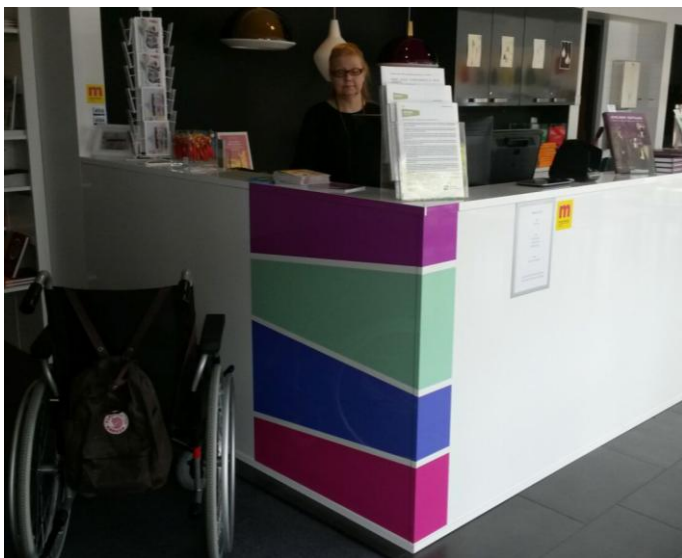
Image 2: Service counter (Laine, 2015)

The main entrance to Sinkka is on the street level with a small level difference that has been corrected with a ramp (Image 1). There are two heavy doors on the entrance, neither of which is automatic. The service counter for the museum and the cafe was high for a customer in wheelchair or for a short person as seen in image 2. Benches and tables were placed in the lobby next to the service counter and cafe area. The staff is extremely helpful and professional with expertise in accessibility matters. A member of the staff highlighted the personnel's willingness to help in all situations by explaining that if the architectural design does not allow the use of services for all customers, the personnel will do its best to provide it in another way, for example assisting a customer in the entrance and whenever needed. All the information, brochures and signs are written in English and Finnish. Around the corner from the service counter there was a clear floor map indicating the customer areas and exhibition halls.

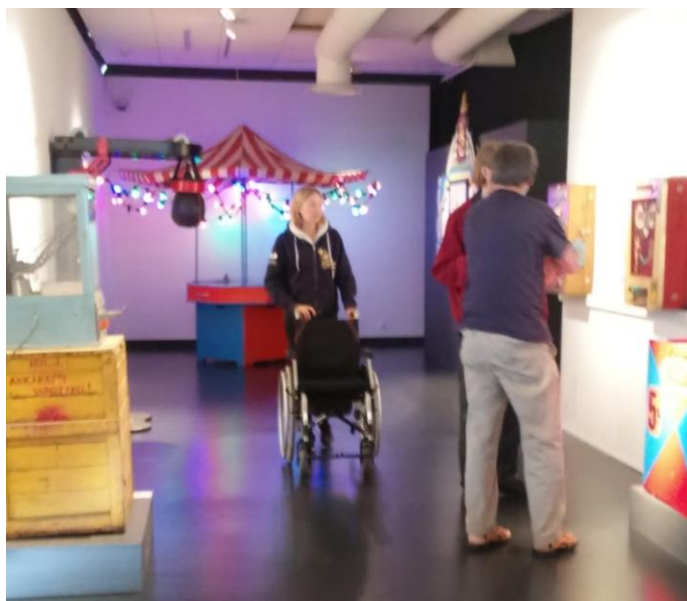
Image 3: Exhibition area, street floor (Toivanen, 2015)

The exhibition was divided between three floors; street level, cellar floor and second floor. The image 3 illustrates the exhibition included artwork for different senses with audio, film and concrete artwork and pieces. The artwork consisted of posters and photographs, games, statues, replicas, artifacts, historical timelines, films and audio effects. It was prohibited to touch most of the artwork, except for the life-sized elephant made of strong enough material to support 80 kilograms' weight. In addition to the elephant there was another interactive piece of art operated with a touch screen. The walking route through the exhibition was a

The contrasts were good with dark gray floors and white walls. Lighting was adequate but in the exhibition halls with films there were minimal lighting and black walls that could cause perception problems for those with impaired vision. The whole exhibition area had no thresholds or other level differences. The only negative remark was in the cellar floor that had an inclined ceiling due to the staircase (Image 4), located right in front of a doorway. This ceiling had no contrast stripe and could cause incidents for unaware customers. The signalization was good, except for the elevator that had only a small text in the upper corner of the door. There was only one call-button for the elevator along with two small screens indicating the vacancy and floor of the elevator.

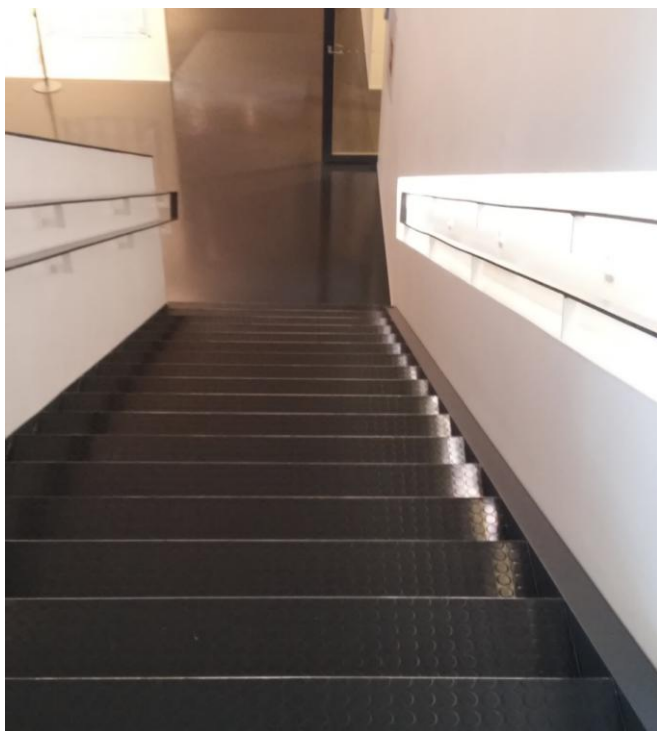
Image 6: The stairs (Toivanen, 2015)

The elevator was large, designed for transporting paintings and large exhibition objects. The door was heavy and had no audio signal for its arrival. There was more than enough room for a wheelchair and other persons (Image 5). However the elevator had no inner doors so the walls moved with the elevator causing a risk for the customers. There was no audio guidance or Braille writing. Obligatory emergency buttons and weight capacity were written inside the elevator as well as the buttons that were distinguishable by touch. The stairs were dark gray with contrast stripes and made of material that prevent slipping. There were embedded railings with light on the other side and normal railings on the other.

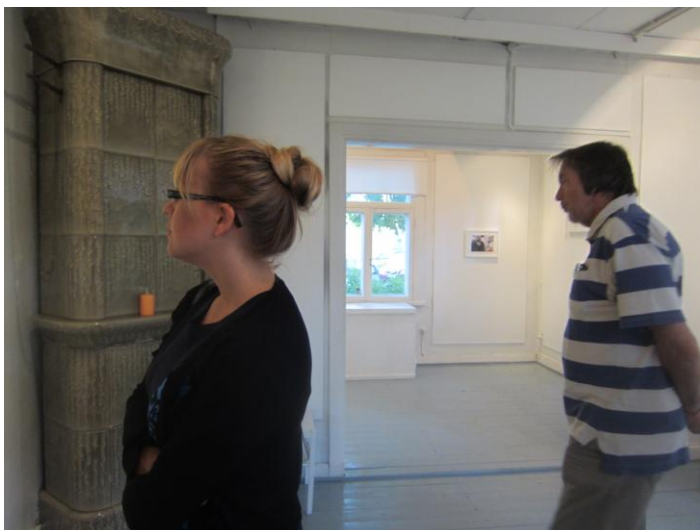
Image 9: Inside of the Gallery (Laine, 2015)

The inside of the gallery's building is divided into four separate rooms, which are all reserved for the exhibitions. The upstairs is not for customer use. As an entity, the Gallery is not accessible. The exhibition space is has high thresholds and narrow doorways, and no accessible toilet. The lighting was sufficient but it was directed at walls where the artwork was presented. There was no need for signalization in the building, except for the information board on the front door where the exhibitions were listed.

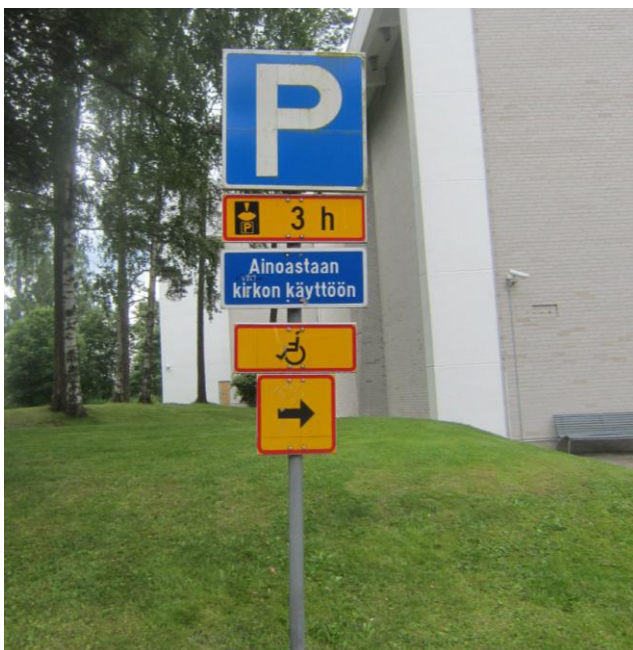
Image 10: Parking signalization (Laine, 2015)

The church is located near the railway station and is easily accessible by a car. The parking area is right in front of the church and a car can be driven right to the main entrance. There are also good signs for parking and accessible entrances. The congregation center is located next to the church and has its own parking area close to the main door. The church and the congregation center have good signalization on the accessible parking, and congregation center also has a map of the premises in the parking area.

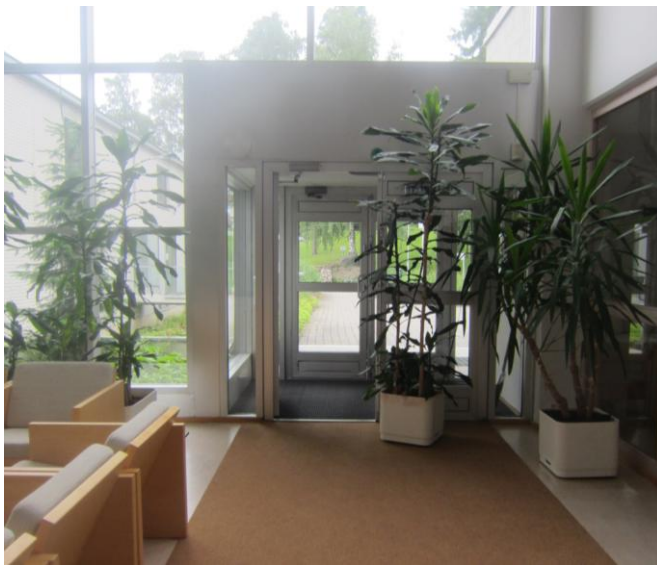
Image 12: The lobby area of the congregation center (Laine, 2015)

The congregation center had also two entrances, both of which were accessible for a wheelchair. In the lobby there are armchairs for customer use. The hall's main entrance had a non-automatic door with a low threshold but the side entrance also had a button for opening the door as seen in Image 13. The lobby area by the main entrance was spacious and well illuminated due to the large windows and light colors (Image 12), with clear signalization of the audio induction loop available. The plant seen in Image 12 was placed temporarily in front of the door due to renovations. The side entrance was only for entering, there were no customer spaces, only offices and the elevator.

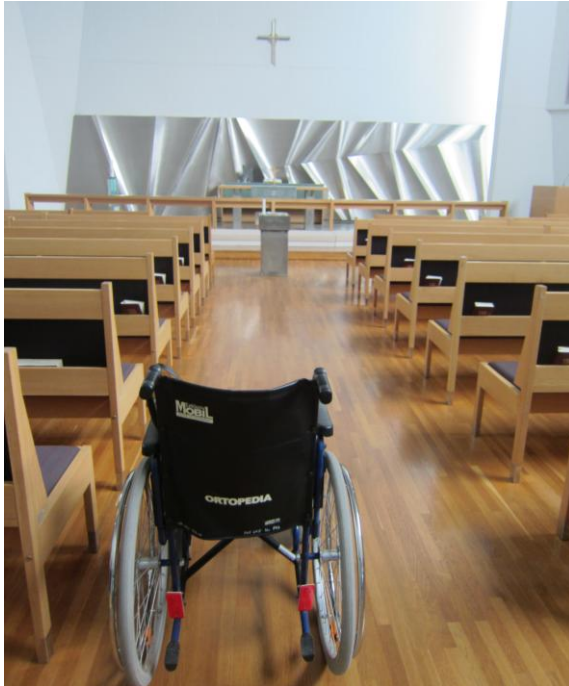
Image 14: The church service hall (Laine, 2015)

The church hall is spacious and well illuminated hall due to the light colors and large windows. There are no level differences in the room except for the altar and the choir balcony. The floor is dark and creates good contrast for the white walls and wooden benches. Due to the long benches there is little space for a wheelchair in the back of the church for three or four wheelchairs. According to the janitor the altar is not accessible for a wheelchair at the moment because of a high step but the communion is served personally to someone who cannot access the altar. The altar lacks a railing but one is planned to be installed in the future. There is a contrast stripe on the step to make it easier to notice.

There is an audio induction loop in the church hall with clear signalization and instructions for the hearing impaired. For the visually impaired there are hymn books written in Braille available on demand. In addition there is also a wheelchair for customer use both in the church hall and in the chapel. There is a noticeable echo in the hall which is why there are sound system and mixing and sound control panels for the speakers' stand and loudspeakers.

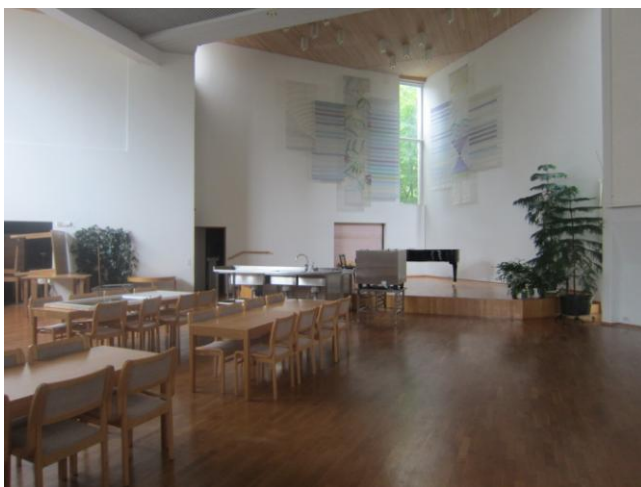
Image 15: The congregation center (Laine, 2015)

People with disability aids have been taken into consideration by miniscule thresholds and other architectural barriers in the hall as well as installing an audio induction loop. The hall has large windows and good contrast colors. The upstairs is divided into two rooms, one larger room where the concerts are held and another smaller room with tables and chairs. In the downstairs of the congregation center besides the stairs there is a ramp with railing and contrast stripes enabling a wheelchair to enter the office area. The doors are not automatic but can be opened by pressing a button on both sides.

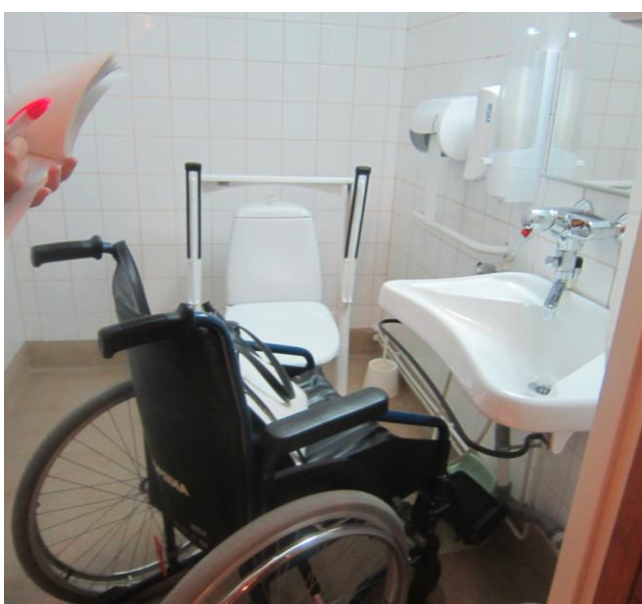
Image 16: The accessible toilet in the church (Laine, 2015)

The church has an accessible toilet downstairs by the parlor. The toilet has good lighting and enough space. There were relevant railings and the sink had enough room under it. The coat hook was placed low but there was no emergency alarm available. In the congregation center the accessible toilets is located upstairs, right by the entrance. The toilet had little space and there was no emergency alarm. The threshold had an inclined ramp made of concrete forming a level difference between the corridor and the toilet (Image 17). It was accessible without a helper but with some difficulties in exceeding the ramp. The lighting was sufficient in both toilets.

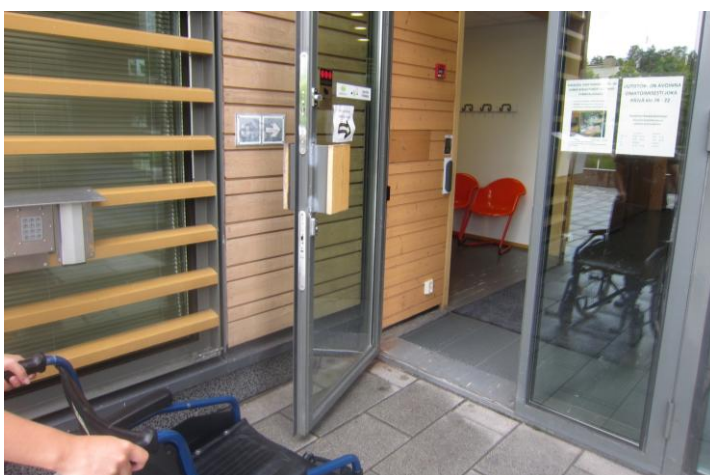
Image 24: The button operated accessible entrance (Jaakkonen, 2015)

The main entrance consisted of stairs with four steps equipped with a railing. There were no contrast stripes and the doors were not automatic and heavy. The entrance for persons with reduced mobility was located at side of the building equipped with a ramp and a door that could be opened by pressing a button (Image 24). The signalization was poor as Image 22 illustrates; the sign was worn off and situated low, next to a bicycle rack causing the bicycles to occasionally cover the sign.

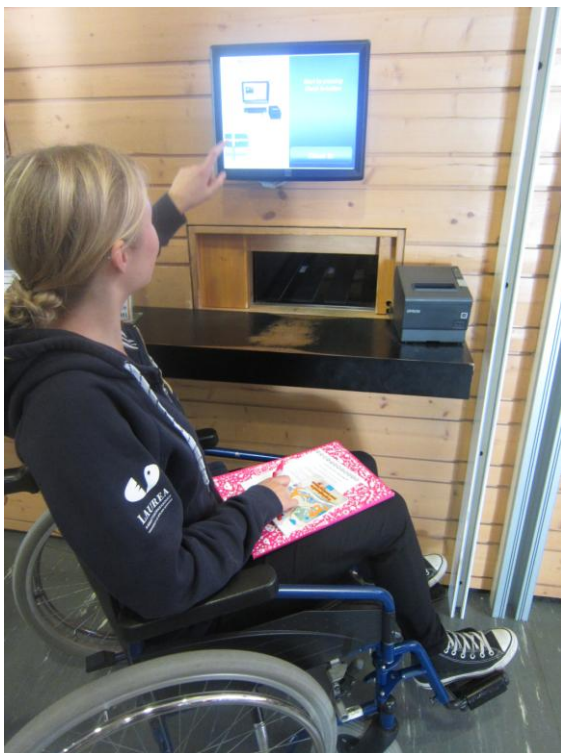
Image 25: The self-service return automat (Jaakkonen, 2015)

The service counters near the entrance were well designed as there were two levels in each service desk. The height was also good making it possible for a wheelchair customer or a short person to reach the counter and self-service automats. The automats shown in Images 25 and 26 are operated with a touch screen making it difficult for visually impaired customers to use independently. There is at least one staff member present at all times willing to help if necessary. An audio induction loop has not been installed in the library service counter area. An employee summed up the personnel's willingness to help in all situations by explaining that if the architectural design does not allow the use of services for all customers, the personnel will do its best to provide it in another way.

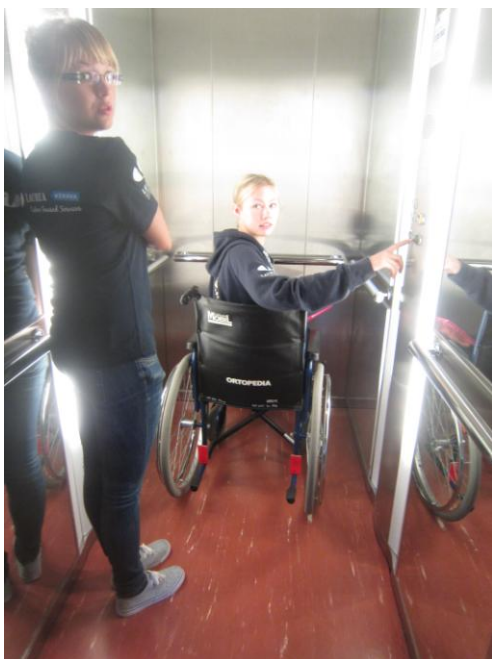
Image 30: Inside of the elevator (Jaakkonen, 2015)

The elevator was located near the entrance and had automatic doors with a voice signal and audio guidance on each floor. In addition the buttons were marked both with Braille and numbers and the call-button for the elevator was on a suitable height. Obligatory emergency buttons and weight capacity were written inside the elevator. The elevator had enough space for a wheelchair and a helper as seen in Image 30. There was also another elevator near the children's area but it was not in customer use. The stairs leading to the second floor and the cellar storage room are made of red tile with railings. There were no contrast stripes on the stairs.

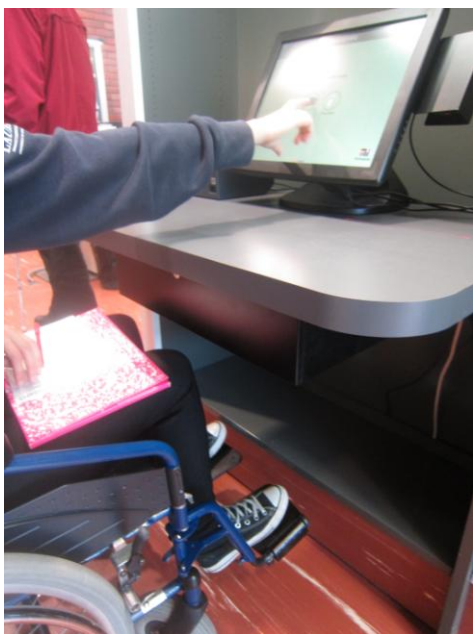
Image 31: The self-service automat and computer in Utistori (Jaakkonen, 2015)

Utistori is a separate reading hall with a return automat located inside the library with longer opening hours. There are magazines and papers available for reading, and there are no personnel present at all times. The self-service automats are accessible with a library card with which literature can be either returned or borrowed. Also computers are available for browsing or searching material. Inside Utistori there are tables and chairs for reading.

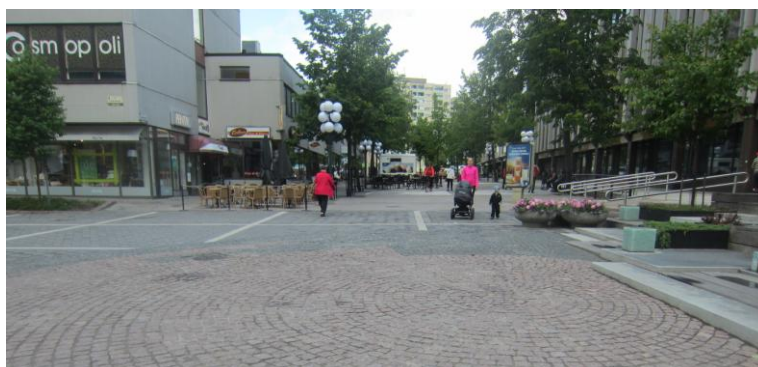
Image 32: Pedestrian Street (Jaakkonen, 2015)

The pedestrian street is barrier free. The only barriers are the caused by the restaurants along the street that have terrace areas with moving furniture during the summer. According to our visually impaired test users the street lamps, sewer grates, benches and other permanent structures do not form barriers after they have been memorized. However, the moving obstacles create more problems. The street is partly paved with cobblestone which causes problems for those who use a cane for orienteering (Image 32). The street has no level differences except for a few stairs that can be avoided by using ramps. There are different materials and colors used in the paving, which create contrast and memorable walking routes.

The pedestrian street is almost completely closed from cars and motorized vehicles, thus making the area safe for pedestrians. Only taxis and maintenance vehicles are allowed, as well as the transport of goods to the market square. Bicycles are allowed and since there are no bicycle lanes they are ridden amongst the pedestrians.

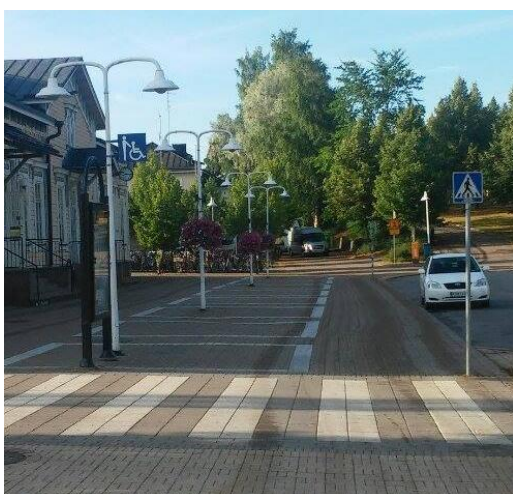
Image 34: Accessible drop-off place in front of the station (Toivanen, 2015)

There are two parking areas, one on each side of the tracks. There are accessible parking spots on each side as well as an accessible drop-off place next to the station building (Image

34). The amount of parking spots with unlimited parking time is inadequate compares to the amount of cars. There are also two-hour parking spots on one side. The way from the parking areas to tracks and the station building is even and relatively short. The bus station is right next to the station building that has straight access to the first track. The tracks can be accessed using the tunnel connecting all the tracks. There are steep stairs and a ramp for bicycles and baby carts but they cannot be used with a wheelchair. There are two elevators that provide access to tracks. However, on the testing day the other elevator did not function which would cause a long detour around the whole station area to the station tunnel leading to the pedestrians' street.

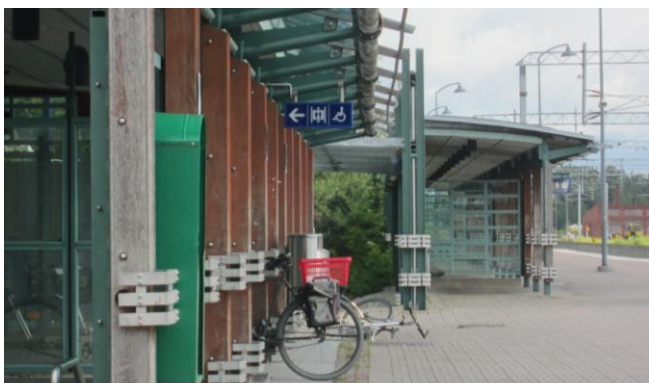
Image 35: The accessible elevator sign (Jaakkonen, 2015)

The signalization of the railways station is sufficient for all senses. There are signs with good contrasts and adequate size indicating the location of the elevators and the number of the track. The information boards displaying the train and bus schedules can be found in more than one place and they are clear. In addition there are announcements informing the visually impaired. The train lines inside HRT area are indicated on large info boards together with the daily train schedules.

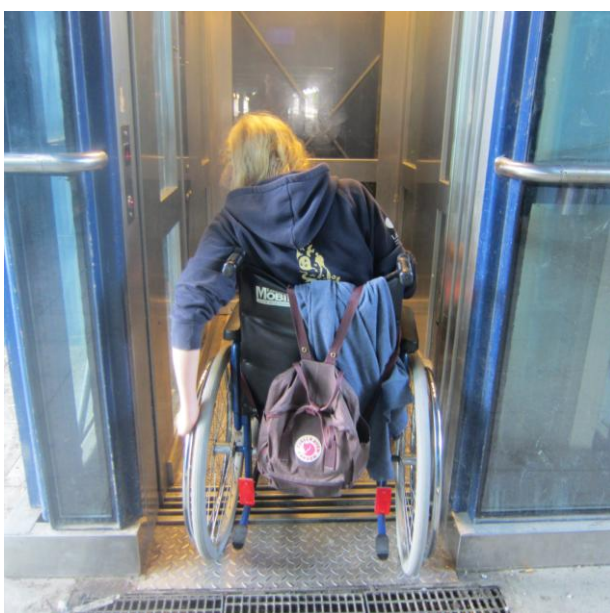
Image 37: The elevator (Jaakkonen, 2015)

The two elevators were located on the first track as well as between the fourth and fifth track providing access to each track. There were good signalization for the elevators and they were wide enough for a wheelchair and a helper. There was only one button for moving up or down in addition to the alarm and a button for closing or opening the doors. There was no audio guidance or Braille except on the alarm button. However, all the buttons had embossed symbols. There was no threshold to the elevator making it easy to access. The stairs were made of homogenous granite tiles that had no contrast stripes and had railings on both sides. There was a ramp that was separated from the rest of the stairs with a railing.

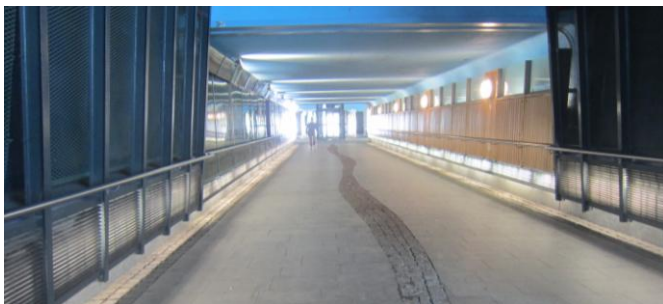
Image 39: The station tunnel under the tracks (Jaakkonen, 2015)

The station tunnel under the tracks was well-illuminated and with good color contrasts and had also a contrast stripe the floor. The railing existed on both walls of the tunnel (Image 39). In the other tunnel that lead from the tracks to the station tunnel near Sampola Service Centre and the pedestrian street in the center was entered by walking a long, downward ramp. In the middle of the ramp there was a plateau for resting, and the gradient was light enough for going up or down using a wheelchair. The ramp was also illuminated and had railings, as well as a contrast stripe on the floor.

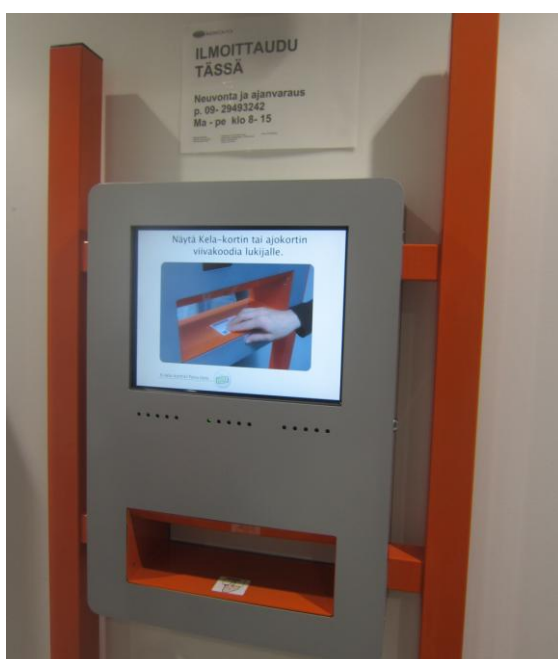
Image 41: The self-service automat with touch screen (Jaakkonen, 2015)

As a whole, Sampola building was accessible and in most cases could be visited without a helper. There were however a few problem areas, the greatest problem for the visually impaired customers being the signing in to the dental services. The signing in was done using a touch screen machine seen in Image 41, where one had to place a social health insurance card and receive a service number. There was an audio signal when a service number was changed and the customer had to check the room number from the service screen. If the customer did not find the right room, the dentist came calling them by name. Otherwise the staff was very helpful and ready to assist a customer in need. The structure of the building was simple and there were no architectural barriers. The signalization was also good and the info desk had a floor map of the building.

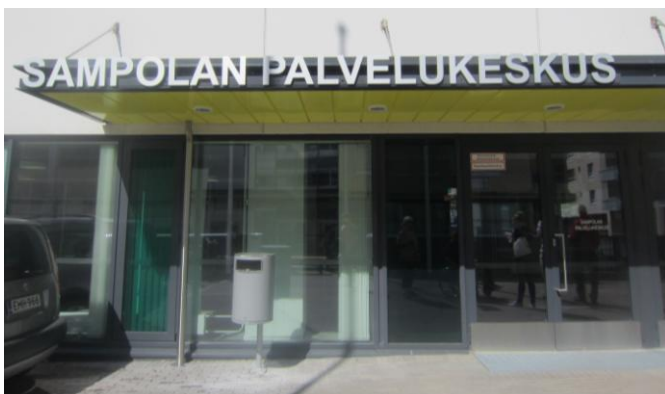
Image 42: In front of the main entrance to Sampola Service Centre (Jaakkonen, 2015)

Sampola is located right next to the railway station and even has an entrance straight from the station's tunnel. There is also an underground parking area and easy access for a car to right in front of the main entrance.

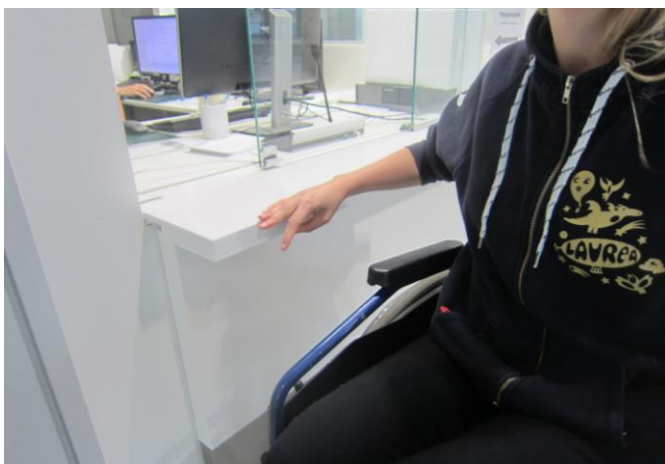
Image 43: The information counter in the entrance hall (Jaakkonen, 2015)

There are two entrances to Sampola, a side entrance below the ground level and a main entrance in the street level. In the side entrance there is an assisted door but not fully automatic. The width of the door was sufficient for a wheelchair and could be managed without a helper. The main entrance had one automatic door out of three doors in total. However, the automatic door did not have any signalization. After pointing out the lack of a sign to the staff they immediately fixed it. In both of the entrance halls the contrasts were good and lighting was excellent leaving no corner dark. The info desk was located directly in front of the entrance thus making it easily accessible for all. There was also an information board of the buildings floors and their services.

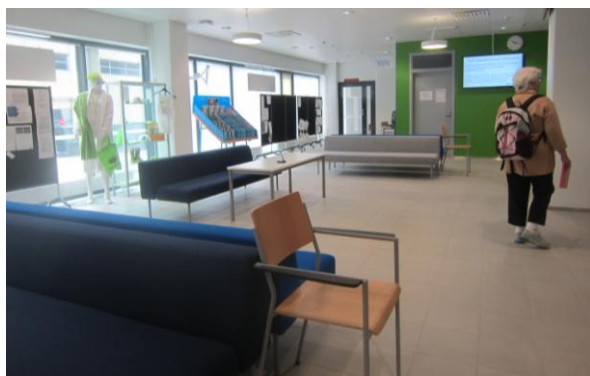
Image 44: The waiting area (Jaakkonen, 2015)

The service encounters were all good height and had two levels, one suitable for a wheelchair customer and one for a walking customer. However there was a partial glass between the customer and the clerk which could cause problems for communication with those that have a

hearing impairment, especially since there was no audio induction loop. The service counters and customer areas on different floors were similar, which makes it easier to orientate for the visually impaired. The waiting areas were spacious and had plenty of seats for customers (Image 44). In the first floor there was also a computer table and a practicing point for using the travel card. All if the counters and information desks were accessible by a wheelchair. The coat racks were ill-placed around the corner with no signalization.
