Standards for handling Controllable Pitch Propeller failures

Bachelor's Thesis

Degree Thesis, Bachelor of Marine Technology (Captain)

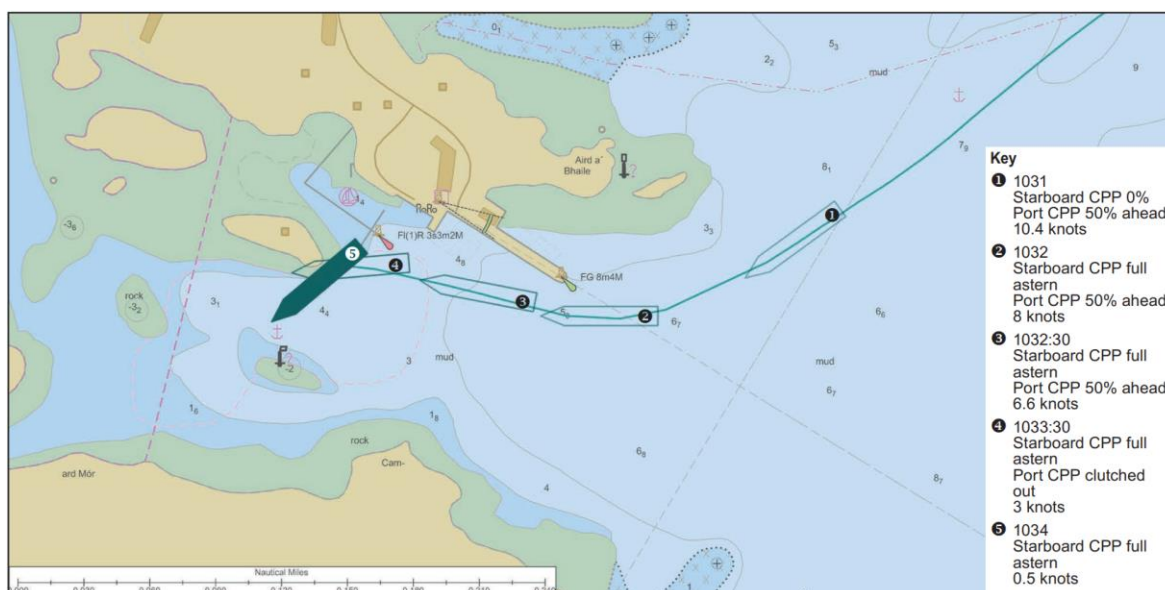
Figure 3, Hebrides track after loss of control

10:31 the master places the port CPP to 70% astern, presumably to decelerate and turn the vessel to port in preparation for reversing to the quay ramp. He notices that his speed isn't reducing, and soon after the third officer informs him that the port CPP indicator still shows 50% ahead. The master reacts by immediately ordering both CPPs full astern. This causes the vessel to turn starboard, as the actual thrust is starboard 100% astern; port 50% ahead. At this point, the vessel is 200m from the pier roundhead. (Marine Accident Investigation Branch, 2017)

10:32, as the Hebrides passes the roundhead, the third officer prompts the master to de-clutch the port propeller, but this proves unsuccessful. A minute later, 10:33:30, this issue is solved, and the propeller clutched out. It was however too late, and the vessel ran over the nearby yachting clubs' pontoons and grounded itself. (Marine Accident Investigation Branch, 2017)

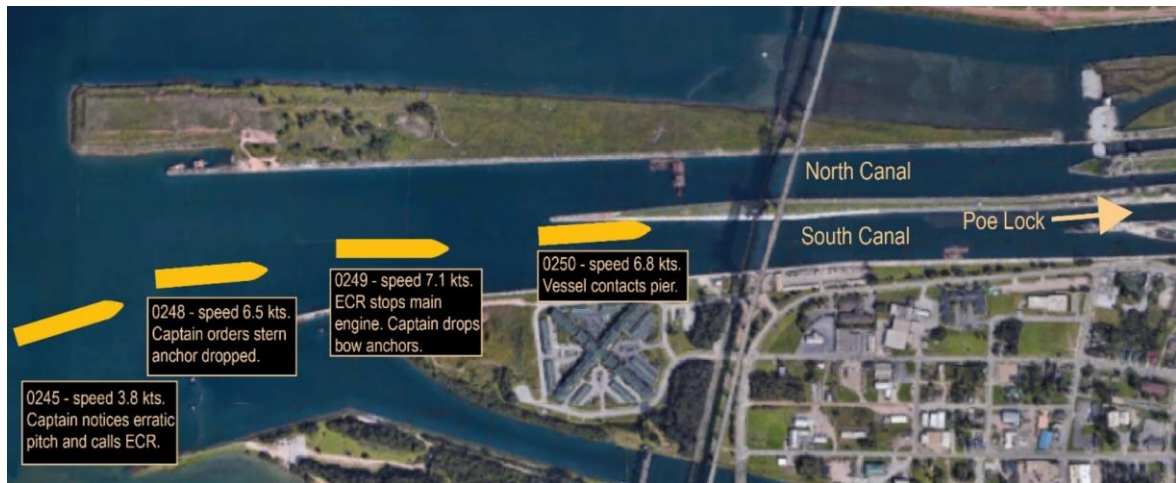
Figure 5, Atlantic Huron collision with pier

As the master was conning the vessel to berth, he noticed that the CPP pitch indicator was acting erratically, and soon later realized that the vessels speed was increasing. He did not order an emergency stop of the engine until 4 minutes later under suggestion from the ECR, when the speed had increased to 7,1 knots and one stern anchor as well as both bow anchors had been dropped. The vessel finally made contact with the pier at 6,8 knots. Damages caused were estimated at \$2,2 million, no human injuries were sustained. (National Transportation Safety Board, 2021)

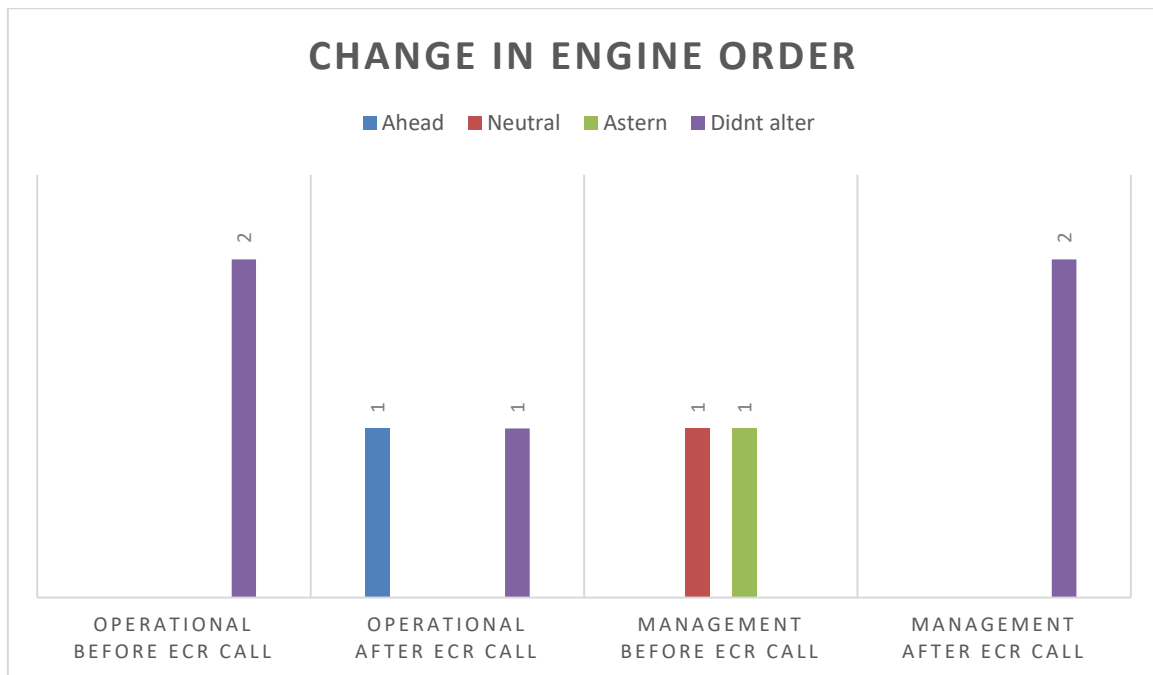
Figure 7, Change in engine order

All students displayed clear reactions to the vessel behaving strangely between 40 and 45 seconds after initial failure, but none contacted any department of the vessel during the following 45-50 seconds before the ECR called them. None of the bridges initiated an emergency stop within 3 minutes of initial failure. However, in the debriefing, both management bridges did after a little thinking state that emergency stopping the engine could have regained control, the operational bridges did not. From the changes in engine orders seen in Figure 7, Change in engine order, it shows that the management students made quicker decisions and stuck to those decisions after the ECR called. There doesn't appear to be any correlation with what engine order was given.

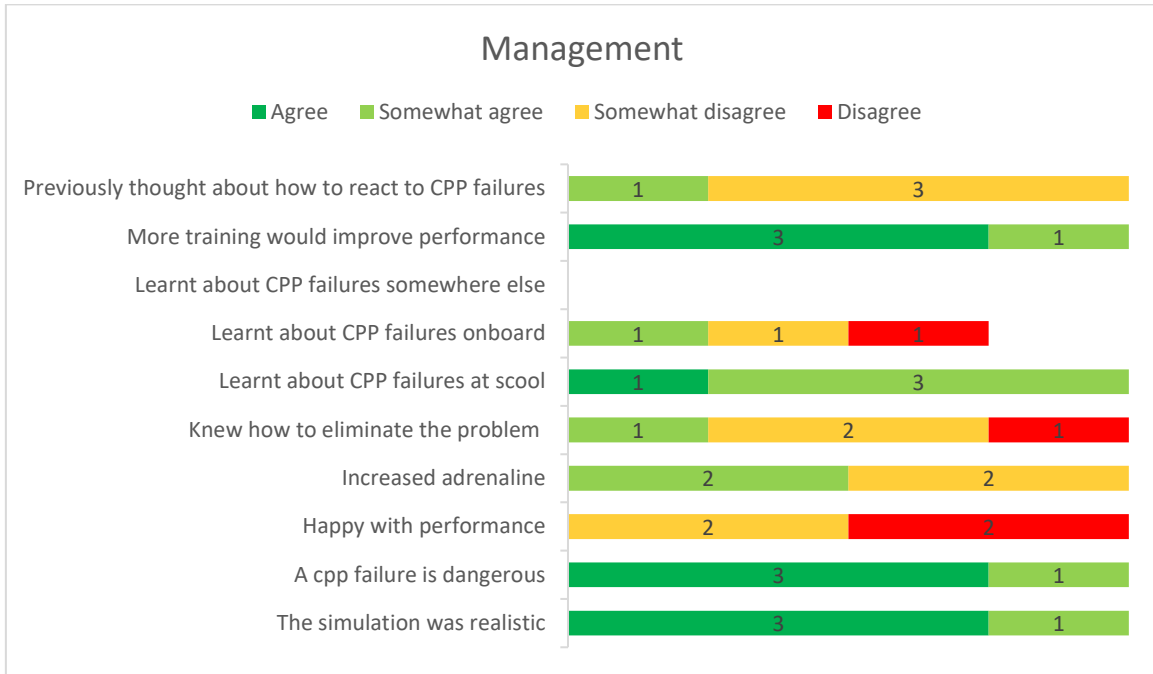
Figure 8, Self-assessment results Management

Figure 8 and Figure 9 show how management and operational students respectively answered in their assessment forms (Appendix 1: Self-assessment form). The colour represents the answer they gave and the number how many of each answer was given. The colours were chosen to allow the reader to effortlessly scan the trend of answers given to each question. The greener the bar is, the more students agree, the redder the bar is, the more they disagree.

Based on the information gathered in Figure 8 and Figure 9, Aboa Mare students appear to become more aware about CPP failures during the management level semester, and report that they have received this awareness from school, not from onboard training. Students from both levels almost unanimously agree that more training would have significantly improved their performance, yet the management students were more disappointed with their performance than the operational students. Only one Management student somewhat agrees that they immediately knew how to eliminate the problem, but determining from 5, had not acted on it. A small to moderate increase of adrenaline was reported by all students, suggesting that cognitive impairment was likely successfully induced. All students agree that this failure has the potential to be very dangerous, and all but one agreed that the scenario was realistic.

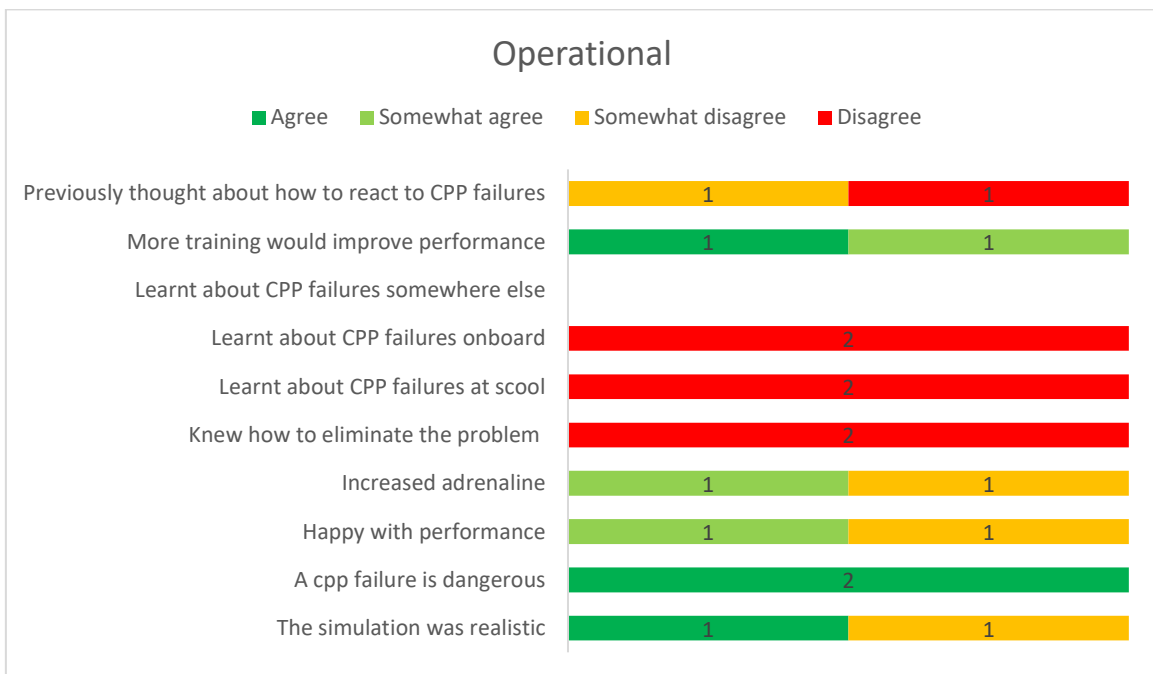
Figure 9, Self-assessment results Operational
