KARELIA UNIVERSITY OF APPLIED SCIENCES  
Degree Programme in Electrical Engineering

Remote Sensing of Medium Voltage Grid: Case Elenia

Thesis  
May 2013

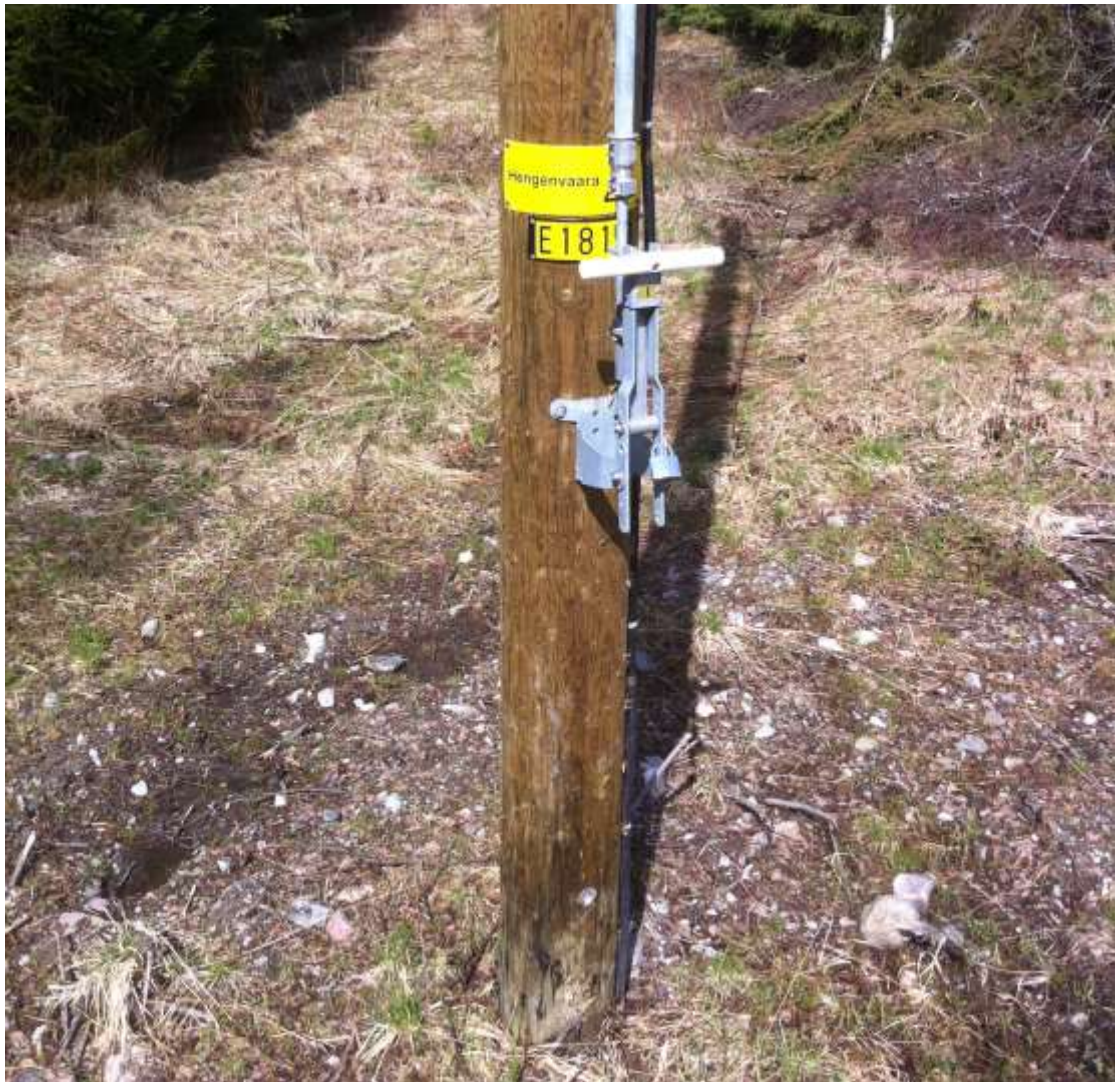
The control pipe, control pipe insulator and disconnector beam must all be properly attached to each other, whereas in a cable operated disconnector the cable tension and condition must be examined. In a more thorough inspection the functioning is also tested, which requires the line to be dead as disconnectors are not designed to handle large currents.

PICTURE 5. Disconnector control device

The control lever must be at highest 1.5 metres from the ground so that enough force can be used to operate it without climbing on the pole. The position of the disconnector must be labeled on the lever with the corresponding 1 / 0.

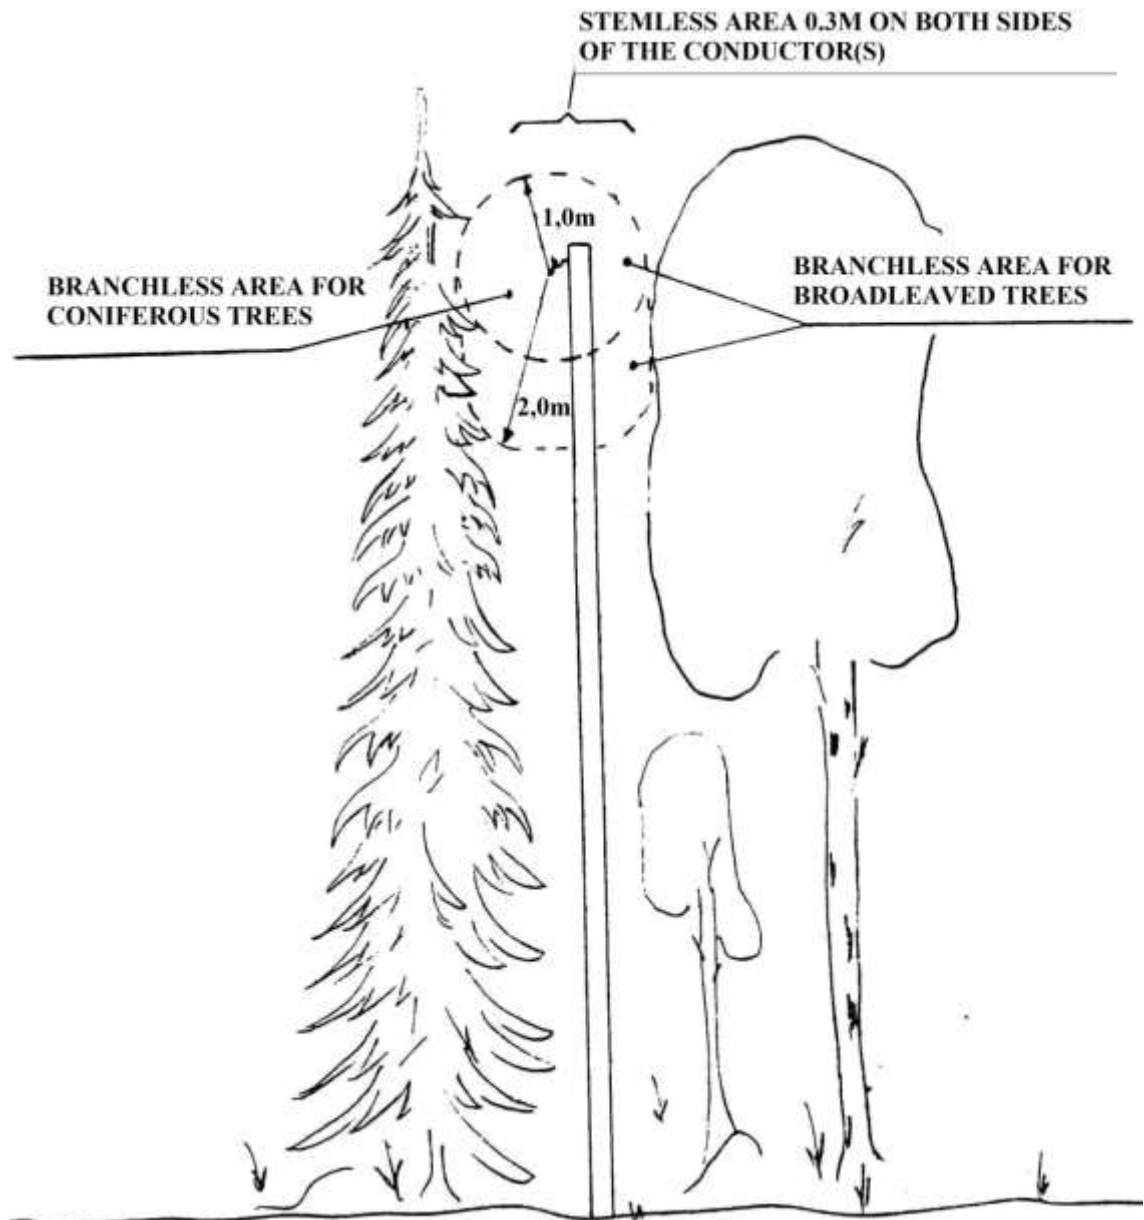
PICTURE 9, 20kV forestland overhead cable line area, SAMKA-conductor

SAMKA is a bundled aerial cable, which is a medium voltage equivalent to the famous low voltage AMKA-cable. As a cable, instead of a wire, it requires very few other components to function well. Polyethylene insulated cables are wrapped around a bare aluminium alloy messenger which acts as the attaching part at a pole, eliminating the need for ceramic insulators. The right of way remains very narrow which allows this cable type to be used in places where a broad right of way is not possible, saving costs in land acquisition. /13/
