COST REPORT OF FAÇADE WOODWORK

Case As Oy Espoon Tähtirikko

Bachelor's thesis

Degree Programme of Construction Engineering

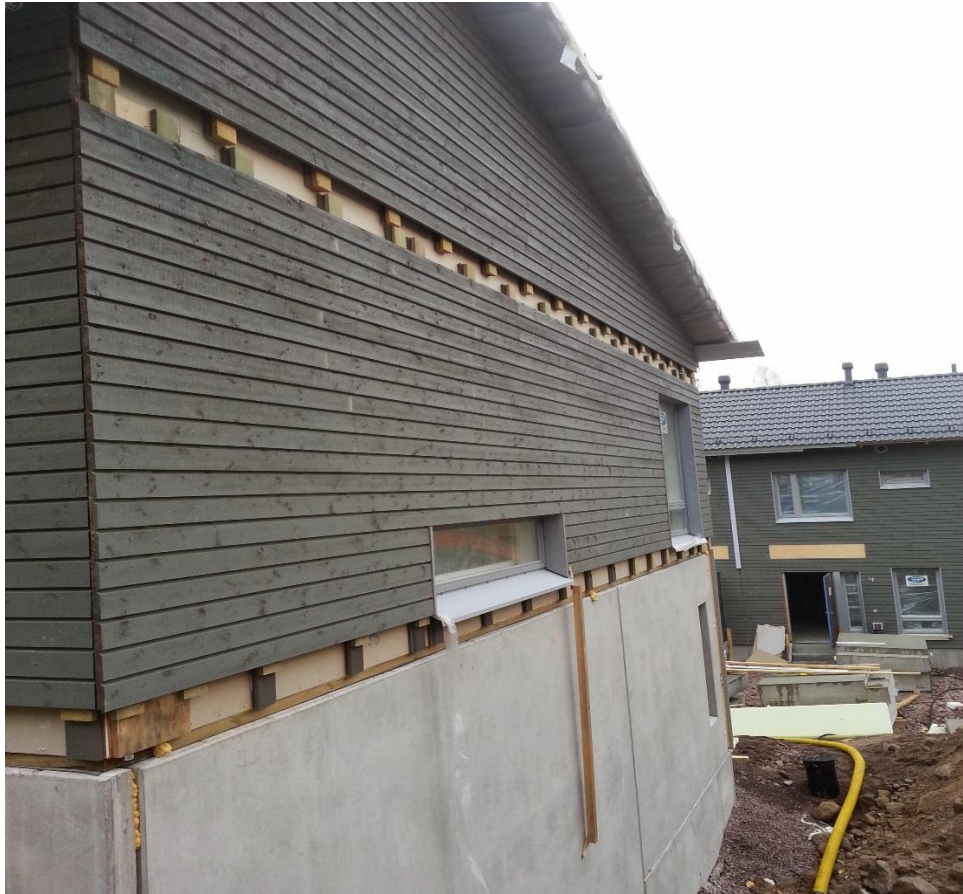
As we can see in Figure 1, problems occurred with accurateness of the element assembly in E-building on Tähtirikko site. The studs and panels will be installed partially on top of the plinth. As we can see in the piece of wood placed hanging, there are differences in the placement of the studs. The studs on the first floor element are approximately 15 mm more inside than the studs on top of the plinth. If panels are installed straight down from the element face, there will be a bulge.

Figure 1 Assembly tolerances and accurateness. Ahokas M. 2014.

When considering the Tähtirikko site, the biggest buildings consist of seven apartments. Therefore, on one side seven elements are also assembled. If elements are assembled with maximum tolerances, the measuring difference at the end of the building can be up to 56mm, compared to the starting point. If this scenario happens, it will cause more work with woodwork. Also, if we consider that assembly tolerances are not in line with the first and second floor, similar difference can be found at the ends of the buildings.

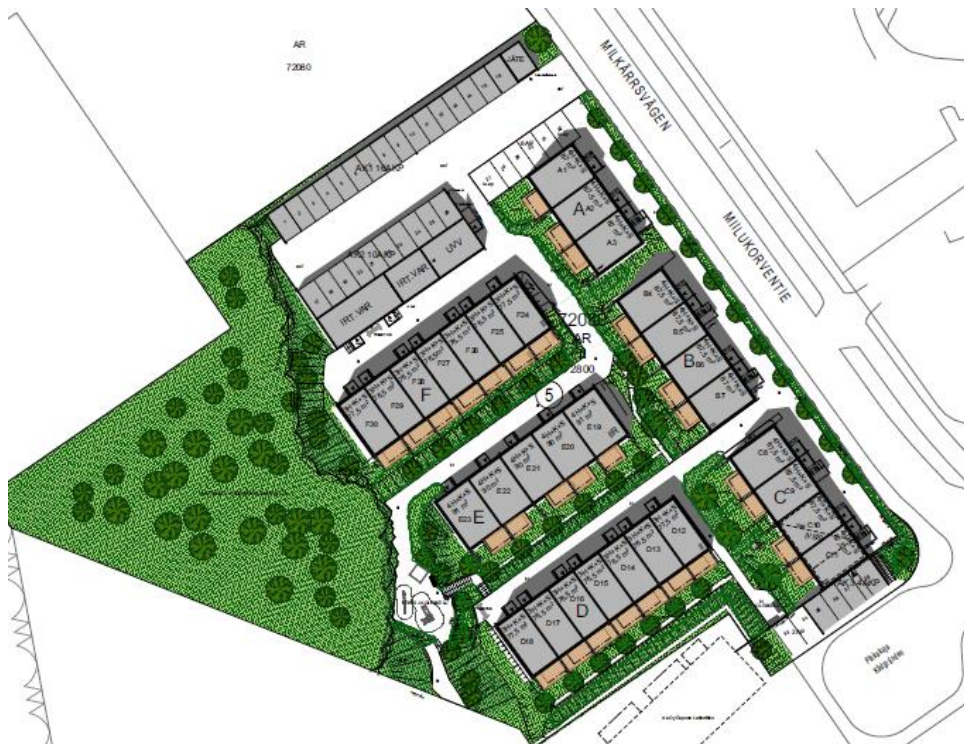
The soil at Tähtirikko site consists mainly of silt moraine, rocks and bedrock. The plot itself has big differences in elevations. Steep bedrock is visible on the western corner of the plot. (Huokuna, Geotek Oy, 19.11.2012). Notable elevation difference can be seen most easily when comparing the first floors of buildings F and C. On the western side, buildings F, E and D are linked to the bedrock. The Storage area is not seen in this picture, it is on the northern point of the plot.

Figure 5 Picture of the plot. Konola A. 2014. General layout.

Due to the flat location, the northern and eastern sides of the buildings cause no difficulties and cause no extra time consuming work phases, i.e. work can be executed at a normal pace. As said before, the storage area on the site is located on the northern point of the plot. As we can see in Figure 5 (page 6), building D is located on the most southern point of the plot,

In E-building, on the soil pressure wall side, there is just one floor. Therefore, big part of façade woodwork could be executed from the ground level, without the passenger crane. As we can see in Figure 5 (page 9), buildings E and D are close to each other. When working on longer sides in between the buildings, the crane movement was minimal. This is a positive aspect on tight plots. Therefore, difficult logistic arrangements in front of D building also had an effect on E building.

As we see in Figure 5 (page 9), buildings A, B and C form a line, with a small distance between each other. This feature decreases the amount of work between the buildings, as moving the passenger crane is minimal, which decreases man-hour per meter. The amount of work increases and man-hour per meter decreases, as we compare A and B buildings.

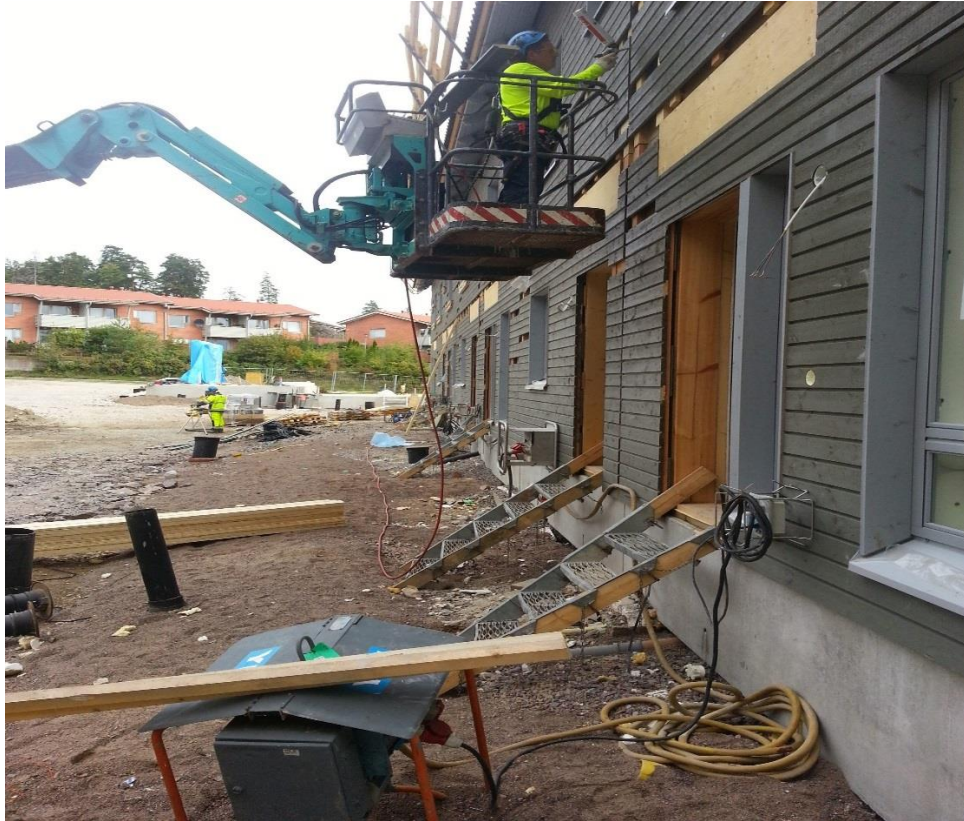
Figure 10 Polyurethane foam sprayed into the vertical seam using a passenger crane. Ahokas M. 2014.

upper seam and rows of panel are missing from the lower seam. The starting point of installation of corner boards can be seen in Figure 11. In Figure 10 we can see the starting point of installation of doorjambs, as plain doorframe is visible.

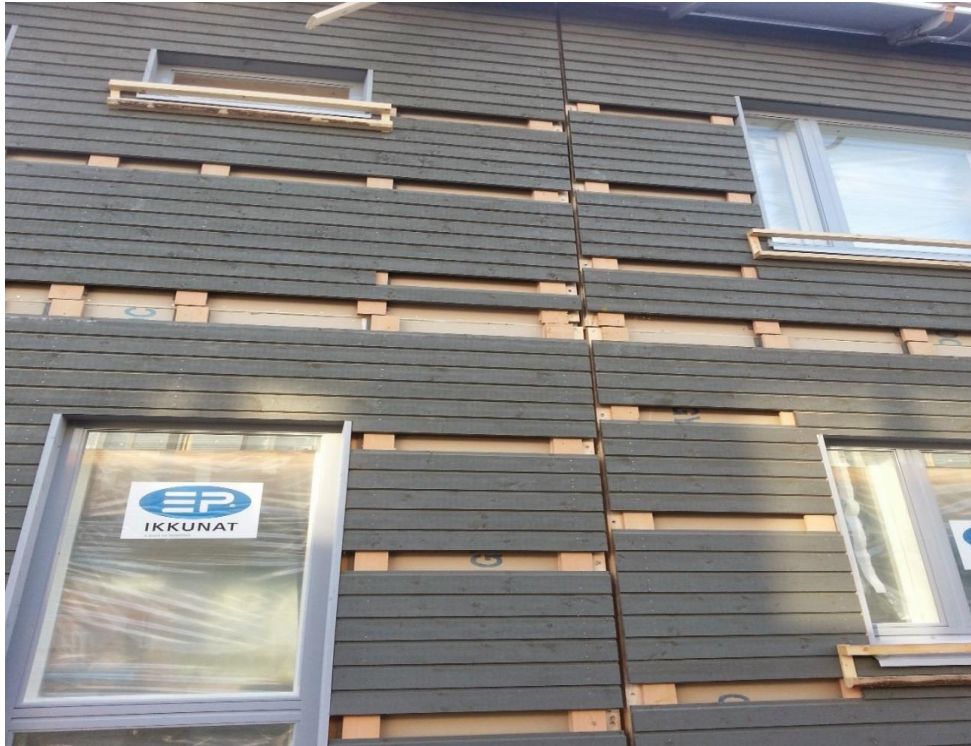
Figure 11 Starting point of façade woodwork. Ahokas M. 2014.

The work content of façade woodwork includes the installation of missing façade panels, the installation of corner boards, fastening of doorjamb boards, fastening of elements and insulation of joints. In Figure 11 (page 14) we can see the starting point of the façade woodwork. There we can see that panels are missing from this point of the building, due to a horizontal seam on top of the element and vertical seam in between two elements. From the picture we can also see that the covers of the window's weathering strip, installed to protect them from damaging during transportation, are still in place.

The attachment of missing panels cause the single biggest difference compared to the estimation. Although the time reserved for the work phase is the largest, working time due to the various difficulties, runs out. As we can see in Figures 11 (page 14) and 13 (page 15), there is a lot of work done by hand; panels must be taken in, notched and cut to length in many places around the building. Different kind of machinery is used in all of these jobs mentioned above, which take time to move, transport, use and maintain.

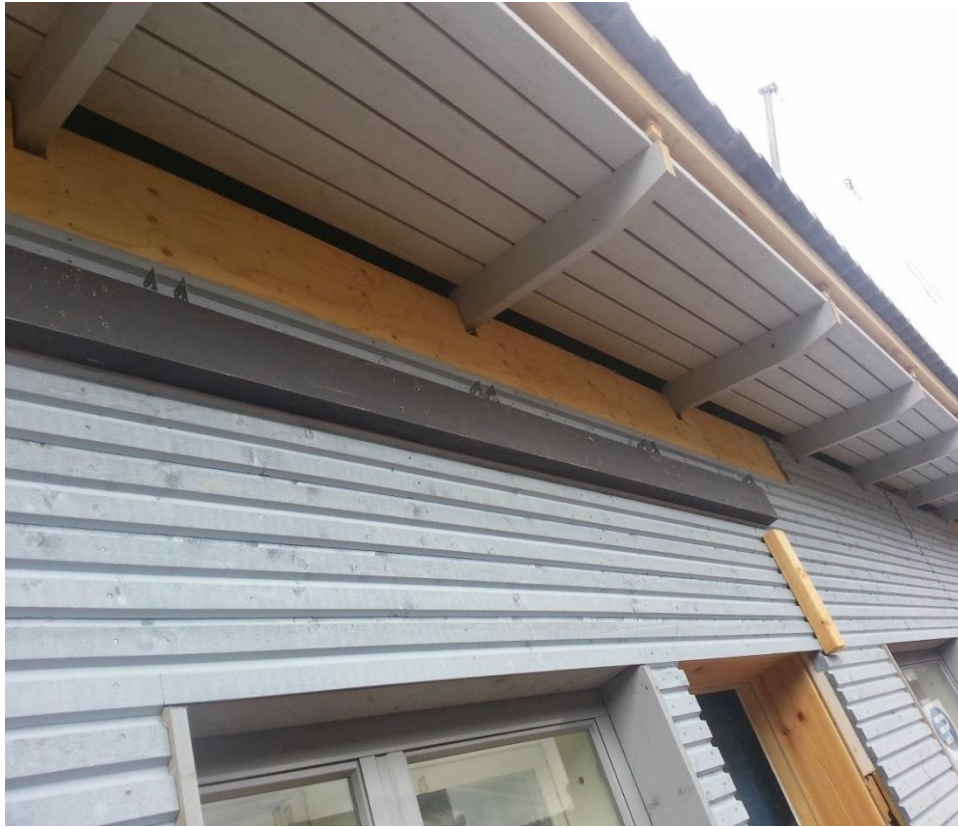
Figure 12 Starting point of the roof woodworks. Ahokas M. 2014.

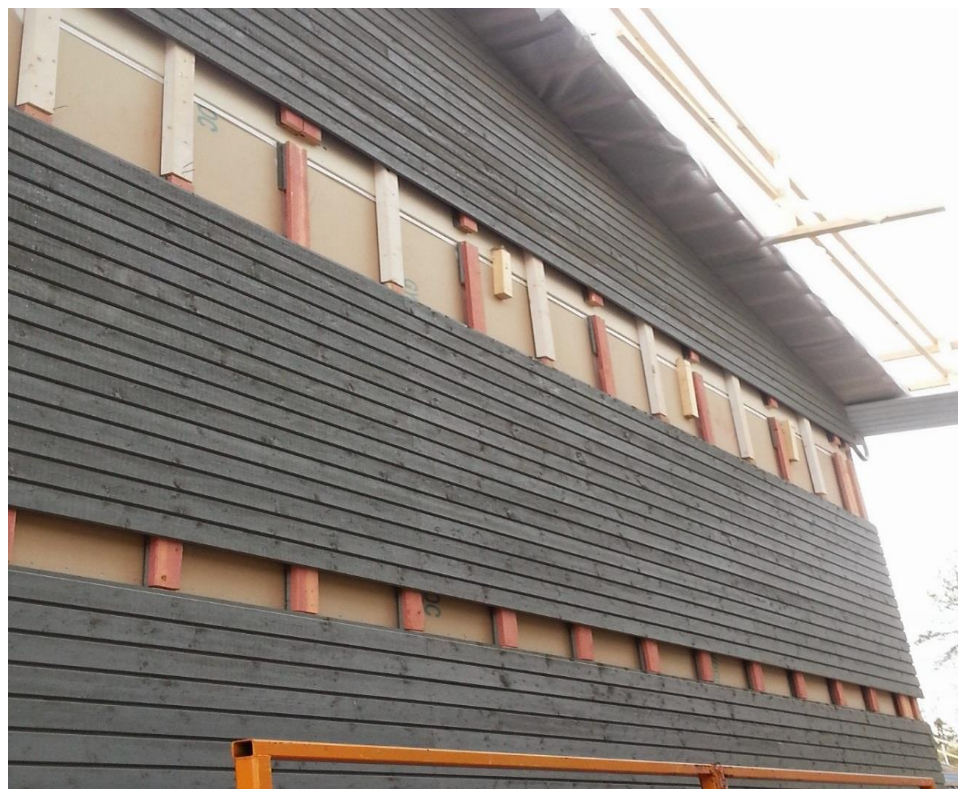
Figure 13 Starting point of the roof woodwork at ends of buildings. Ahokas M. 2014.

In Figure 13 we can see the starting situation of façade woodwork at the ends of the buildings. As we can see, rows of panel are missing from the

Work content of roof woodwork includes the installation of eaves soffit boards on long and end eaves of the building. In Figure 13 we can see the starting point of roof woodworks at the ends of buildings. It is noticeable matter that there is no eaves soffit cladding installed by subcontractor.

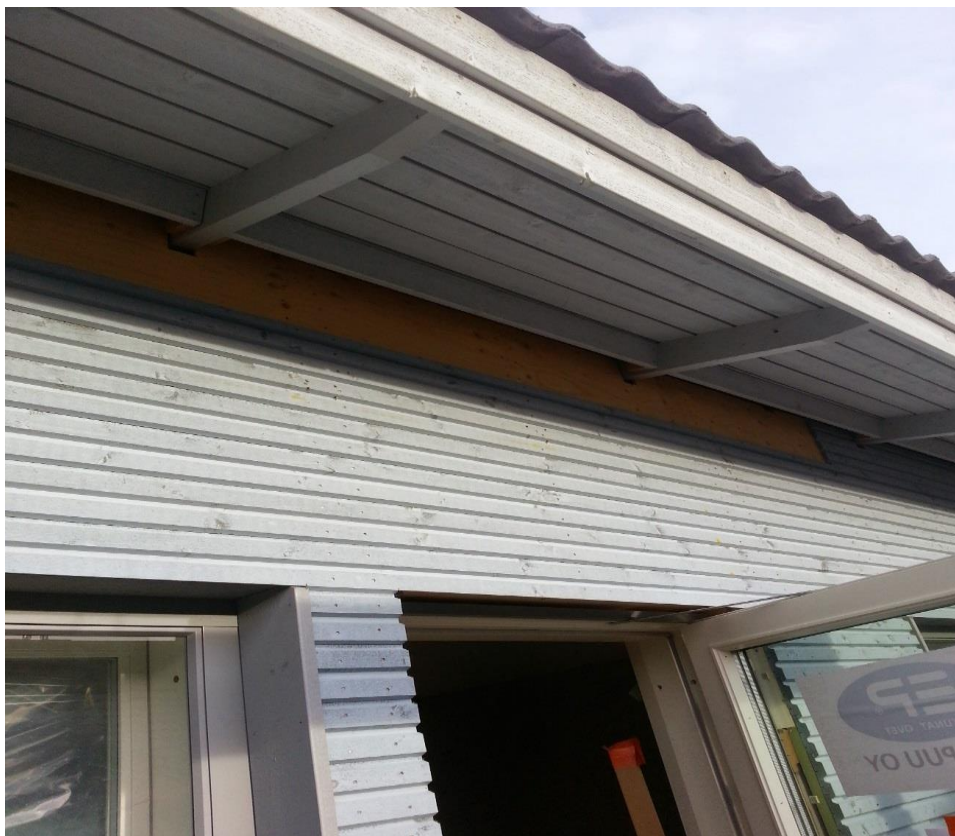
Figure 14 Storm boards and side eaves finished. Ahokas M. 2014.

The detail drawing in Figure 2 (page 5), explaining the assembly of the highest panels and on longer sides, can be seen in Figure 14 (page 16). The storm boards are not drawn into this figure, since they were not included during the design phase, they were installed due to orders of the client. The detail in Figure 3 (page 6), can be seen in Figures 14 (page 16) and 17 (page 17). Two boards on the face of eaves are installed so, that the roof sheet can be fixed to them.

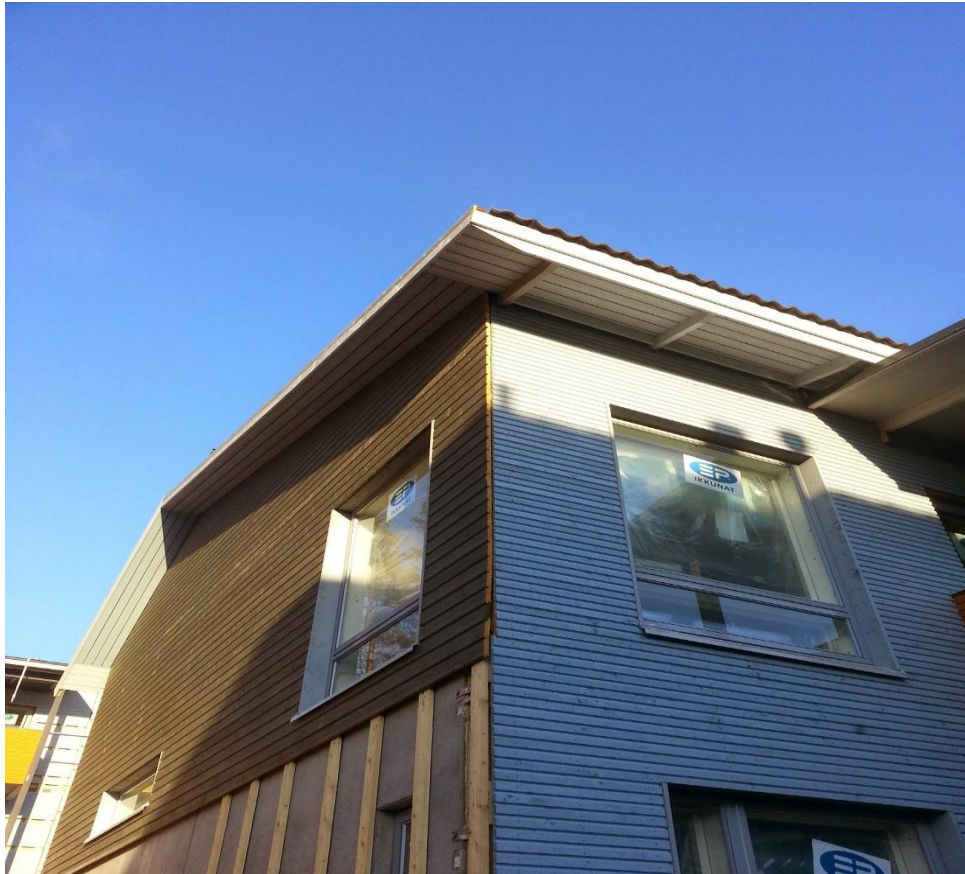
Figure 15 The junction of eaves in building E. Ahokas M. 2014.

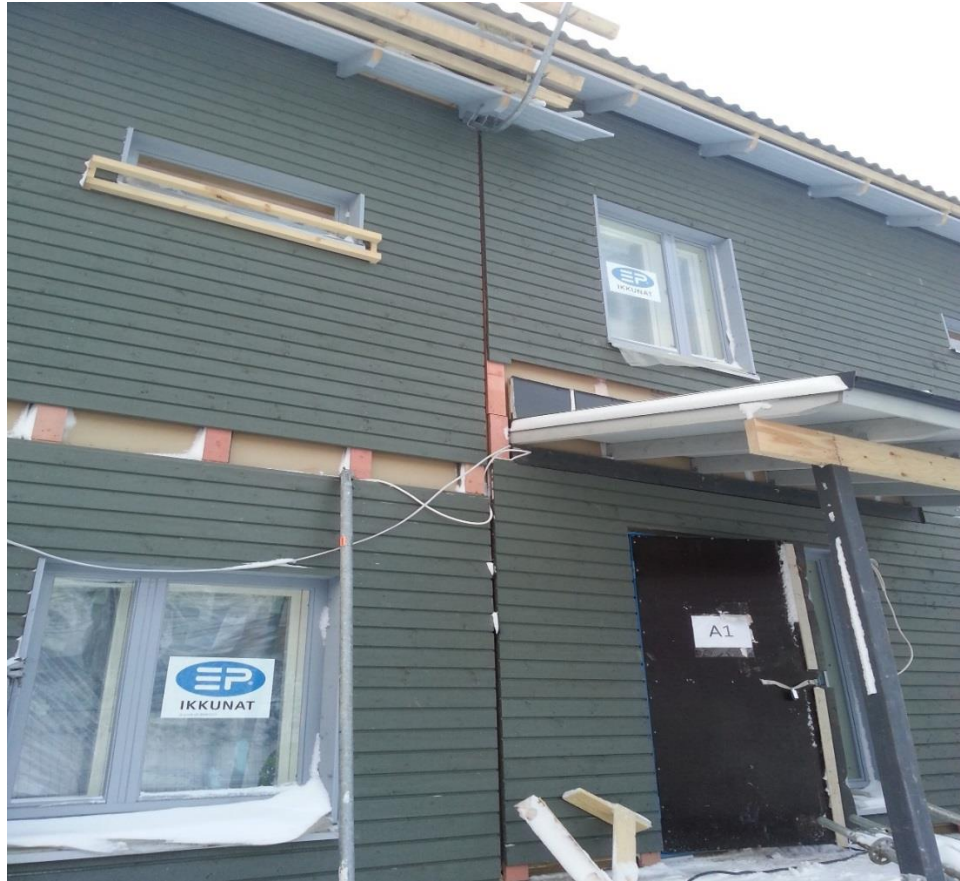
A special feature in A, B and C buildings is the level differences, since all of the buildings are located parallel to the slope. As we can see Figure 16, the level difference at the eaves is more laborious to be done than a straight eave. In building A, the level difference is situated between first and second apartments.

Figure 16 Level difference in A building. Problematic electrical cabling also visible. Ahokas M. 2015.

Due to the overlapping of the work phases, when working on the side eaves of the building, fall protection railings on the roof must be taken off. As wall elements are delivered to the site, the protection shields of windows are used to protect the weathering strip. The uninstallation of these weathering strips and fall protection railings are calculated in the work input of element fastenings. Railings and weathering strips can be seen in Figure 16.

As we take a look at the issues with A building, there were problematic electrical cables, as seen in Figure 16. The working time lost with the wiring is four hours. Wirings had to be placed in between the studwork and to be able to do that, studwork had to be cut. When paneling the wall, the carpenter had to be very careful, so that nails don't penetrate the electric cables. This problem could be taken into account as elements are designed. A casing pipeline could be installed as element as it's being manufactured, so that it is placed inside the studwork, to prevent this kind of problematic work phase on site.

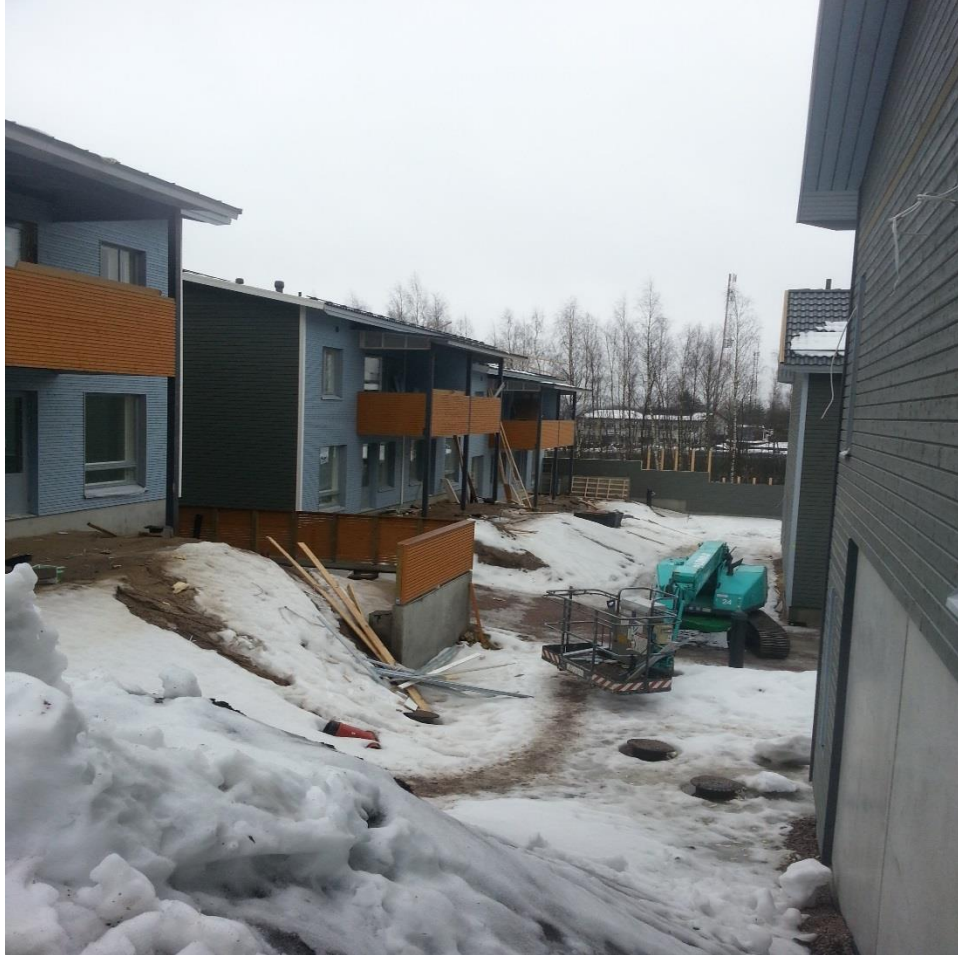
in the middle of the building. The terrain on side next to building E is very steep, as seen in Figure 18. With that side, long extensions of the boom are needed to be able to construct the eaves. The ends of the building are very narrow, buildings A and C are very close on each end. On the eastern side of the building, the terrain is in good condition.

Figure 18 The terrain on the western side of the building B and the eastern ends of buildings D and E. Ahokas M. 2014.

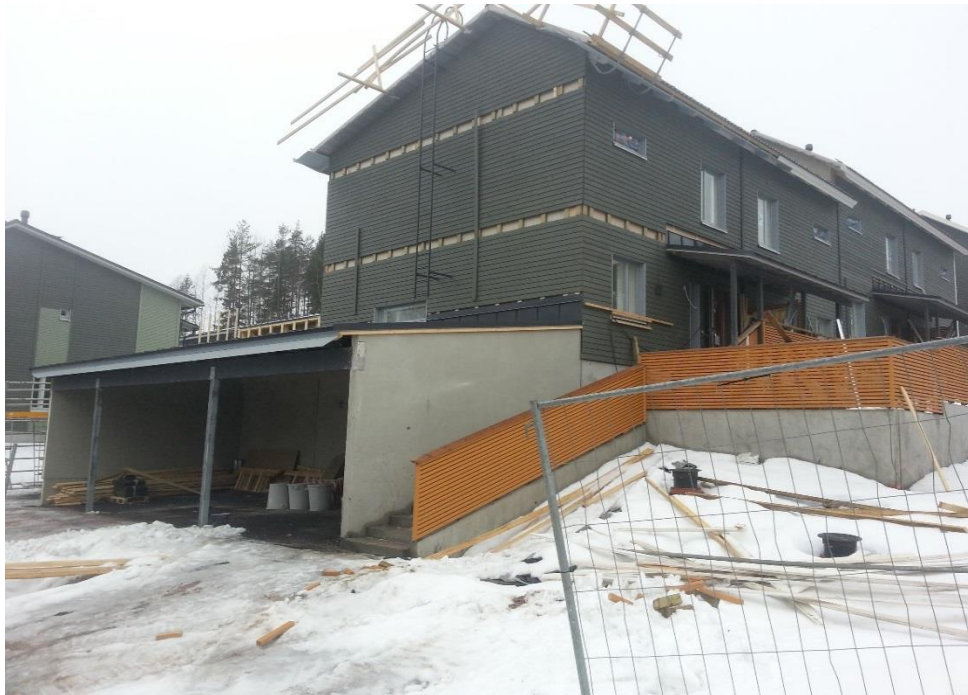
C-building differs from other buildings in that in the cellar of the building lies the air raid shelter. However this doesn't have an effect on the façade woodwork. The car port at the end of the building has a significant effect on the work, as seen in Figure 19. Due to the level differences at the site, at the end where also the car port lies, is a retaining wall that connects C building and the past project, Lehtorikko's outmost corner.

Figure 19 The southern end of the C building. Ahokas M. 2015.

As we can see in Figure 19, car port makes a difference in the façade woodwork so that some of the paneling is left out at the end. The height difference between the highest point of the building and ground level in front of the car port is approximately 11 meters. The level difference at the point also causes a long extensions of the passenger crane's boom. Stairs leading to the car port lie on the eastern side of the building. These stairs

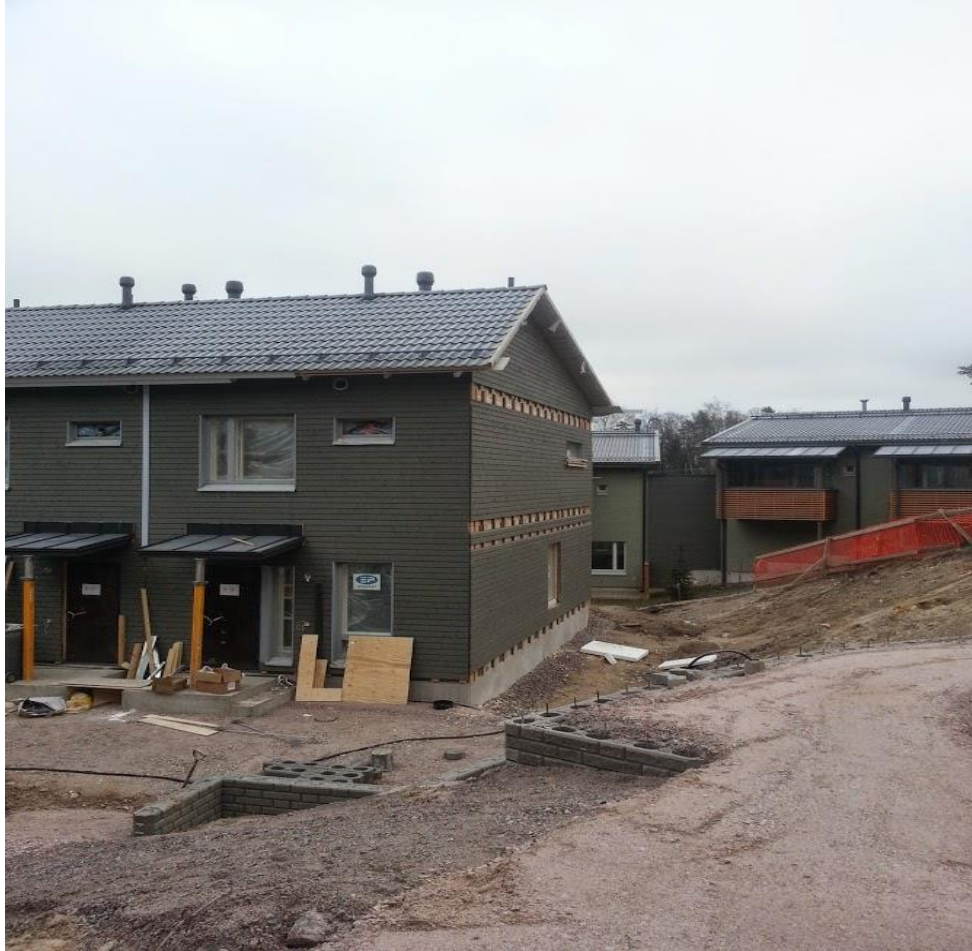
Building D lies in a flat location and consists of seven apartments. The exception is the western end of the building, which is near to the slope. There is a steep climb up, as we can see in Figure 20, which makes working there more difficult. A carpenter cannot drive the passenger crane in that area in the end of building. The end must be done so that the passenger crane is driven right to the end of the building and the work is done with a fully extended boom or by changing the passenger crane. This increases the man-hour per unit or the rental costs of the new passenger crane.

Figure 20 The western end of building D. Ahokas M. 2014.

We can also see in Figure 20 that on the southern side of the building F, there are other buildings, too. These buildings limit the working area in the zone. As we can see in Figure 21, the southern side is also profiled by the earthwork subcontractor and due to that the area is not accessible to the passenger crane. Due to this poor scheduling of work, the façade on this side was not accessible with the passenger crane. The woodwork was done from wooden bridges, assembled in between the balconies. This method is slower, which increases the man-hour per meter and more importantly the work safety of the carpenter cannot be ensured as well as working from the passenger crane. The woodworks were done at the same time as the partition walls of balconies and other woodworks were done.

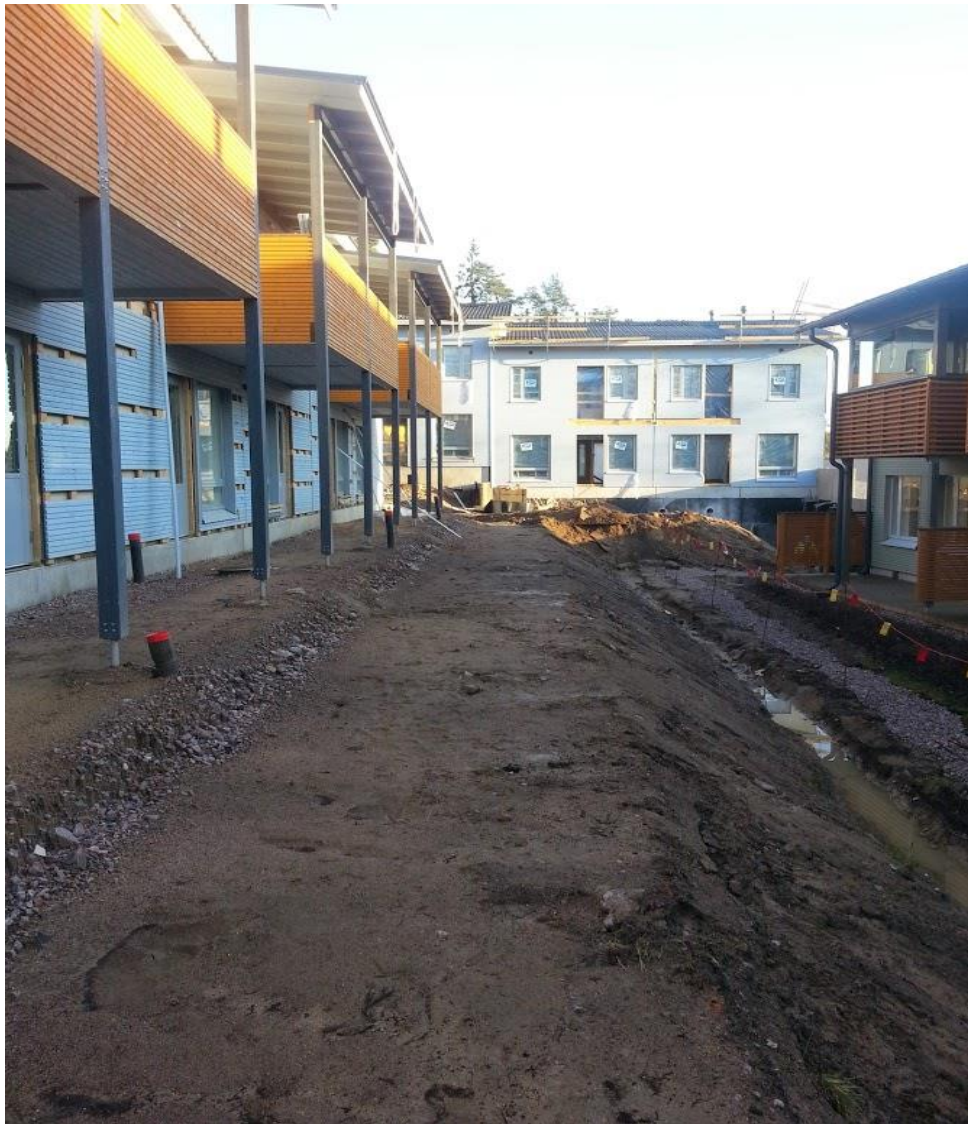
Figure 21 The southern side of building D. Ahokas M. 2014.

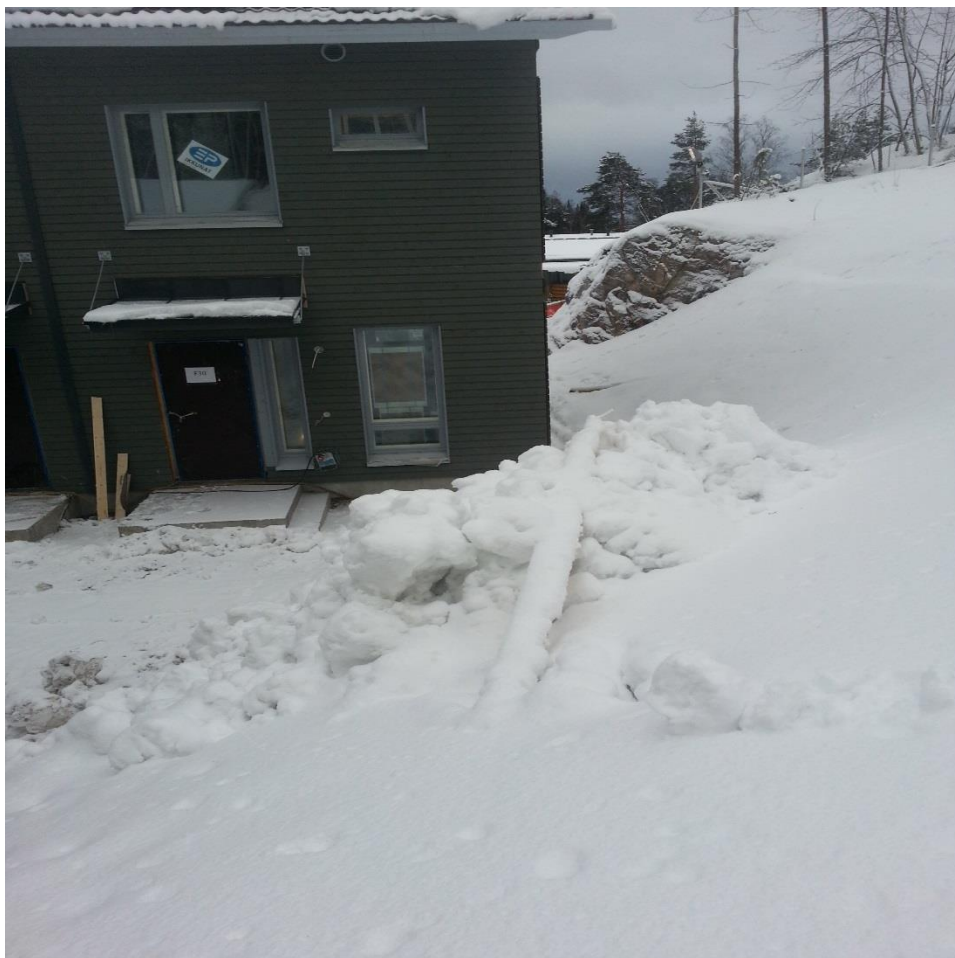
The most problematic area lies on the western end. The area is near to the rocks and it is very steep. Moving to the position with a passenger crane is very difficult, as we can see in Figure 23. On the northern side there is a big pile of snow and on the southern side the road doesn't continue far enough.

Figure 23 Building F, western end. Ahokas M. 2014.

Building F lies on a decent place of the plot from the point of view of construction. The using of passenger crane is easy on every side of the building, except on the western end. As we can see in Figure 23, the condition of the end is not suitable for passenger crane to drive to. In this case, the façade woodwork has to be done from very long extended boom, which slows down the work pace. The work can be executed from the southern side of the building, as on a northern side, there is a limited area for the passenger crane to operate, due to the closeness of car ports.

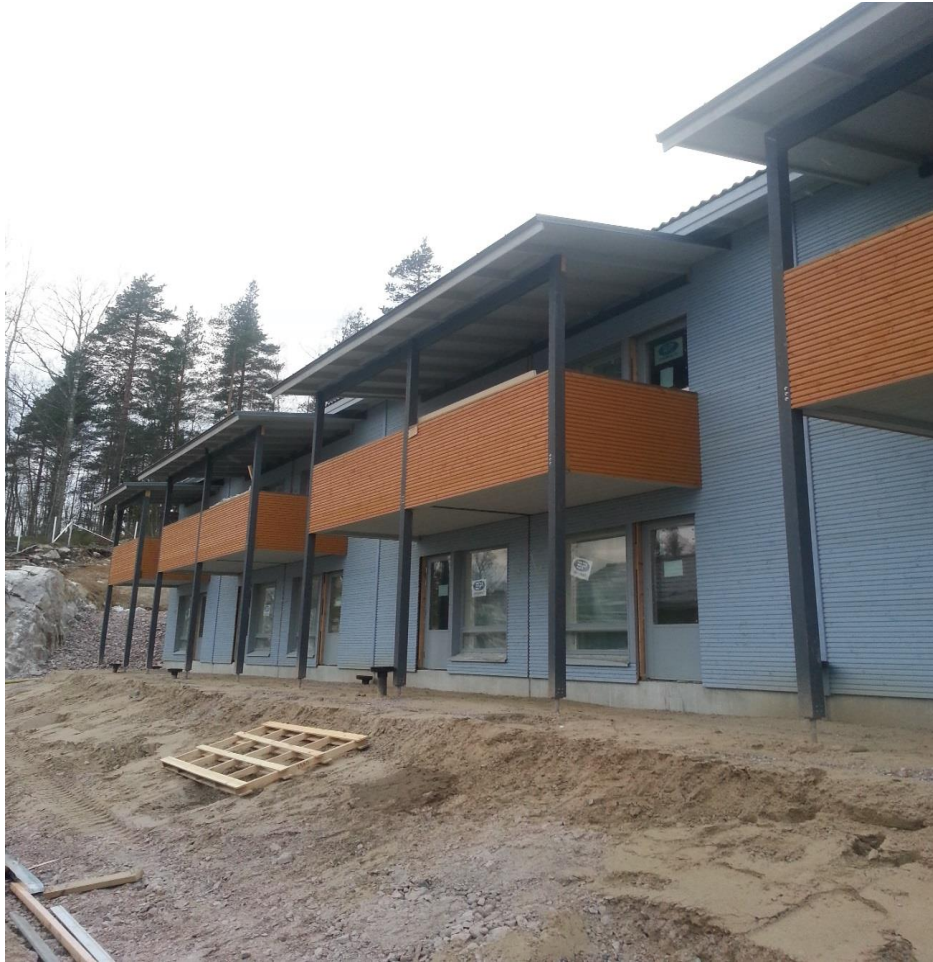
On the southern side of the building, the closeness of the building E cuts down the working time, as the movement of the crane and material can be minimized. Although this is the case, the extension of the boom is significant as we can see in Figure 24. The passenger crane can be driven on a spot so that the right track of the machine lies on a bottom left corner in Figure 24, where we can see the wooden boards. This position is safe to be driven to, as the base is a drive path for cars. This ensures the safety of the work, as the stability of the crane is ensured as the boom is extended.

Figure 24 Building F, southern side. Ahokas M. 2014.
